SOME 2CV HARD LUCK STORIES ALONG THE ROAD

By Graeme Dennes

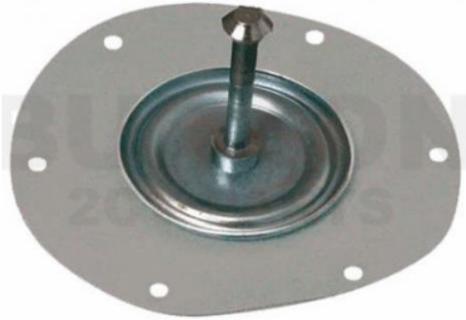
Away From Home Problem 1:

While away from home, our orange 2CV would run for perhaps 2-3 km, then almost die from what seemed like fuel starvation, but, with much encouragement it would (blurrp, blurrp, blurrp, just) come good again and off we'd go (blurrp, blurrping blurrping), with the process being repeated. Fuel was not overflowing from the carburettor, which would otherwise indicate a failed float valve. It seemed probable that it was being caused by either dirty fuel (possible), a restriction in the fuel line from rubbish from the tank (less likely), a dirty fuel filter (possible, but the filter had just been changed), a sticking carburettor float valve (cycling with a repeated sticking action) is very unlikely), dirt in or around the carburettor jets (possible), or a fuel pump failure (possible). It could also have been due to rubbish trapped in the fuel filter, whereby the very act of fuel being drawn through the fuel filter by the pump pulls on the rubbish sufficiently to cause the filter to block itself off, when the engine would stop or almost stop, at which point the rubbish would fall away again, allowing fuel to pass, and repeating the cycle. However, as the fuel filter had just been replaced, I discounted that option for the moment. I therefore put my money on the fuel pump, so my first step was to disconnect the rubber fuel hose from the carburettor inlet pipe, then start and run the engine for just a few seconds to check how much fuel was being discharged from the fuel hose. Ah ha, it was found to be almost zero. As no spare fuel pump or diaphragm was carried as a spare, RACV Total Care was called to take us home!

I later confirmed that the fuel pump diaphragm had failed. The diaphragm material had become sufficiently "floppy" due to its age that no pump action occurred.

And what have we learnt? As the fuel pump diaphragm is not generally inspected, my new rule is to change it every five years, reminding myself by an entry in the maintenance log book. If unsure when the diaphragm was last replaced in your car, do it now as a matter of urgency. Always carry a new spare diaphragm or pump with you.

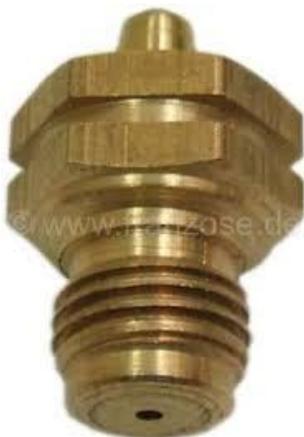
Away From Home Problem 2:

During Raid 2016, our orange 2CV started to blurrp, blurrp, then slow down and almost stop, so up went the bonnet. Clearly, the carburettor float valve wasn't shutting off the fuel as fuel was overflowing from the carburettor onto the engine below it. Not good! The problem could also be caused by an incorrect float height, a damaged float or binding float, or a damaged/worn float valve. The carburettor top cover was removed, both floats appeared intact, visually fine and doing their job, and both float heights were found to be correct at 18mm (with the gasket in place). The float valve was deemed to be the problem and it was replaced with a new one provided by a fellow Raider. (Thank you Alan!) The car started fine and all was good.

And what have we learnt? As the internal state of a float valve is essentially impossible to determine by inspection, my new rule is to change the float valve every five years, reminded by an entry in the maintenance log book. If unsure when the float valve was last replaced in your car, do it now as a matter of urgency. Always carry a new spare float valve with you.

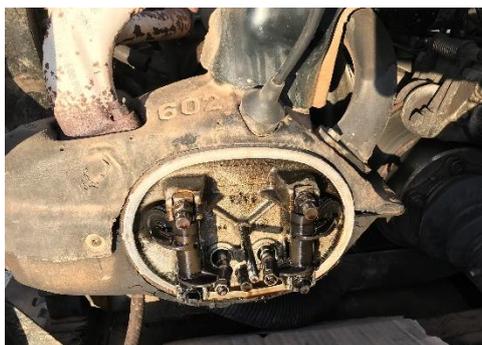
There was another item which hadn't been checked. After the engine had fully cooled down, the rocker covers were removed. The head bolts seemed tight but were not further tightened (no torque wrench at hand). The valve clearances were checked, and this is what was found: the two inlet valves were exactly correct at 0.2mm, but both exhaust valves had not only presented with *zero* clearance, but were in fact being held open by some small amount, meaning they were never able to fully close. Definitely not good.

Normally, in the four-stroke engine cycle, the exhaust valves are opened near the bottom of the expansion/power stroke after most of the power (and heat) from the burning/expanding gas has been extracted from the fuel mixture and converted into work by the pistons acting on the crankshaft. However, with the valves (always) open at the point of ignition and on the expansion stroke, the valve faces and seats are being subjected to the blisteringly high temperatures (even for steel!) of the burning mixture from the top to the bottom of the expansion stroke.

The analysis. I expect the large out of balance forces (the engine was pounding the engine mounts after it fired and until it reached idling speed) was because only one cylinder was firing during startup and idle because the other cylinder couldn't raise the necessary compression pressure required to ignite the fuel mixture because its exhaust valve was being held open too far. However, it still managed to start on one cylinder which already had a held-open exhaust valve! How the car even started leaves me astounded. Above idling speed and up to driving speed, the (slightly) held-open exhaust valves would have had less effect on engine power, as by then, both cylinders would be firing and providing their part of the total engine power with plenty of air-fuel mixture being drawn in at the higher engine RPMs, so the small amount of mixture escaping during the compression and expansion strokes via the open exhaust valves may not be readily noticed. If only one cylinder was operating at idle, it would help to explain why adjustment of the idle mixture screw had such little effect.

With the exhaust valves held open in this manner, the basic engine timing diagram (crankshaft angle vs valve open/close positions) was quite displaced from the correct settings. This, coupled with only one cylinder operating at idle, could well have caused the weird engine/manifold/exhaust note. It also means that instead of all the fuel-rich air mixture previously drawn in on the inlet stroke remaining in the cylinder to be compressed on the compression stroke, some of it was escaping (being pushed out) via the held-open exhaust valve and pushed into the exhaust manifold and cross box where it was later ignited in an explosive manner by the next burst of hot burnt gasses discharged on the following exhaust stroke. This too would have changed the engine sound.

It seems very odd that the inlet valve clearances were on specification but the exhaust valve clearances had not only closed up to zero so the rocker arm adjustment screws were always in contact with the valve stems, but the adjustment screws had been positioned even further inwards (clockwise) to where the valves were no longer able to close. That's the only way to cause the valves to remain open, apart from them being set incorrectly at some point in the past. Further, the lock nuts were definitely very tight! Could it have been due to the locknuts not being adequately tightened, allowing/causing the rocker adjustment screws to rotate in a clockwise direction under the influence of the net mechanical forces at work, driving the valves further out of the heads. Perhaps it was only because the locknuts had tightened up that prevented the valves being pushed even further into the combustion space, and into the domain of the piston!! I'm at a loss to explain how this situation could arise if the exhaust valves had been set correctly last time they were adjusted. Luckily, the exhaust valves hadn't contacted the piston crowns, otherwise it would have been all over red rover.

After setting the exhaust valve clearances to 0.2mm, the rocker covers were refitted. The idle mixture screw was set to three and one half turns outwards (counter-clockwise) from being (gently!) seated. The engine started immediately, and the strange engine sound had gone. After checking there were no oil leaks from the rocker cover gaskets, the idle speed was adjusted to 825 RPM in conjunction with adjustment of the idle mixture screw. The oil was topped up. All was good.

And what have we learnt? At each annual service, check the valve clearances. It only takes a few minutes. However, before doing that, *slightly* crack and then re-torque the head bolts to Citroen's specifications. It only adds a couple of minutes to the task, and by using multi-use rocker cover gaskets, the job becomes much easier. Do both these tasks with a cold engine. If unsure when the head bolts were torqued and valve clearances were set, do them now as a matter of urgency. It won't take you long.
