More talk about Light 15 crown wheel and pinions by Bernie Hadaway

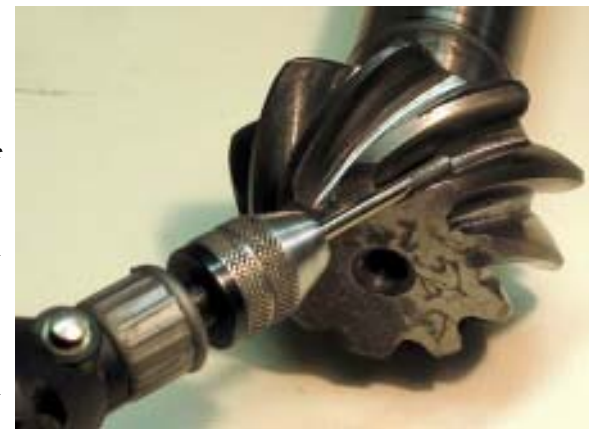
Photo 1: 1/8 inch diameter diamond plated burr driven by a s m a l l 25,000rpm modellers' power head

Photo No. 1 shows a pinion where the gullet imperfections are converted into a smooth fillet radius. It will provide the opportunity for uniform stresses in this vital area and should increase operational life.

The correcting tool is shown. This is a relatively inexpensive  $\frac{1}{8}$  inch diameter diamond plated burr driven by a small 25,000rpm modellers' power head. The tool's rotation leaves directional marks in the tooth gullet which will not cause *fatigue*. The longitudinal imperfections have gone.

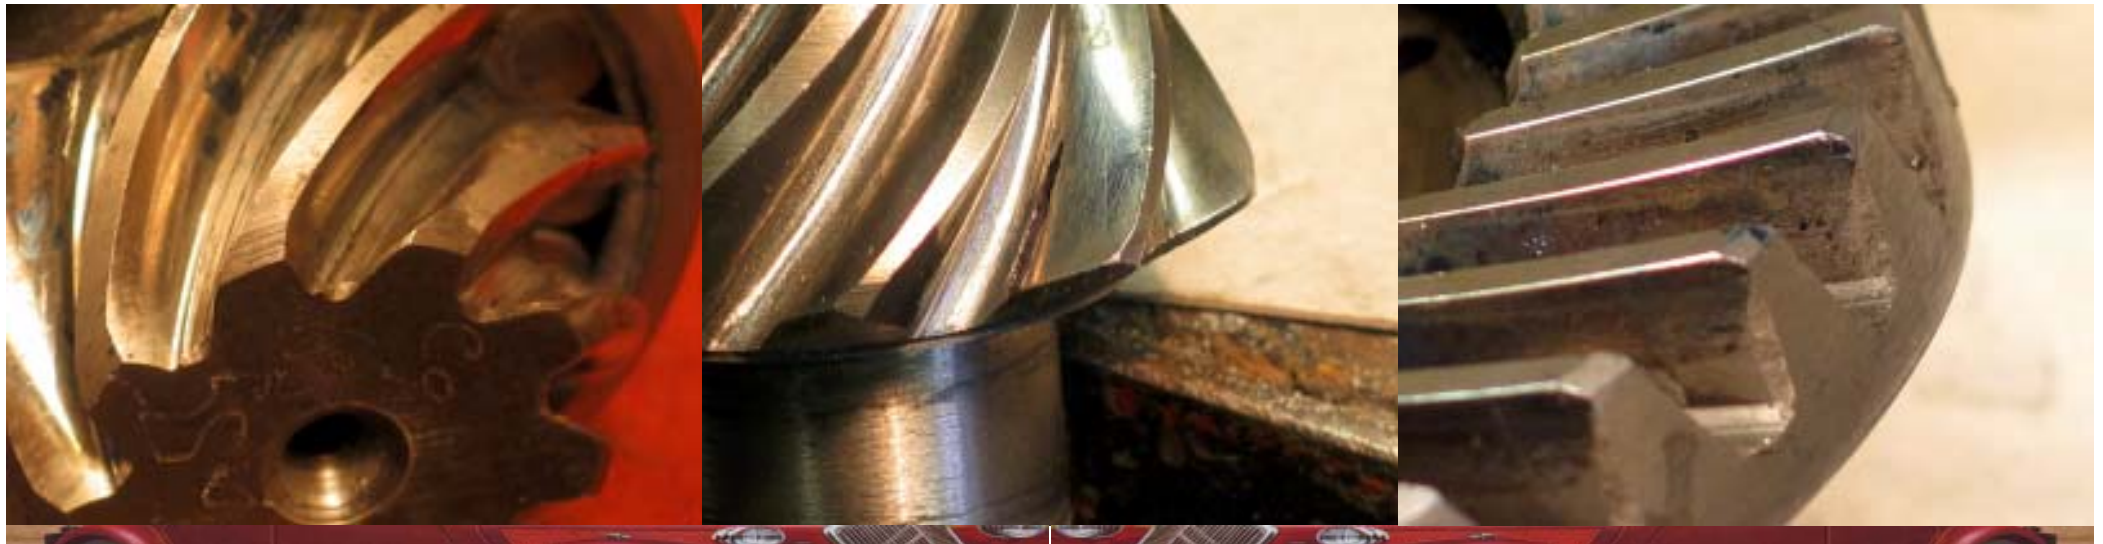
*Below left to right.*

Photo No. 2 shows typical hobbing marks before removal.

Photo No. 3 shows what to look for. I have exaggerated a typical defect for photographic purposes.

If we examine the crown wheel – as is the case with my example – we will see evidence of the high-pressure edge at the tips of the teeth, which is a bright, shiny line. Some indication of the contact forces involved can be appreciated by the slight chipping of the teeth on outside corners

Photo No. 4 shows this quite clearly.

*Photo 2: Typical hobbing marks prior to removal.*

*Photo 3: An exaggerated image of what to look for.*

*Photo 4: Slight chipping of the teeth on the outside corners.*

too much meshing clearance between crown wheel and pinion, and are discovered when we pull down a box for maintenance. These marks are caused by *tip interference* when the pure involute action under power is not achieved. The tips of the crown wheel teeth bear hard into the pinion tooth face due to poor involute action, resulting in surface spalling of the pinion tooth faces. If these marks are not too bad I am inclined to blend them out before returning to service.

In any case, the meshing clearance, which our manual tells us about, is usually about 0.008inches.

This should be observed and certainly not exceeded because it could generate another source for *fatigue* problems.
