TECHNICAL TALK

I have 'volunteered' to investigate the problem of the Door Handle Droop, which has plagued my English Light Fifteen for ever.

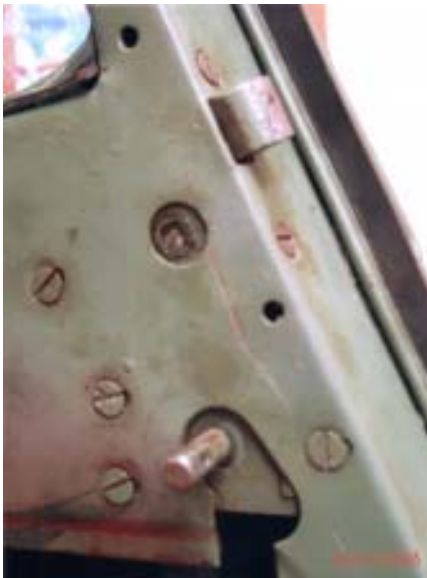
involved the removal of all handles, inside and out, door linings and trim strips to lay bare the mechanism location – as shown in photo #1. Six countersunk screws can now

be accessed for removal of whatever lies within!

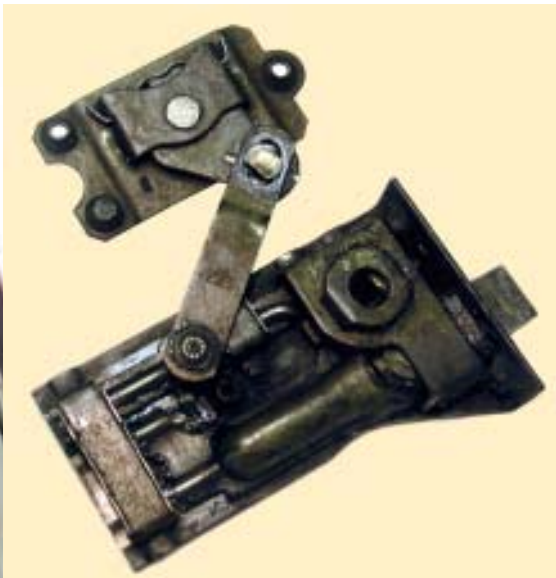
It was pleasing to find that with the removal of the six countersunk screws the whole latch mechanism can be withdrawn easily. It consists of two assemblies connected by a

lever which can be readily disengaged [photo #2].

Installation requires that the two assemblies are pre-engaged before presentation into the door cavity. [photo #2].

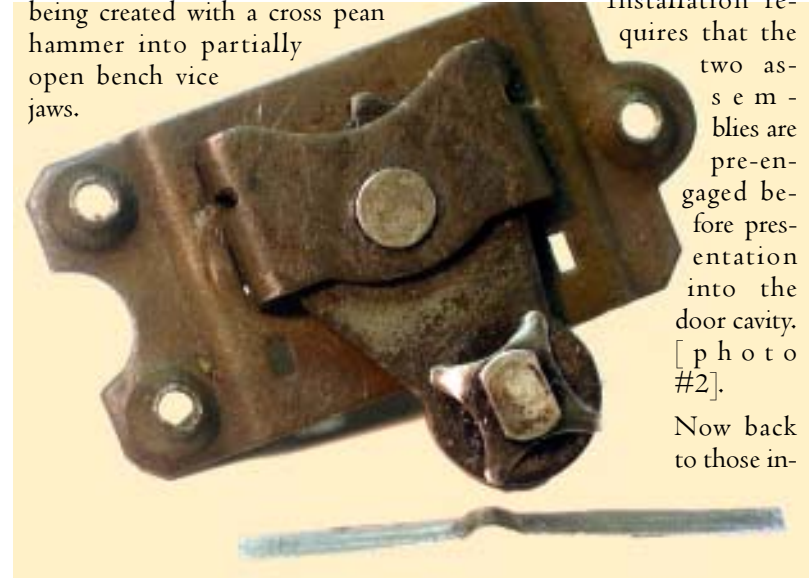
The top assembly is directly related to the interior door handle. I was very pleased with my deduction to observe that whilst there existed a cam profile lever on the spindle axis, with two engagement notches, there was no corresponding engaging device [photo #3]. This was a good start.

This assembly suggested that a spring had once operated within the assembly to provide a positive two-position location for our door handle. Anyway, I made a spring, in fact, I made two, and perhaps I should have experimented with a *third*.

Photo #3 shows a spring with a central engagement notch. This I cut from springy stainless steel 5mm wide x 160mm long. The notch being created with a cross pean hammer into partially open bench vice jaws.

I made my first spring 0.500mm stock, which functioned OK, but had very little positive feel. My second spring from 0.750mm stock was much better with a positive click feel. I did not have any 1.000mm stock to try and it could be the way to go, but subsequent fitting may be more difficult. [Perhaps two 0.500 springs?]

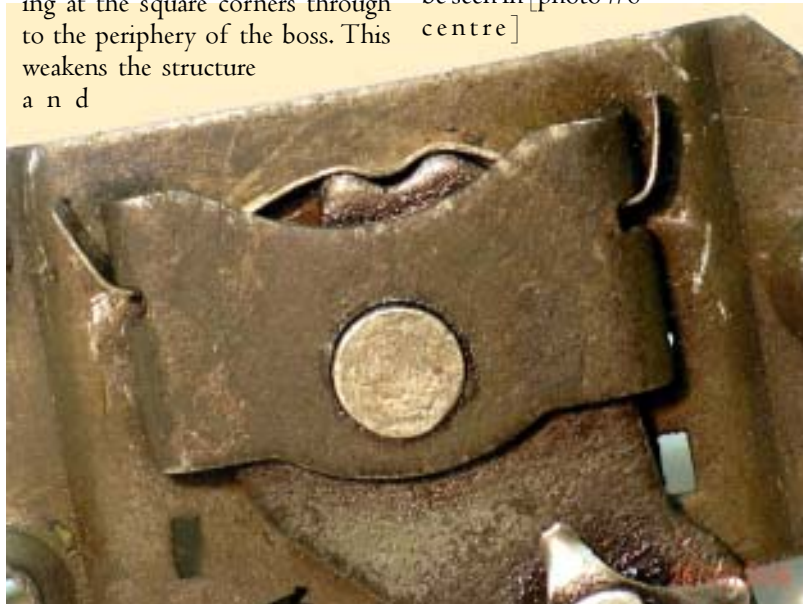
Photo #4 shows the spring fitted, which was not too difficult, with the two protruding ends bent after assembly – making sure that the notch is central. I do not know what the original spring looked like, but it would be similar to the one shown. I suspect it would be manufactured from carbon-spring steel and manufactured from too thick a stock, resulting in a high rate, overstressed, short life situation.

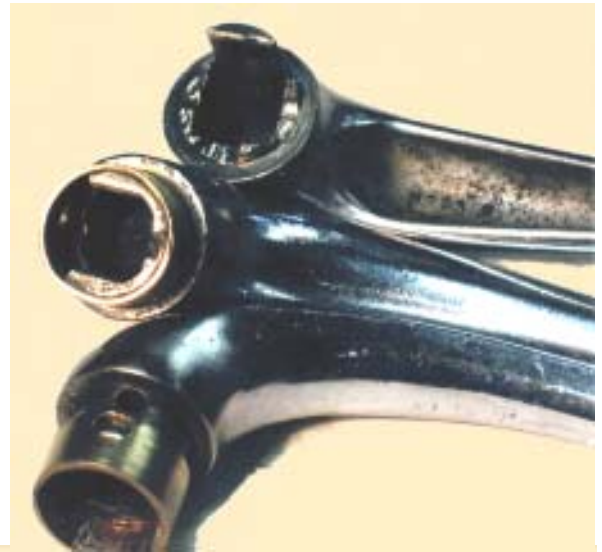
eventually a breakout can result with detachment from the spindle. This happened to me some years back [Photo #5 second from left] and I had forgotten, until this exercise,

not completely react the operating torque but serve to hold the winder and handle in position when the cross pin is inserted. The design is poor and when subjected to the 'rock and roll' of the agricultural tolerances this soon takes its toll. The window winder is further disadvantaged by the fact that it locates upon a 10mm square spindle. [The door handle is 9.5mm.] and this is short on material in this vital area.

Failure occurs in the way of cracking at the square corners through to the periphery of the boss. This weakens the structure

these components. It is gratifying to find that it has been successful and [photo #5] shows what I did].

A bush with a 15mm bore and a 17mm outside diameter [with cross holes for the locating pins] was pushed over the vulnerable bosses with an application of Loctite to consummate the marriage!

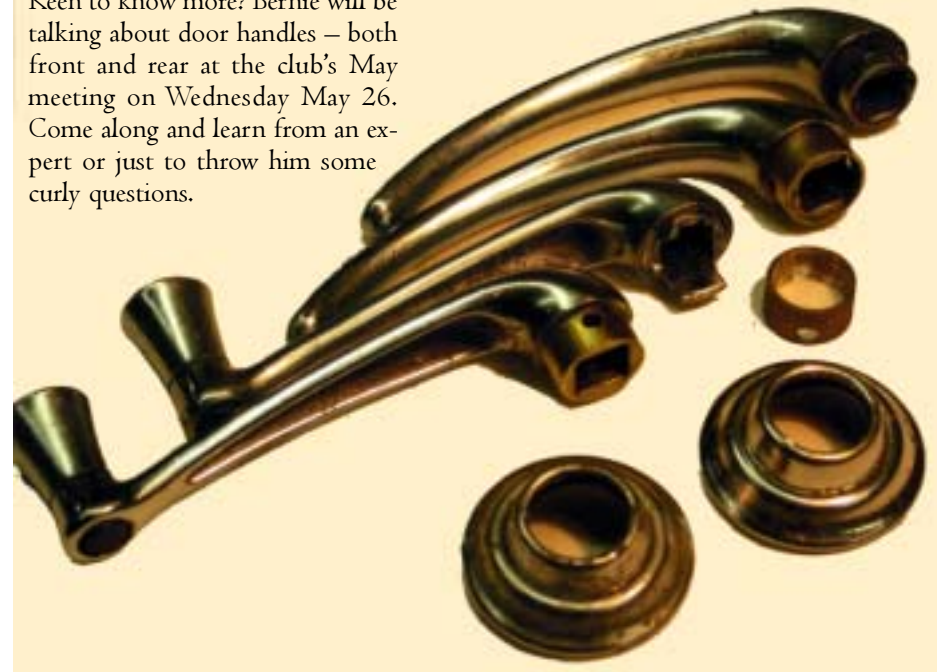
If the bosses are in good condition, then no harm is done and it is a good precaution anyway, but as can be seen in [photo #6 centre]

even if one segment of the square has been lost then this winder or lever can still be recovered and put to work with confidence. This one has worked for many years.

It is a requirement that the ferrel must fit over the new 17mm diameter boss, which is achieved by a minor enlargement with a hand file. Not a big deal.
