SAFETY WARNING FOR TRACTION OWNERS

NOTE: THIS WARNING APPLIES TO BOTH 4 & 6 CYLINDER TRACCTIONS

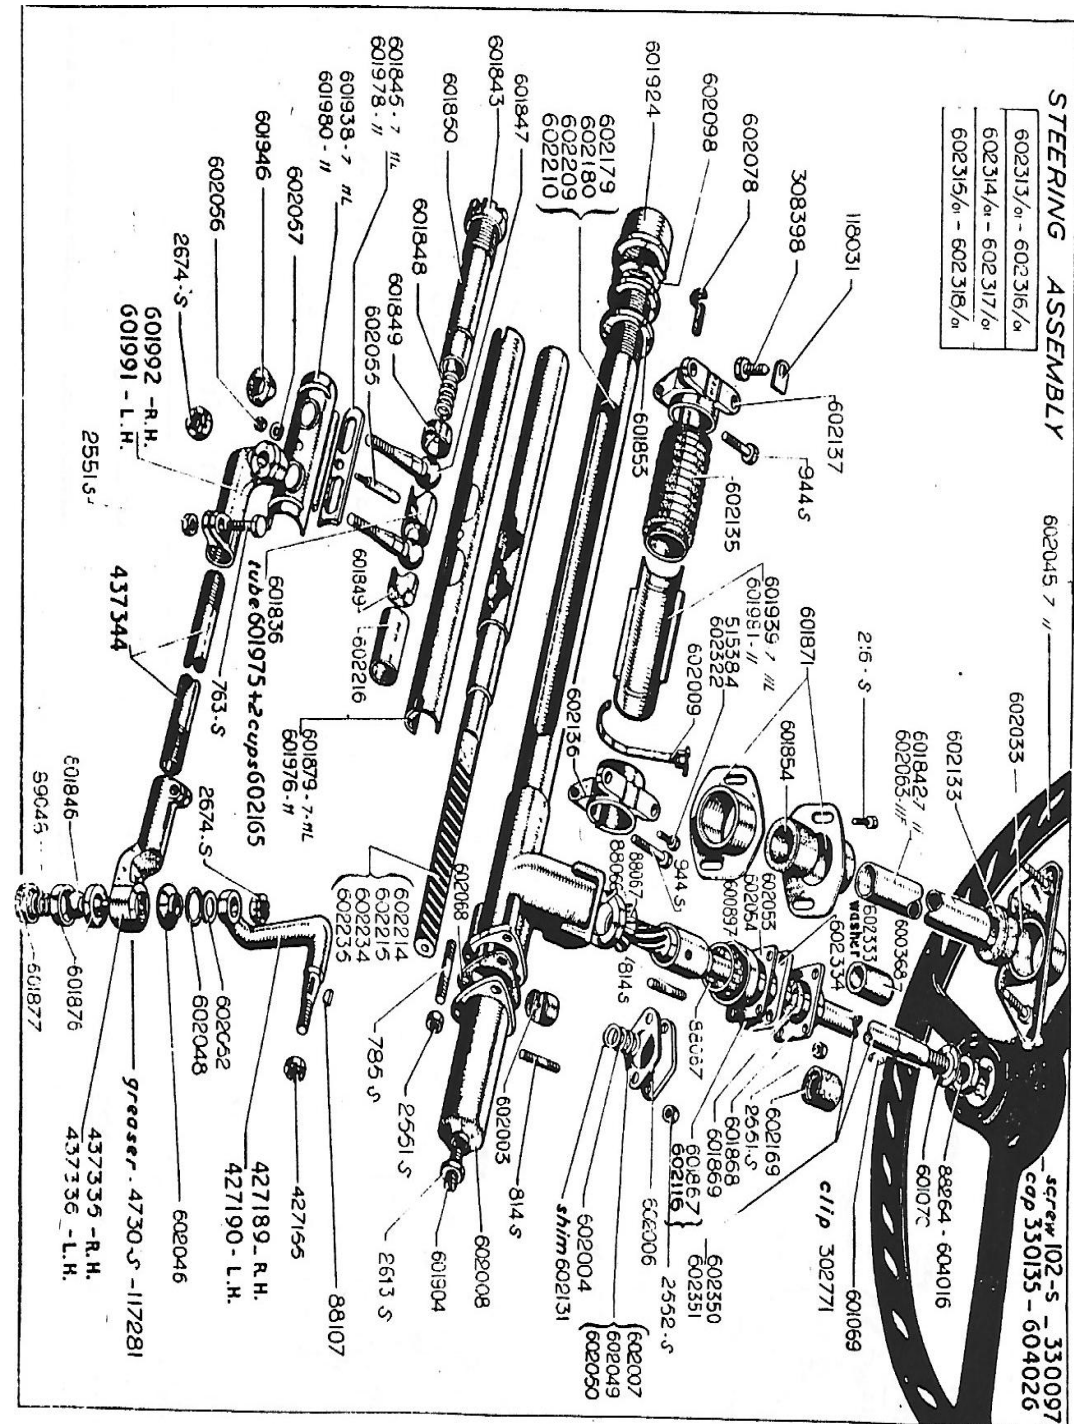
THE SECOND CASE WAS A NEWLY RESTORED CAR THAT HAD NOT LONG PASSED A ROADWORTHY BUT DESCRIBED SIMILAR SYMPTOMS. IN BOTH CASES THE PROBLEM WAS TRACED TO A LOOSE STEERING ARM WHERE IT PASSES THROUGH THE FRONT WHEEL HUB.

THESE ARMS WHICH CONNECT TO THE STEERING RODS AND ARE FITTED TO THE HUBS WITH A TAPER AND WOODRUFF KEY ARE SECURED WITH A CASSELLATED NUT AND SPLIT PIN AND HAD OVER THE YEARS WORKED LOOSE TO THE EXTENT THE WOODRUFF KEY HAD WORN VERY BADLY AND THE ARMS COULD MOVE IN THEIR TAPERS. IN BOTH INSTANCES REMOVAL, CLEANING AND REFITTING WITH A NEW KEY CURED THE PROBLEM.

I AM ISSUING THIS WARNING BECAUSE NONE OF THESE ARMS APPEARED LOOSE ON INSPECTION AND WERE NOT NOTICEABLY LOOSE ON REMOVAL, AS THESE ARMS MOVE IT AFFECTS THE WHEEL ALIGNMENT CAUSING THE ERRATIC STEERING SYMPTOMS, SO IF YOU ARE RESTORING OR JUST SERVICING YOUR TRACTION THESE ARMS SHOULD BE INCLUDED ON YOUR CHECKLIST.

IN THE PARTS DIAGRAM ATTACHED THE STEERING ARM PART NUMBERS ARE 427189 RH & 427190 LH, THE WOODRUFF KEY AND RETAINING NUT ARE CLEARLY VISIBLE.
