# What about that second gear

by Bernie Hadaway

The "Traction Box"

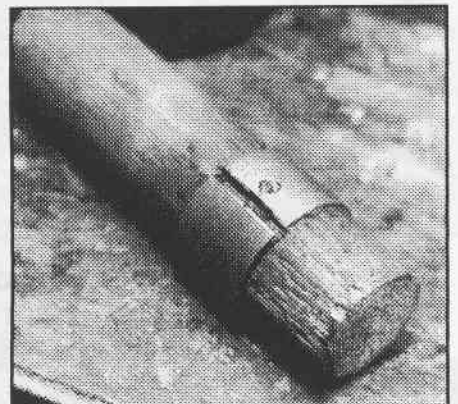
The improvised lapping tool

There are a few requirements. The broached bore of the pinion will benefit from a smoother finish. This was rotary lapped in the lathe using an improvised lapping tool made from an old pinion bush, split, expanded and secured to a timber dowel. When loaded with a medium valve grinding paste it made short work of producing an accurate, excellent finish whilst fixing that closing down problem at the syncro end (No. 2). Very satisfactory.

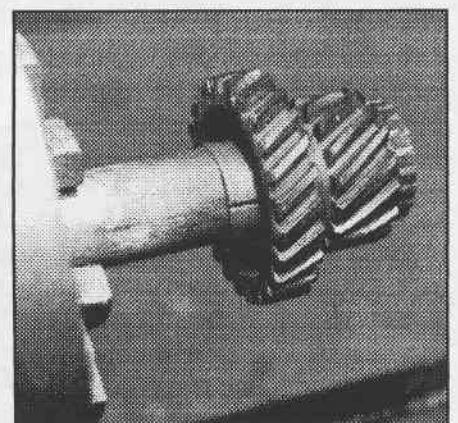
The lapping tool in the lathe with second gear pinion

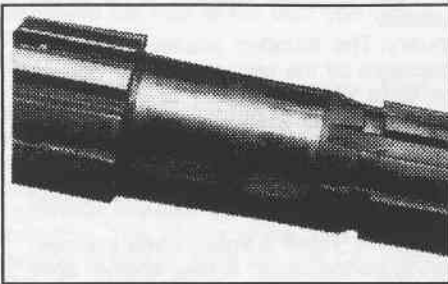
3. The journal length does not exploit the opportunity for maximum stability of the 2nd and associated gear. I think that those blue collar lads years ago decided to reduce the shaft diameter at the spline run out and one wonders if the drawing office ever found out. The illustration in the manual suggests not.

**Mainshaft showing reduction of journal at spline runout**

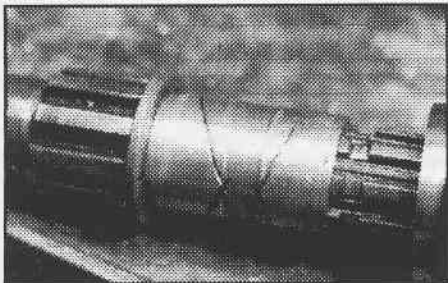
**The new phos. Bronze bush installed**

We considered fixing a full length bronze bush to the main shaft journal and running the bare pinion bore on the outer diameter of the bush. There are apparent advan-

tages. One can choose an appropriate diametrical running (I've used 0.05 mm) and also get the full length bearing. Also, the greater bearing surface improve load carrying capability.

The bore of the new bush was machined to be a reasonably tight fit over the splines with small low-angle chamfers provided on both bore ends.

Assembly of the bush on to the main shaft, was preceded by a good cleaning of surfaces with a fine grit wet and dry paper (used dry). The bush was then tapped over the spline onto the journal, after first positioning the thrust washer NOTE: The washer must be positioned to accept the small anti-rotation key and pre-wetting with Loctite 680. Immediately float and wet the bush bore before it grabs (for good, we hope).

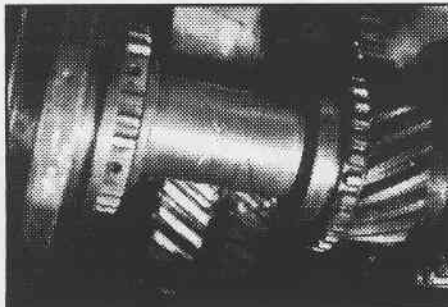
**The new bush in position on the mainshaft**

The chamfers are important in this process to assist with full fill of Loctite into the approximate 0.07 mm clearance which is just about right for this Loctite.

Oh, by the way, that thrust washer should be positioned to accept the small anti rotation key. The washer becomes a fixture and can't be budged.

After assembly, the four oil grooves can be filed to enter the central oil reservoir groove and that's the lot!
