THE TALE OF THE DUCK THAT ALMOST COOKED ITS GOOSE

By Graeme Dennes

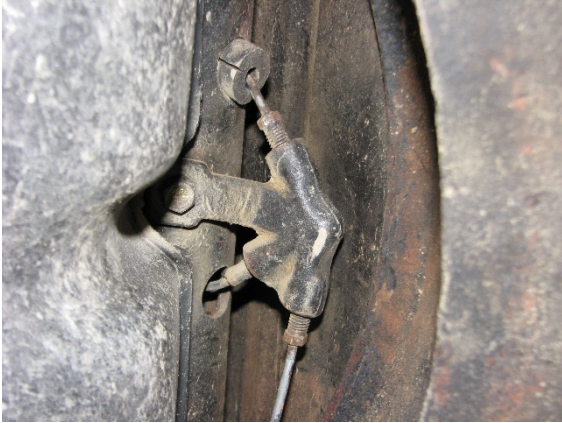
Figure 2 Rear brake line union, next to fuel tank

24. Perhaps the old brake line rubber seals in the rear brake line union had broken up a little and were partially blocking the return fluid flow to the master cylinder, resulting in the 10-second retraction time of the master cylinder piston. The union had previously been subjected to three hours of high heat to enable the three brake line fittings to be removed without damage. Perhaps they had been untouched since the car was new 43 years

25. Thus, decided to again remove and thoroughly check/clean the rear brake line union for partial blockage, just to be sure. Nothing was found to constrict the fluid flow inside the metal union. All clear. Three new LHM brake line rubber seals were fitted and all three fittings done up securely. No problems there. However, the weak fluid flow during bleeding operations remained, as did the 10-second delay in retraction of the master cylinder piston, so I presumed the roadside brake lock-up problem was also still a possibility.

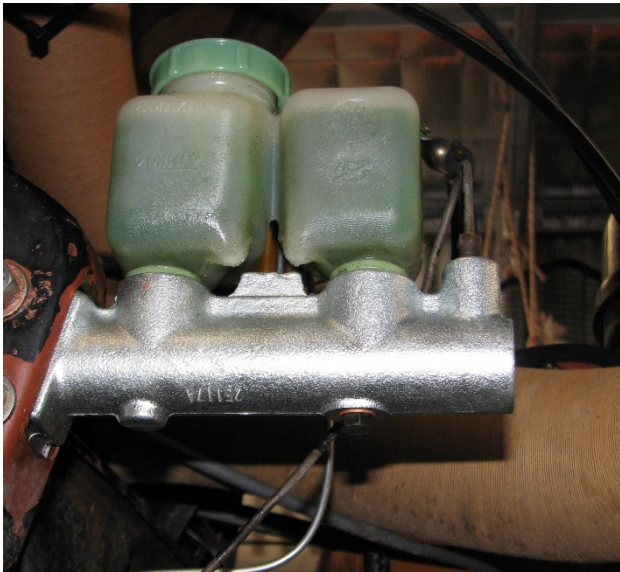
Figure 4 New brake master cylinder and reservoir

13. Logically, the symptoms point to a faulty brake master cylinder, although it was brand new.

Yes, two brand new master cylinders of different brands and different part numbers from different major European spare parts suppliers were faulty, and with not totally dissimilar symptoms. They were visually different products and with completely different packaging - brand, colours, part numbers, labels, barcodes, etc.

Perhaps they were from the same OEM batch from somewhere on the globe. That seems highly probable, but I don't know and perhaps I'll never know.

37. After returning home from New Zealand Raid and after picking up the car from the shipping company, the master cylinder and calipers were removed and returned to the green car from whence they came. A third new master cylinder was ordered from a (third) parts supplier, along with new calipers. These were subsequently received and fitted to the Duck, and all was finally perfect. What a saga. All it took was three new master cylinders!!!
