## 2CV HARD LUCK STORIES

By Graeme Dennes

Revision 2

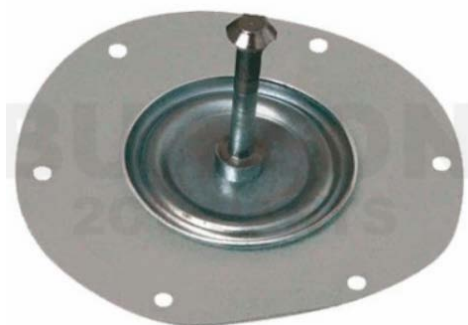
While away from home, our orange 2CV would run for perhaps 2-3 km, then almost die from what seemed like fuel starvation, but, with much encouragement it would (blorp, blorp, blorp, just) come good again, and after a couple of kangaroo hops, off we'd go again (blorp, blurping blurping), with the process being repeated. Fuel was not overflowing from the carburettor, which would otherwise indicate a failed float valve. It seemed probable that it was being caused by either dirty fuel (possible), a restriction in the fuel line from rubbish from the tank (less likely), a dirty fuel filter (possible, but the filter had just been changed), a sticking carburettor float valve (cycling with a repeated sticking action is very unlikely), dirt in or around the carburettor jets (possible), or a fuel pump failure (possible). It could also have been due to rubbish trapped in the fuel filter, whereby the very act of fuel being drawn through the fuel filter by the pump pulls on the rubbish sufficiently to cause the filter to block itself off, when the engine would stop or almost stop, at which point the rubbish would fall away again, allowing fuel to pass, and repeating the cycle. However, as the fuel filter had just been replaced, I discounted that option for the moment. I therefore put my money on the fuel pump diaphragm, so my first step was to disconnect the rubber fuel hose from the carburettor inlet pipe, then start and run the engine for just a few seconds to check how much fuel was being discharged from the fuel hose. Ah ha, gotcha! It was found to be almost zero. As no spare fuel pump or diaphragm was carried as a spare, RACV Total Care gave us a lift home!

I later confirmed that the fuel pump diaphragm had failed. The diaphragm material had become sufficiently "floppy" such that no pumping action was occurring.

And what have we learnt? As the fuel pump diaphragm is not generally inspected, my new rule is to change it every five years, reminding myself by an entry in the maintenance log book. If unsure when the diaphragm was last replaced in your car, do it now as a matter of urgency. Always carry a new spare diaphragm or pump with you.

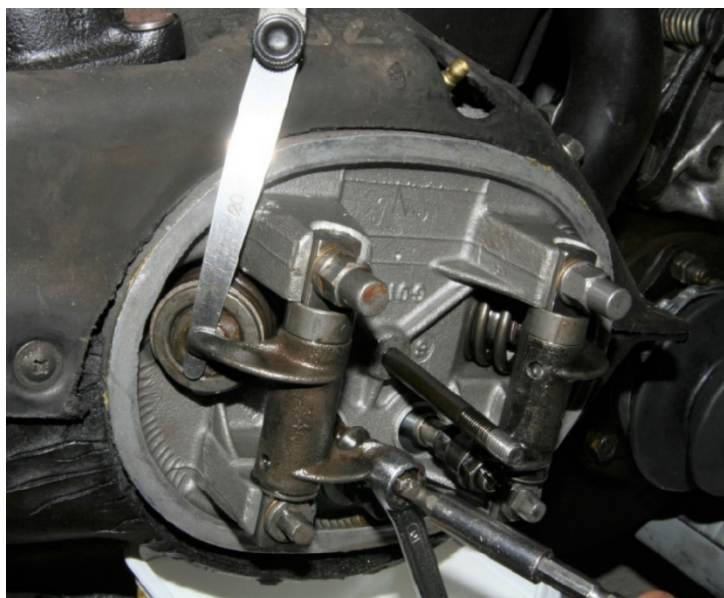
There was another item which hadn't been checked. Valve clearances. See photo at left. After the engine had fully cooled down, the rocker covers were removed. The head bolts seemed tight but were not further tightened (no torque wrench at hand). The valve clearances were checked, and this is what was found: the two inlet valves were exactly correct at 0.2mm, but both exhaust valves had not only presented with *zero* clearance, but were in fact being held open by some small amount, meaning they were never able to fully close. Definitely not good!

However, with the exhaust valves always open at the point of ignition and on the expansion stroke, the valve faces and seats are being subjected to the blisteringly high temperatures of the burning mixture from the top to the bottom of the expansion stroke! Further, the exhaust valves received no cooling from coming into contact with the valve seats. This would have resulted in the exhaust valves running at very high temperatures. Definitely not good!

On analysis. I expect the large out of balance forces (the engine was pounding the engine mounts after it fired and until it reached idling speed) was because only one cylinder was firing during start up and idle because the other cylinder couldn't raise the necessary compression pressure required to ignite the fuel mixture because its exhaust valve was being held open too far. However, it still managed to start on one cylinder which already had a held-open exhaust valve! How the car even started leaves me astounded. Above idling speed and up to driving speed, the (slightly) held-open exhaust valves would have had less effect on engine power, as by then, both cylinders would be firing and providing their part of the total engine power with plenty of air-fuel mixture being drawn in at the higher engine RPMs, so the small amount of mixture escaping during the compression and expansion strokes via the open exhaust valves may not be readily noticed. If only one cylinder was operating at idle, it would help to explain why adjustment of the idle mixture screw had such little effect.

With the exhaust valves held open in this manner, the basic engine timing diagram (crankshaft angle vs valve open/close positions) was quite displaced from the correct settings. This, coupled with only one cylinder operating at idle, could well have caused the weird engine/manifold/exhaust note. It also means that instead of all the fuel-rich air mixture previously drawn in on the inlet stroke remaining in the cylinder to be compressed on the compression stroke, some of it was escaping (being pushed out) via the held-open exhaust valve and pushed into the exhaust manifold and cross box where it was later ignited in an explosive manner by the next burst of hot burnt gasses discharged on the following exhaust stroke. This too would have changed the engine sound.

It seems very odd that the inlet valve clearances were on specification but the exhaust valve clearances had not only closed up to zero so the rocker arm adjustment screws were always in contact with the valve stems, but the adjustment screws had been positioned even further inwards (clockwise) to where the valves were no longer able to close. That's the only way to cause the valves to remain open, apart from them being set incorrectly at some point in the past. Further, the lock nuts were definitely very tight!

Could it have been due to the locknuts not being adequately tightened, allowing/ causing the rocker adjustment screws to rotate in a clockwise direction under the influence of the net mechanical forces at work, driving the valves further out of the heads. Perhaps it was only because the locknuts had tightened up that prevented the valves being pushed even further into the combustion space, and into the domain of the piston!! I'm at a loss to explain how this situation could arise if the exhaust valves had been set correctly last time they were adjusted.

After setting the exhaust valve clearances to 0.2mm, the rocker covers were refitted. The idle mixture screw was set to three and one half turns outwards (counter-clockwise) from being (gently!) seated. The engine started immediately, and the strange engine sound had gone. After checking there were no oil leaks from the rocker cover gaskets, the idle speed was adjusted to 825 RPM in conjunction with adjustment of the idle mixture screw. The oil was topped up. All seemed fine as far as could be determined.

In summary, at each annual service, set the valve clearances. It only takes a few minutes. Refer to the writer's article, *2CV Valve Clearance Adjustment* for the complete procedure.

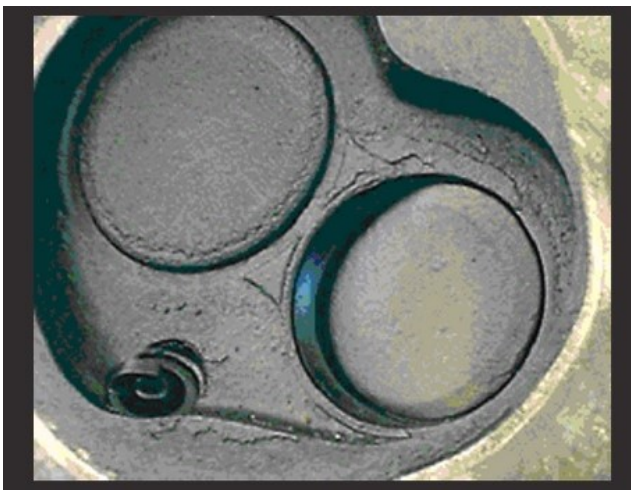
This implies hardened exhaust valve seats were used in 602cc engines. If this is the case, then it's most unlikely to be exhaust valve recession, but it still could be. The engine heads will require removal and inspection. The valve at the lower right in the photo on the left (not a 2CV) has a bad case of valve recession. The valve seat has worn away quite severely, allowing the valve to sit quite deeply into the head. A head repair *will* be needed to fit at least one new valve seat and one new valve.
