## **Fitting modern drive shafts – not as simple as it seems!**

This document is the outline of a presentation by Ian Macdermott at a CCOCA meeting in 2019.

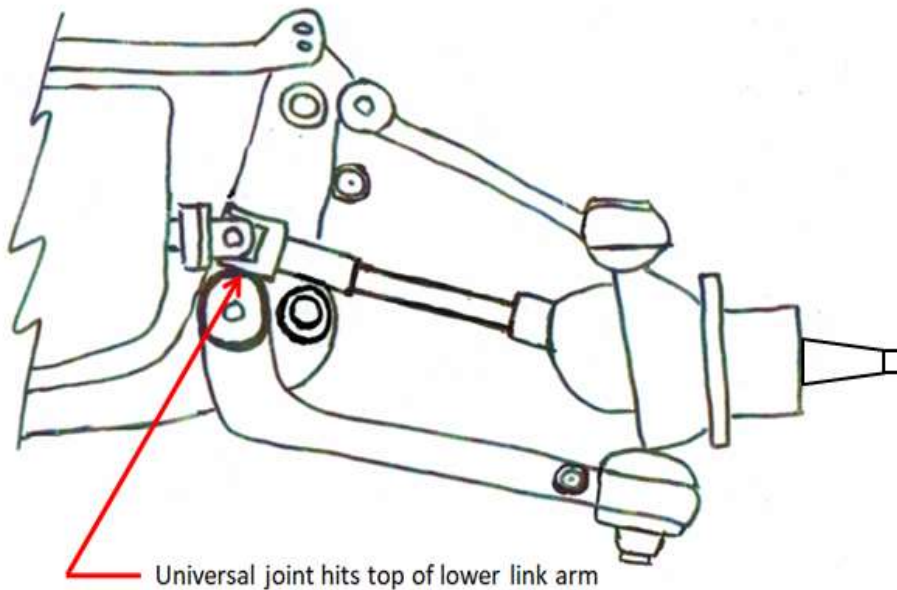
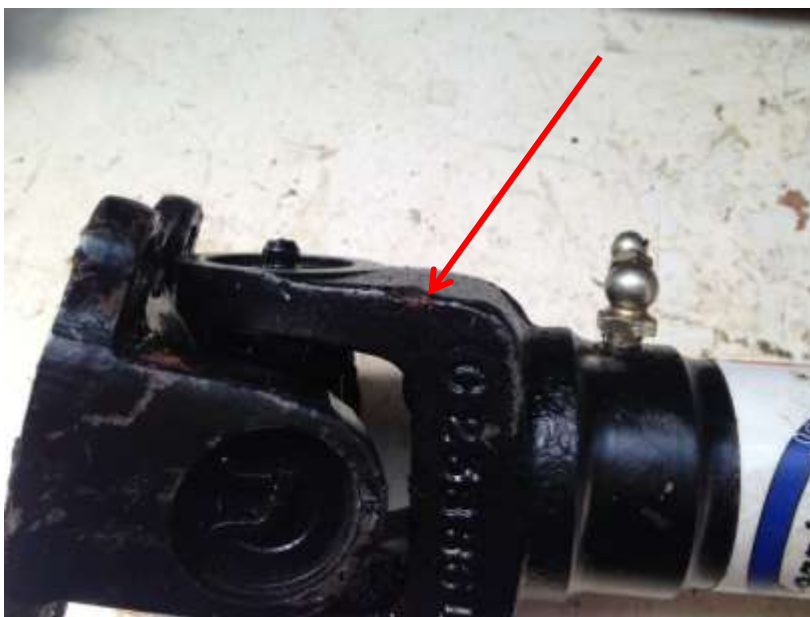
- I had lent my engine stand to another club member, so I fitted the shafts by breaking ball joints as per the procedure outlined in the workshop manual, rather than by removing the engine and gearbox and working from the inside of the cradle.
- The result: Clunk, clunk, .... Click on link to play a YouTube clip.  
[Traction drive shaft conversion](#)
- The inner universal fouled on the lower link arm of the suspension when the suspension was hanging down.

- I noticed that if I lifted the swivel housing, the clunk disappeared.

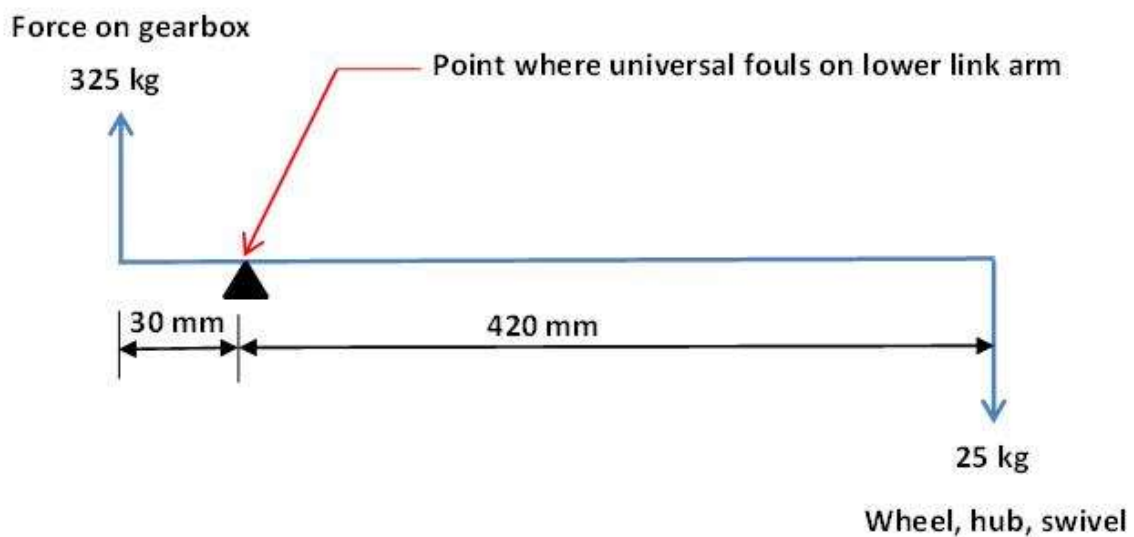
- Lengthen the shafts to reduce travel of the suspension. I didn't think this is a good idea:
  - Suspension needs to be allowed to travel to its design maximum without doing any damage to something else. Chances of needing maximum suspension travel are slim, but one day it might be necessary.
  - If interference is not removed, forces exerted on the aluminium gearbox housing are likely to cause catastrophic damage.

At 85 km/hr, force is hammering on gearbox at 50 Hz

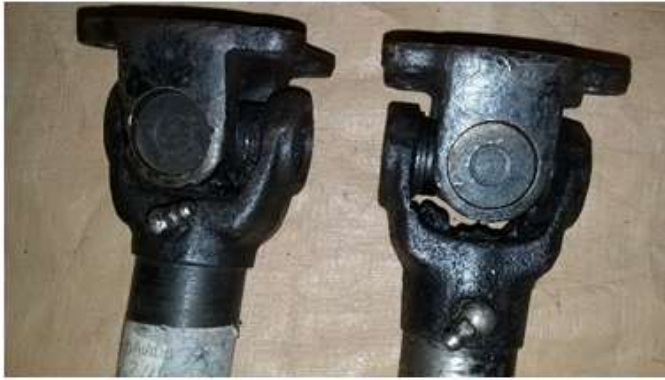
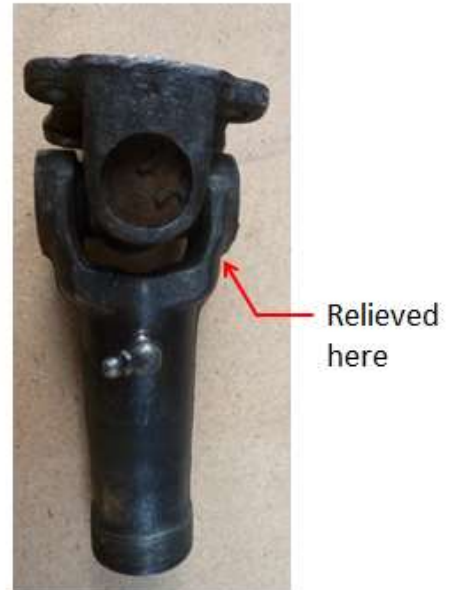
- I took a conservative approach, taking 1 mm off at a time, and finished up doing the first one 5 times before noticing something about original Citroën shafts.
- I had some old inner universals which were relieved at exactly the point where I was having trouble. (Leads one to suspect that Citroën knew about this interference problem, and maybe not all suppliers made identical length shafts)?
- Photos from Dave Gilbert show that there are several variations of universal joints – maybe from different years or different suppliers.

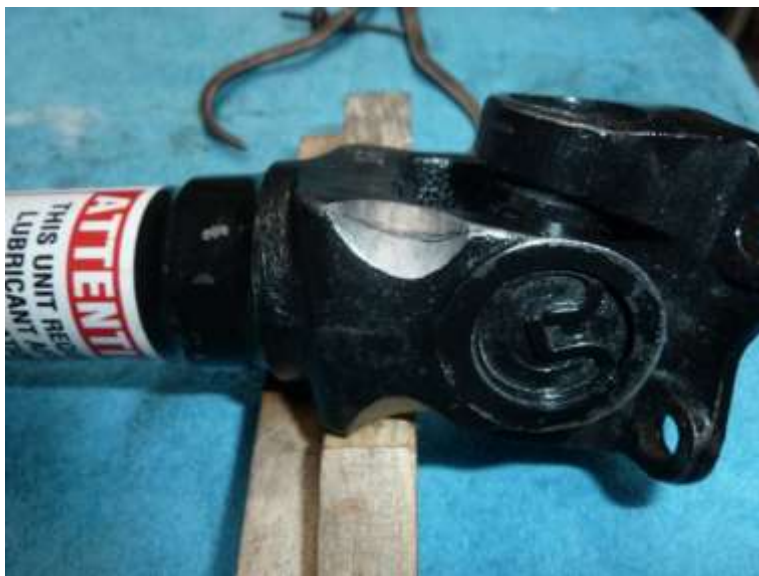
- I even found one universal in which the plug had been removed, which would allow the shaft to shorten even further than as originally built.
  - Might be convenient for removing the shaft from the car
  - Potentially dangerous if it allows the universal joint to hit the lower link arm.
- The diagonal measurement of the Citroen yokes at the interference point was 64 mm. I had reduced from 76 to 71, and still hadn't eliminated the interference.
- OK, go for it! Got down to 67 mm and thought things were starting to look a bit too thin, so I stopped and fitted them the car. No Clunking!

- Took the other one down to 68 mm. No clunking on that one either. After driving 1,000 km since refitting the shafts, including all sorts of terrain, they haven't broken. I think they will be OK.
- Answer seems to be a diagonal measurement somewhere between 68 and 71 mm.

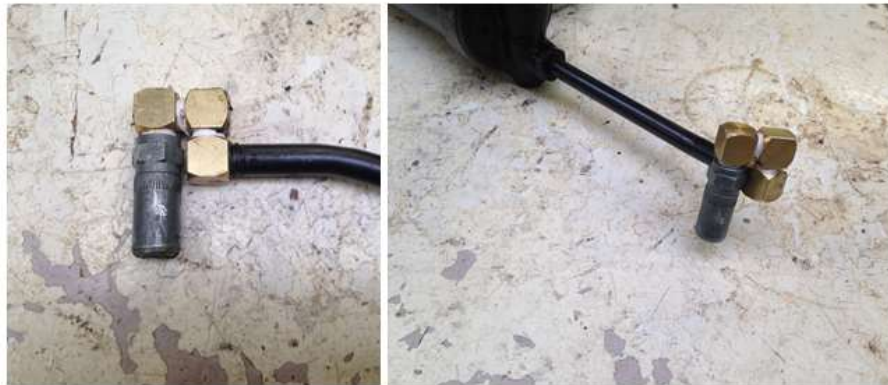
- Difficult to fit grease gun on straight nipples without interference from the cradle. Convoluted collection of fittings is required to allow grease gun to attach to nipples.
- Threads on grease nipples are odd balls, and I haven't found a suitable angled nipple to get better access for greasing.

Greasing the cross

Greasing the spline

Vehicle jacked up under cradle, suspension hanging down

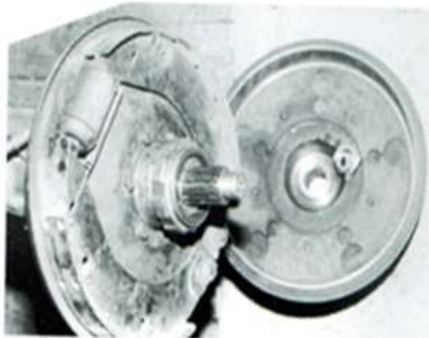
Light 15 drive shaft (splined hub fitting)

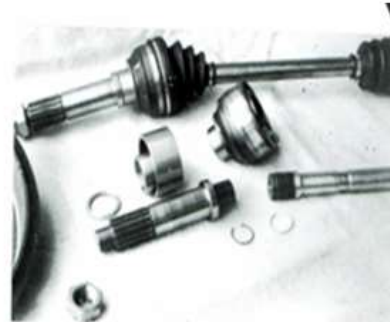
Component parts and complete driveshaft for L15 with spline drive and CV joints at each end
