2CV HARD LUCK STORIES

Revision 4

By Graeme Dennes

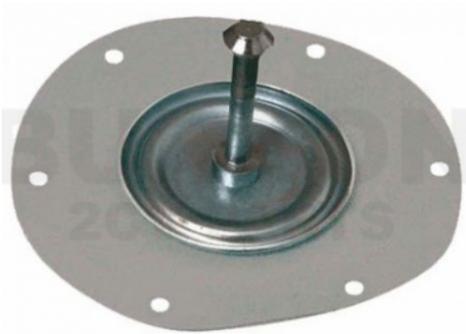
Away From Home Problem 1:

While away from home, our orange 2CV would run for perhaps 2-3 km, then almost die from what seemed like fuel starvation, but, with much encouragement it would (blorp, blorp, blorp, just) come good again, and after a couple of kangaroo hops, off we'd go again (blorp, blorping blorping), with the process being repeated. Fuel was not overflowing from the carburettor, which would otherwise indicate a failed float valve. It seemed probable that it was being caused by either dirty fuel (possible), a restriction in the fuel line from rubbish from the tank (less likely), a dirty fuel filter (possible, but the filter had just been changed), a sticking carburettor float valve (repeated cycling with a sticking action is very unlikely), dirt in or around the carburettor jets (possible), or a fuel pump failure (possible). It could also have been due to rubbish trapped in the fuel filter, whereby the very act of fuel being drawn through the fuel filter by the pump pulls on the rubbish sufficiently to cause the filter to block itself off, when the engine would stop or almost stop, at which point the rubbish would fall away again, allowing fuel to pass, and repeating the cycle. However, as the fuel filter had just been replaced as noted, I discounted that option for the moment. I therefore put my money on the fuel pump diaphragm, so my first step was to disconnect the rubber fuel hose from the carburettor fuel inlet spigot, then start the engine for just a few seconds to check how much fuel was being discharged from the fuel hose. Ah ha, gotcha! It was found to be almost zero. As no spare fuel pump or diaphragm was carried as a spare, RACV Total Care gave us a lift home!

I later confirmed that the fuel pump diaphragm had suffered a small tear, causing the problem. The diaphragm material had also become sufficiently "floppy" such that very little pumping action was occurring anyway.

And what have we learnt? As the fuel pump diaphragm is not generally inspected, my new rule is to change it every five years, reminding myself by an entry in the maintenance log book. If unsure when the diaphragm was last replaced in your car, do it now as a matter of urgency. Always carry a new spare diaphragm or pump with you.

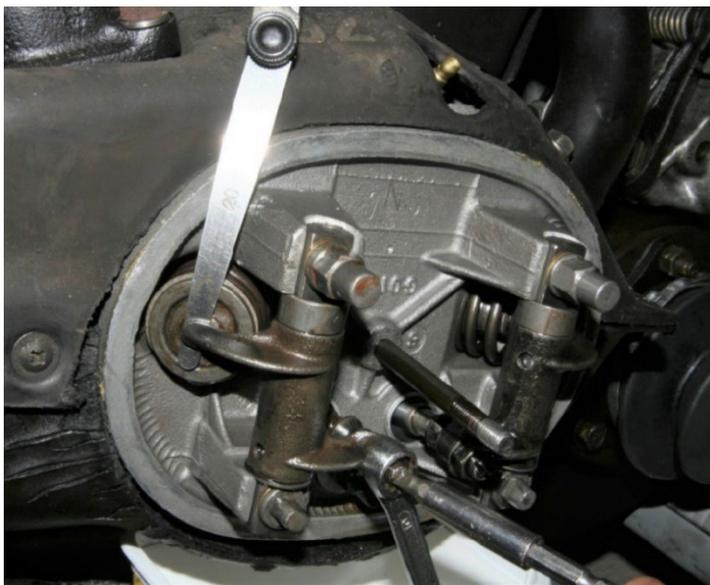
There was another item which hadn't been checked. Valve clearances. See photo at left. After the engine had fully cooled down, the rocker covers were removed. The head bolts seemed tight but were not further tightened (no torque wrench at hand). The valve clearances were checked, and this is what was found: the two inlet valves were exactly correct at 0.2mm, but both exhaust valves had not only presented with *zero* clearance, but were in fact being held open by some small amount, meaning they were never able to fully close. Definitely not good!

Further, the exhaust valves were receiving no cooling as they never came into contact with the valve seats. This would have resulted in the exhaust valves running at very high temperatures and potentially being destroyed. Definitely not good!

It seems very odd that the inlet valve clearances were on specification but the exhaust valve clearances had not only closed up to zero so the rocker arms were always in contact with the valve stems, but the adjustment screws had been positioned even further inwards (clockwise) to where the valves were no longer able to close. The adjusting lock nuts appeared to be tight!

After setting the exhaust valve clearances to 0.2mm, the rocker covers and nuts were refitted hand tight, then a further one and one-half turns with the spanner. The idle mixture screw was set to three and one half turns outwards (counter-clockwise) from being (gently!) seated. The engine started immediately, and the strange engine sound had gone. After checking there were no oil leaks from the rocker cover gaskets, the idle speed was adjusted to 825 RPM in conjunction with adjustment of the idle mixture screw. The oil was topped up. All seemed fine as far as could be determined.

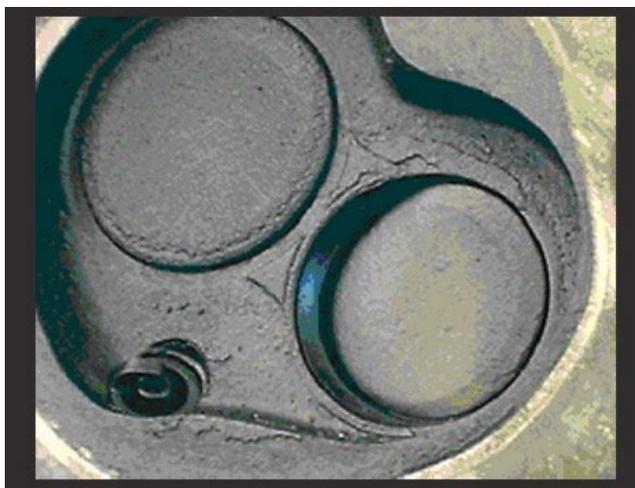
This implies hardened exhaust valve seats were used in 602cc engines. If this is the case, then it's most unlikely to be exhaust valve recession, but it still could be. The engine heads will require removal and inspection. The valve at the lower right in the photo on the left (not a 2CV) has a bad case of valve recession. The valve seat has worn away quite severely, allowing the valve to sit quite deeply into the head. A head repair *will* be needed to fit at least one new valve seat and one new valve.

In summary, at each annual service, set the valve clearances. It only takes a few minutes. Refer to the writer's article, *2CV Valve Clearance Adjustment* for the complete procedure.
