OVERHAULING A FOUR CYLINDER TRACTION GEARBOX

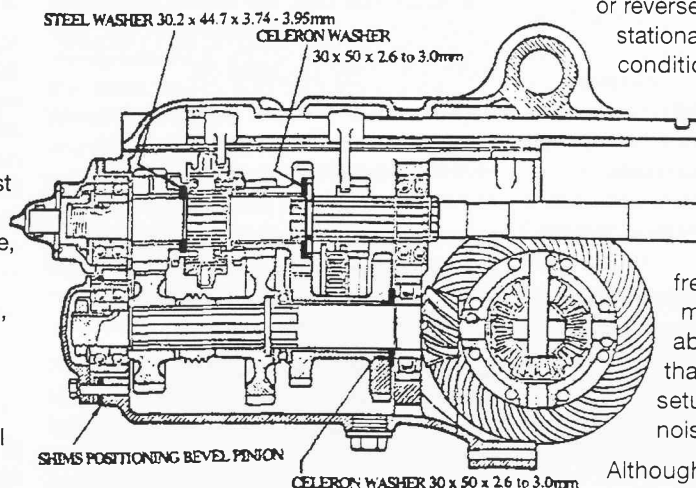
FIG. 1. CROSS-SECTION ON LONGITUDINAL CENTRE LINE SHOWING WASHERS CONTROLLING END PLAY AND POSITIONING.

When assembling the mainshaft don't forget the locking key [500528] which spaces the washers retaining the synchromesh hub and ensure that the key engages in both washers. End play, 0.05 - 0.10mm, of the second gear idler [500763] is controlled by the thickness of the Celeron washer [500774 etc., 30.2 x 44.7 x 3.75 - 3.95mm]. Try to achieve these clearances by selective assembly, as excessive end play affects the synchromesh operation.

End play of the first/reverse pinion shaft gear [507270] is controlled by yet another Celeron washer which is identical with the second gear idler washer. If there is appreciable wear in the pinion shaft front bearing it will be impossible to accurately set the position of the pinion shaft.

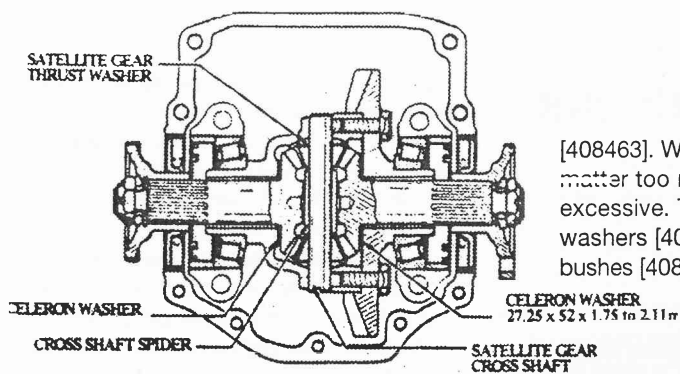
FIG. 2. CROSS SECTION OF DIFFERENTIAL

Turning to the differential, apart from the satellite gears mentioned earlier, the wear points are the cross shafts [40828 and 408333], the satellite gear thrust washers [408304] and the thrust washer mating surfaces in the differential housing

[408463]. Wear of the shafts doesn't matter too much unless obviously excessive. The Celeron thrust washers [408467] and output shaft bushes [408442] show little wear.

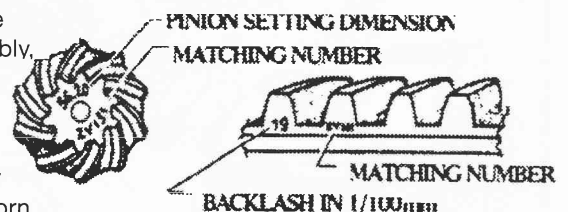
FIG. 3. CROWN WHEEL AND PINION SETTINGS

Regarding the crown wheel backlash, it's useful to note that with a 9 x 31 crown wheel and pinion there are 270-odd meshing positions. Obviously, it is impractical to check the backlash of all, but select a few at random. With a well used CWP it is surprising what variation can be observed.

NOTE: FIGURES ON CROWN WHEEL MAY BE ON BACK FACE
