OVERHAULING FOUR CYLINDER TRACTION GEARBOXES *****

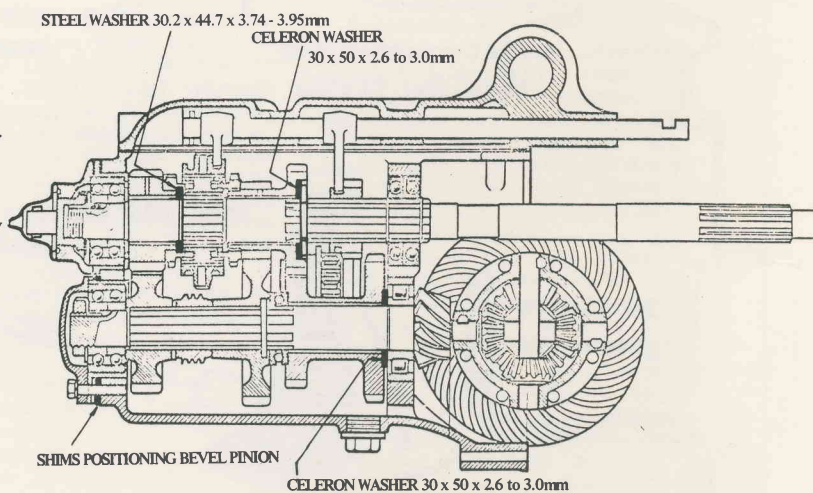
FIG. 1. CROSS-SECTION ON LONGITUDINAL CENTRE-LINE SHOWING WASHERS CONTROLLING END PLAY AND POSITIONING.

End play of the first/second pinion shaft and main shaft gears(507270 and 500763) is controlled by a non-metallic (Celeron) thrust washers. These **DO** wear and on occasion can break-up due to old age. Tractionistes seem to collect a selection of washers out of boxes that have expired, but there is no reason why they cannot be machined from a similar cloth re-inforced resin or even bronze and finally finished to the thickness required by rubbing on a sheet of fine emery laid on a surface plate or a sheet of plate glass. Don't forget the oil grooves.

When assembling the mainshaft don't forget the locking key(500528) which spaces the washers retaining the synchromesh hub and ensure that the key engages in both washers. End play, 0.05 - 0.10mm, of the second gear idler(500763) is controlled by the thickness of the Celeron washer(500774 etc., - 30 x 50 x 2.6 - 3.0mm) and that of the top gear pinion, 0.10 - 0.20mm, by the synchro hub steel washer (500776 etc., - 30.2 x 44.7 x 3.75 - 3.95mm). Try to achieve these clearances by selective assembly, as excessive end play affects the synchromesh operation.

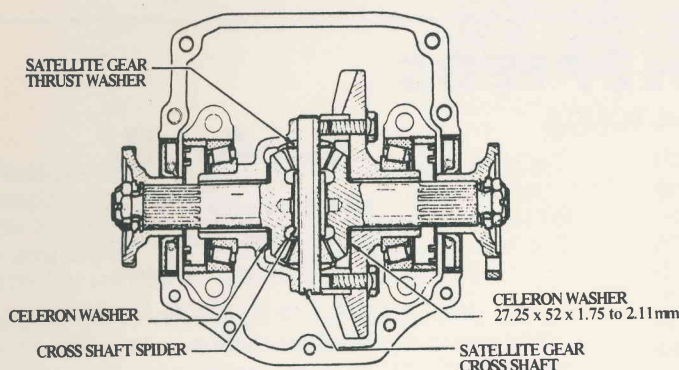
FIG. 2. CROSS SECTION OF DIFFERENTIAL

Turning to the differential, apart from the satellite gears mentioned earlier, the wear points are the cross shafts (40828 and 408333), the satellite gear thrust washers (408304) and the thrust washer mating surfaces in the differential housing(408463). Wear of the shafts doesn't matter too much unless obviously excessive. A method of taking up the thrust washer wear was given in the Classic Register Restorer's Guide of 1976 and copies of this article are available from the Technical Officer. The Celeron thrust washers(408467) and output shaft bushes(408442) show little wear.
