## 2CV CARBURETTOR COVER SCREWS

(Revised)

by Graeme Dennes

This article applies to the dual-choke carburettor fitted to the 2CV from 1978 onwards.

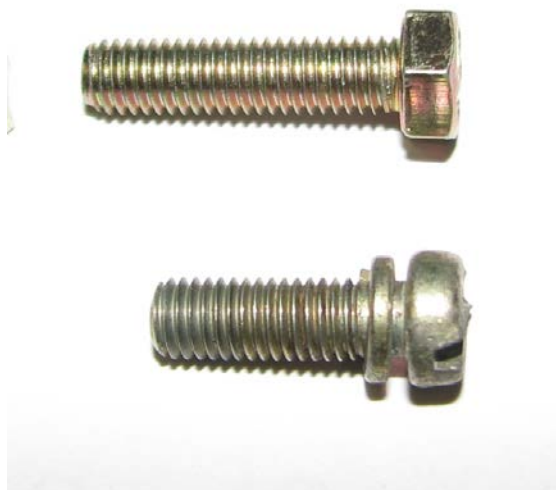
PHOTO 1

Photo 1 shows a standard Solex M5 x 0.8 x 15 screw, with its fitted split washer, alongside an M5 x 0.8 x 20 replacement screw (hex headed bolt).

For my "English" 2CV, which was fitted with 0.8mm threads(!), I made up a set of six custom-length M5 x 0.8 "screws" from hex-headed bolts with a screwdriver slot neatly cut in the heads. Each screw was cut to the maximum length allowable for each position, providing for the correct sealing between the top cover and the body, and the longest maintenance life of the carburettor body threads. Don't forget to slip a split washer under each screw head.

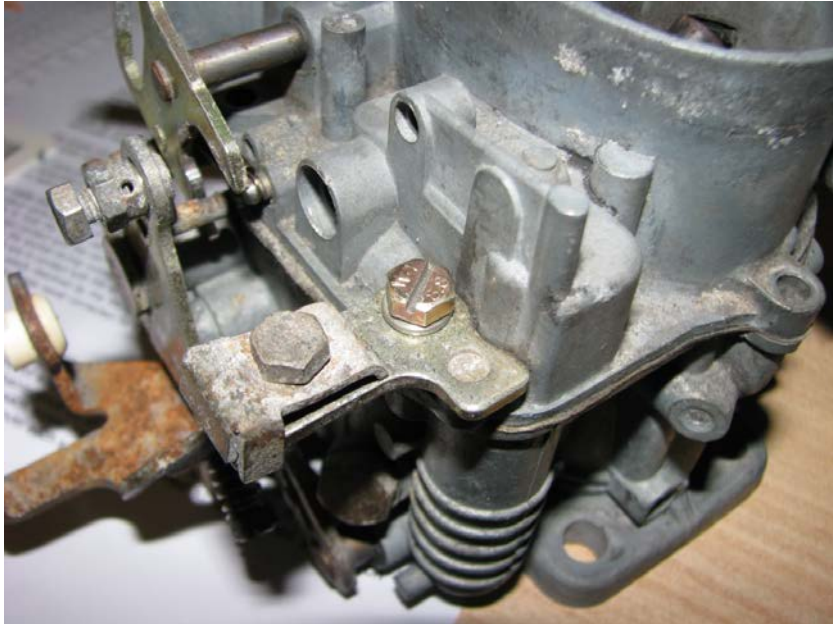
PHOTO 2

The standard carburettor top cover screws are typically 15mm in length. However, the screw which does double duty to hold the choke cable mounting bracket should be around 22mm length (but no longer) to maximise thread contact with the carburettor body. The effect of this 7mm shortfall is the eventual stripping of the threads in the body socket during normal carburettor maintenance activities because only about *one third* of the body threads are in contact with the screw. A helicoil repair will be needed if the threads are stripped. The problem may be easily resolved by the fitting of a 22mm length screw of the *same* thread type as the original. It seems this issue was never corrected by Citroen. Again, Wilson Carburettor Service can provide the 22mm screw.

Photo 2 shows the new M5 x 0.8 x 22 screw fitted to the choke cable mounting bracket position. Note the slot cut in the head for a screwdriver.

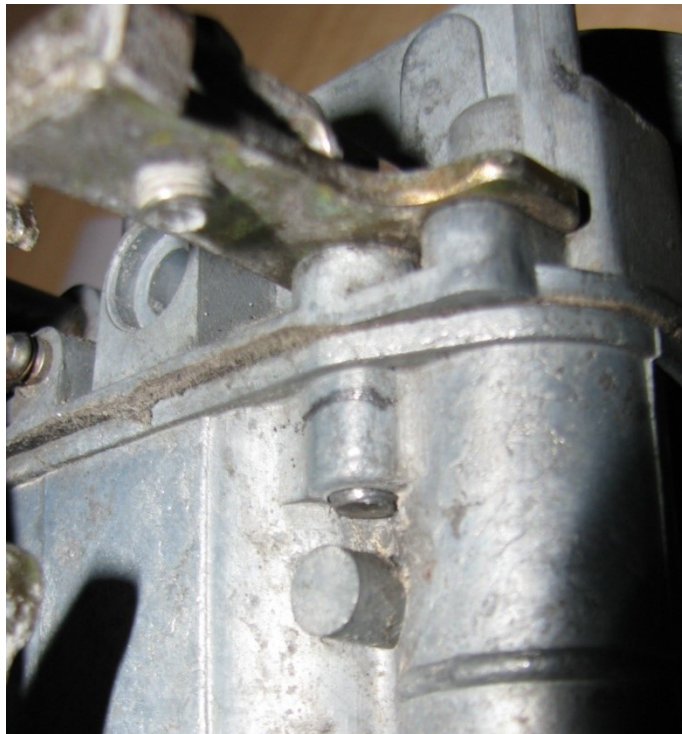
PHOTO 3

Photo 3 shows a side view of the choke cable mounting bracket, with the new M5 x 0.8 x 22 screw in position. Note the end of the screw just projecting outside of the lower opening of the carburettor body socket (centre of photo), ensuring the maximum possible thread area is being utilised. Ensure all new screws are not *too* long to cause binding against the carburettor body, else more stripped threads will result.
