## ROB LITTLE – SPARE PARTS OFFICER

## FLEET FOLLIES

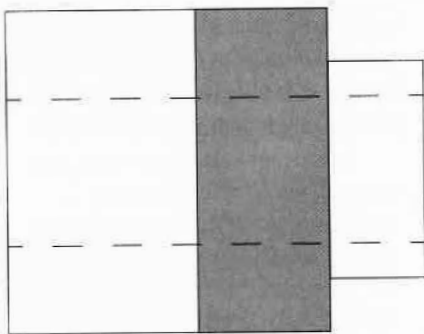
Part number 451751. Machine shaded shoulder to accommodate spark plug seal – allow 0.5mm crush.

the oil was coming from the back of the camshaft. With the transmission out it was quite evident that this was the cause of a lot of the problem, I had fitted an 'O' ring to seal the bush in place that acts as a sleeve for the water

pump driveshaft which has an oil return thread to drain the oil from the rear of the camshaft back into the sump. It was at this stage I was wandering around about looking for a better way, then my mind strayed to 'D' series spark plug seals which are of the ideal size both ID and OD and a lovely compressible soft rubber, I then needed to machine the shoulder back on the sleeve to accommodate the deeper seal and leave a bit protruding for a compression fit against the engine block, this was done and when fitted with a bit of Silicone sealant a lovely ring of sealant was left around the joint. I do not know what other people have done to seal this but if you see the accompanying drawing this is a very simple fix. I have not included dimensions as I lost my original drawing. Any other fixes for this problem or any other please feel free to submit them to
