Flywheel

Removed this and had it and have the clutch face cleaned up, lightened and balanced.

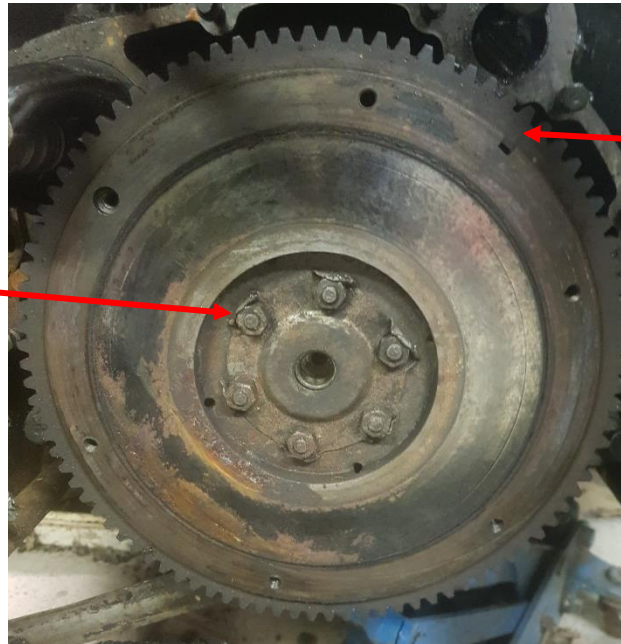
To remove straighten out the locking plate and undo the mounting bolts. Ensure you mark the position of the flywheel on the mounting bolts for timing on the engine

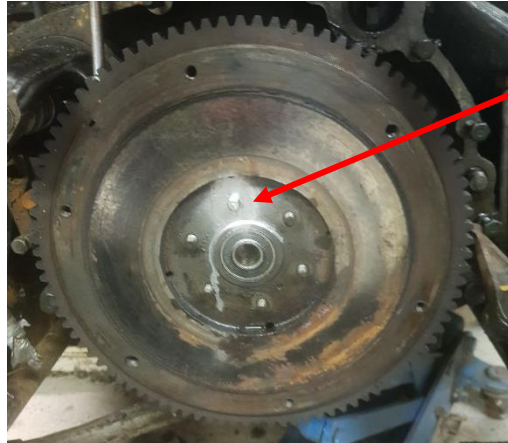
This is the 8 degree timing mark that the 6 mm pin will sit in through the bell housing

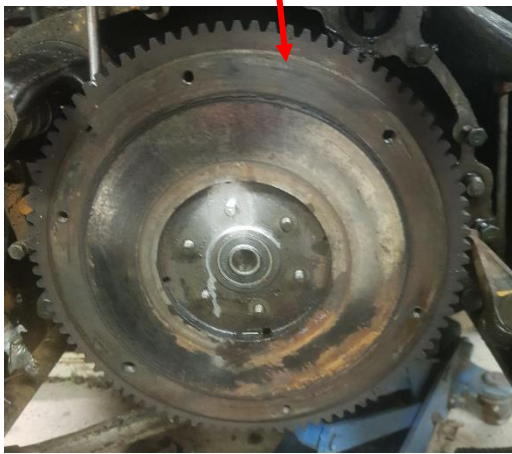
Thought this ring at the front can be removed by getting a cold chisel in behind it and hitting the chisel with a hammer

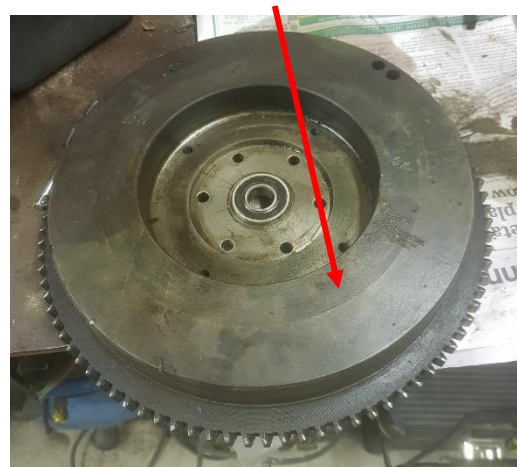
Alternatively, you can shave off the full face of the metal at the back of the flywheel

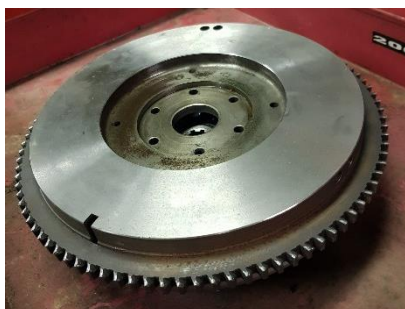
The flywheel ended up having 15 mm taken off the back of it. This reduced the original flywheel weight of 15.2 kgs to 11.6 Kgs.

Flywheel with 15 mm of full face shaved off

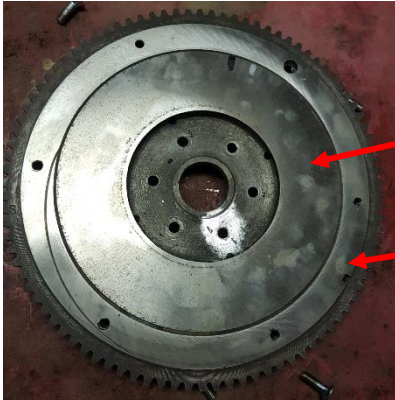
Clutch plate face dressed.

Note that the clutch assembly mounting surface has also been dressed down the same amount as the clutch plate face to maintain the correct mounting distance of the clutch plate

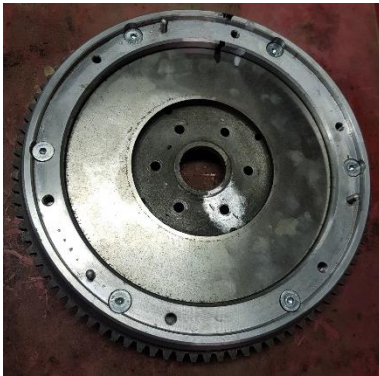
The flywheel with the new clutch assembly mounting ring attached

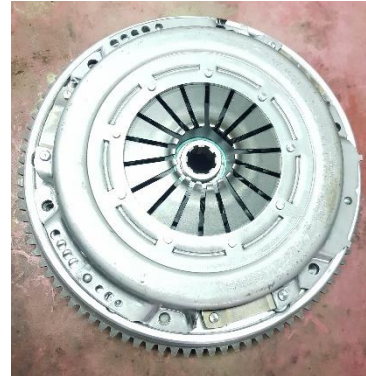
And with the diaphragm clutch body in place.

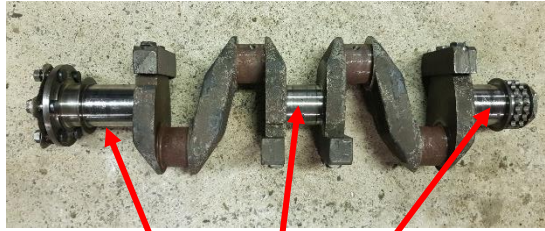
Old crankshaft to spin the flywheel on. Cleaned up main bearings so it ran well in the balancing jig

They found that the flywheel was 70 grms out of balance which they said was quite significant and would certainly cause vibrations within the car at certain speeds. They corrected this to 0 and then added the new diaphragm clutch body (minus the clutch plate) and did similar.

They found that when they added the new diaphragm body that it was 49 grms out of balance which is also quite significant and would be on its own creating vibrations, maybe something that members need to be aware of if they are just changing from the original clutch assembly to the later diaphragm system?
