2CV SECONDARY CHOKE BUTTERFLY ADJUSTMENT

By Graeme Dennes

Revision 4

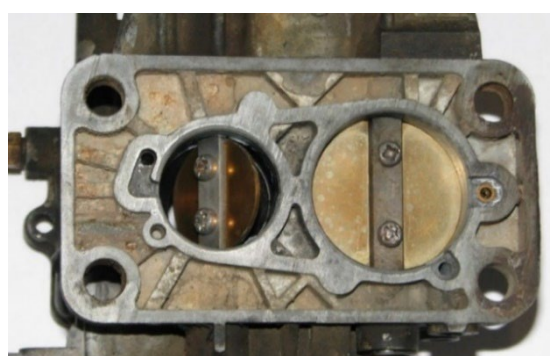
Photo 2 shows the butterflies as they appear with a partially open throttle. The primary choke butterfly on the left is around half open, while the secondary choke butterfly on the right is (still) closed. In fact, the secondary butterfly remains closed until around half throttle, after which it starts to open. Both butterflies reach maximum opening at full throttle.

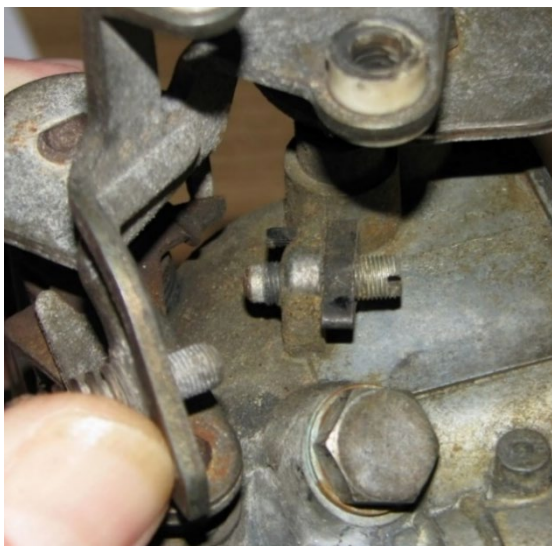
Photo 3 below shows the secondary butterfly adjustment screw in the centre of the photo. Note the small spring clip fitted to it to ensure it does not move. The throttle is being held in the fully open position.

6. If the secondary choke butterfly adjustment screw is fitted with an anti-tamper cap, remove the cap to expose the slotted screw head. In Photos 3 and 4, the cap has been removed.

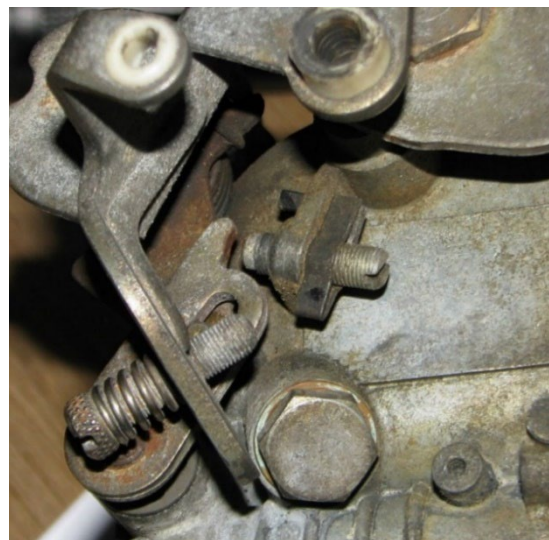
Photo 4 shows the "stop" arm which is attached to the secondary choke butterfly shaft. It's the partially hidden, slotted, elongated metal fitting positioned behind the idle speed adjustment screw and spring at the lower left. For clarity, the butterfly adjustment screw has been unscrewed several turns so its tip is well clear of the small tab on the end of the "stop" arm.

7. With the throttle fully closed, turn the secondary butterfly adjustment screw anti-clockwise five turns so its tip is **well clear** of the “stop” arm tab, as per Photo 4.

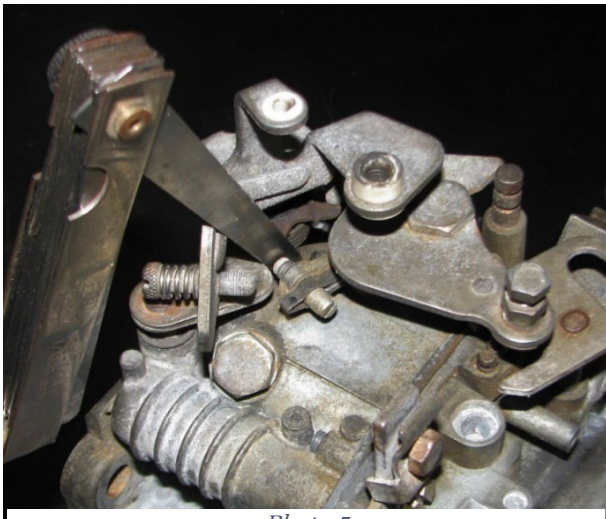
Recent analysis by the writer identifies how! See Photo 5 on left. At idle, the secondary butterfly adjustment screw is adjusted with a feeler gauge to provide a clearance of **0.5 mm** between the tip of the secondary butterfly adjustment screw and the tab on the "stop" arm. That's it! All done! Ship it out!

9. With the carburettor in the idle position, adjust the secondary choke butterfly adjustment screw until a 0.5 mm feeler gauge just fits nicely between the tab on the “stop” arm and the tip of the adjustment screw per Photo 5. It should be an easy sliding fit, not a tight fit or a loose fit. “Snap” the throttle by hand a few more times, then recheck the clearance. Snap some more and recheck. And again. Setting the 0.5 mm clearance with the secondary butterfly properly closing off the secondary choke *is the most important part of the entire procedure.*
