2CV CARBURETTOR COVER SCREWS

Revision 3

By Graeme Dennes

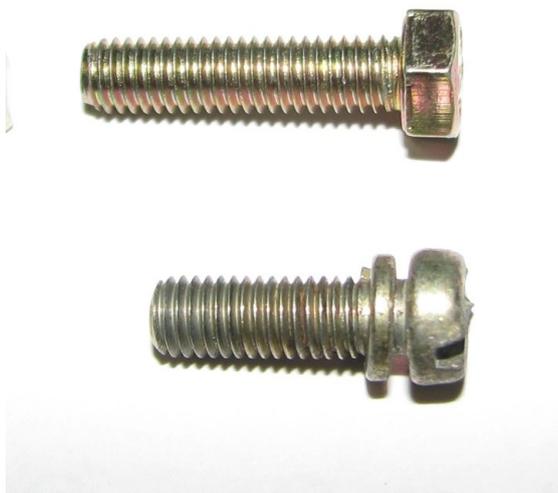
PHOTO 1

At bottom of Photo 1 is a standard Solex M5 x 0.8 x 15 screw with its fitted split washer, alongside an M5 x 0.8 x 20 replacement screw (hex headed bolt).

For my green "English" 2CV, which was fitted with 0.8mm threads (yes, ISO threads!), I made up a set of six custom-length M5 x 0.8 "screws" from hex-headed bolts with a screwdriver slot neatly cut in the heads. Each screw was cut to the maximum length allowable for each position, which provided for the correct sealing between the top cover and the body, and the longest maintenance life of the carburettor body threads. Don't forget to add a split washer under each screw head, and always return each screw to the same position.

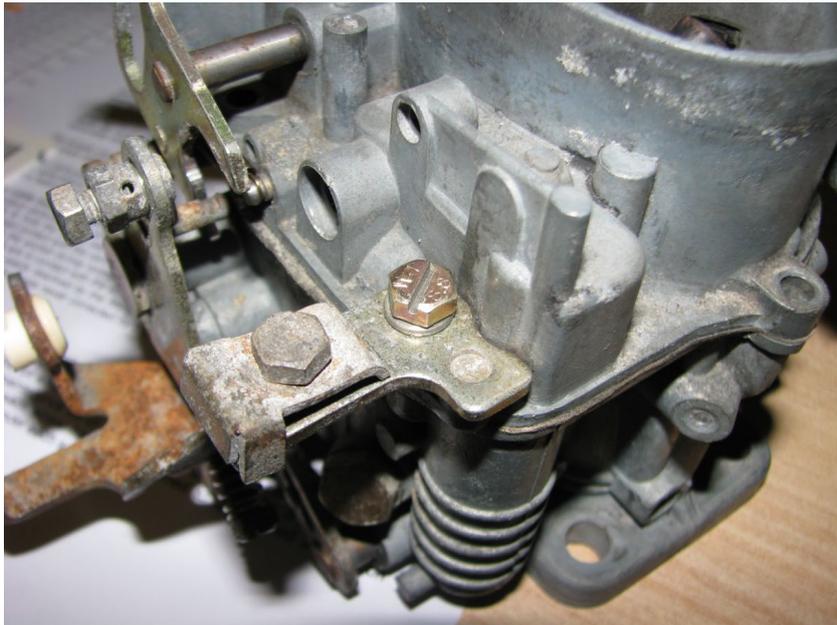
PHOTO 2

The standard carburettor top cover screws are typically 15mm in length. However, the screw which does double duty to hold the choke cable mounting bracket should be around 22mm in length (but no longer) to maximise thread contact with the carburettor body. The effect of this 7mm shortfall is the eventual stripping of the threads in the body socket during normal carburettor maintenance activities because only about *one third* of the carburettor body threads engage with the screw. A helicoil repair will be needed if the threads are stripped. The problem may be easily resolved by fitting a 22mm length screw of the *same* thread type as the original. It seems this issue was never corrected by Citroen. Again, Wilson Carburettor Service can provide the 22mm screw.

Photo 2 shows the new M5 x 0.8 x 22 screw fitted to the choke cable mounting bracket position. Note the slot cut in the head for a screwdriver.

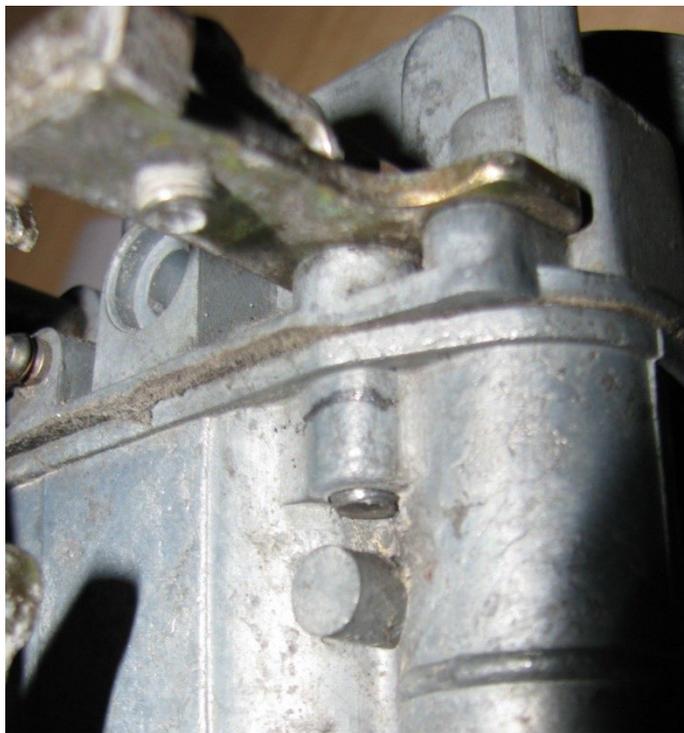
PHOTO 3

Photo 3 shows a side view of the choke cable mounting bracket, with the new M5 x 0.8 x 22 screw in position. Note the end of the screw just projecting outside of the lower opening of the carburettor body socket (centre of photo), ensuring the maximum number of engaged threads is being utilised. Ensure all new screws are not *too* long to cause binding against the carburettor body, else more stripped threads will result.
