2CV CARBURETTOR COVER SCREWS

Revision 4

Graeme Dennes

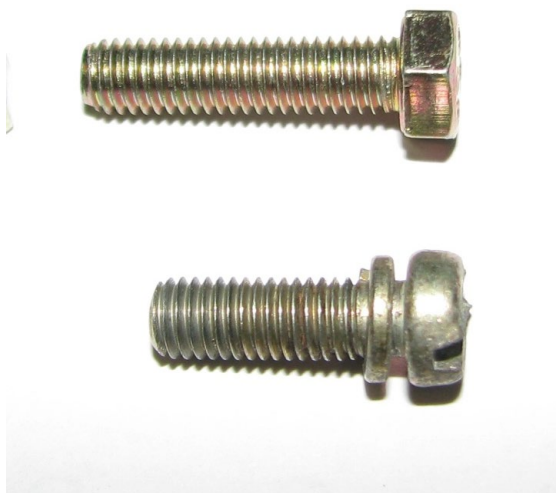
PHOTO 1

At bottom of Photo 1 is a standard Solex M5 x 0.8 x 15 screw with its fitted split washer, alongside an M5 x 0.8 x 20 replacement screw (hex headed bolt).

For my green "English" 2CV, which was fitted with 0.8mm threads (yes, ISO threads!), I made up a set of six custom-length M5 x 0.8 "screws" from hex-headed bolts with a screwdriver slot neatly cut in the heads. Each screw was cut to the maximum length allowable for each position, which provided for the correct sealing between the top cover and the body, and the longest maintenance life of the carburettor body threads. Don't forget to add a split washer under each screw head, and always return each screw to the same position.

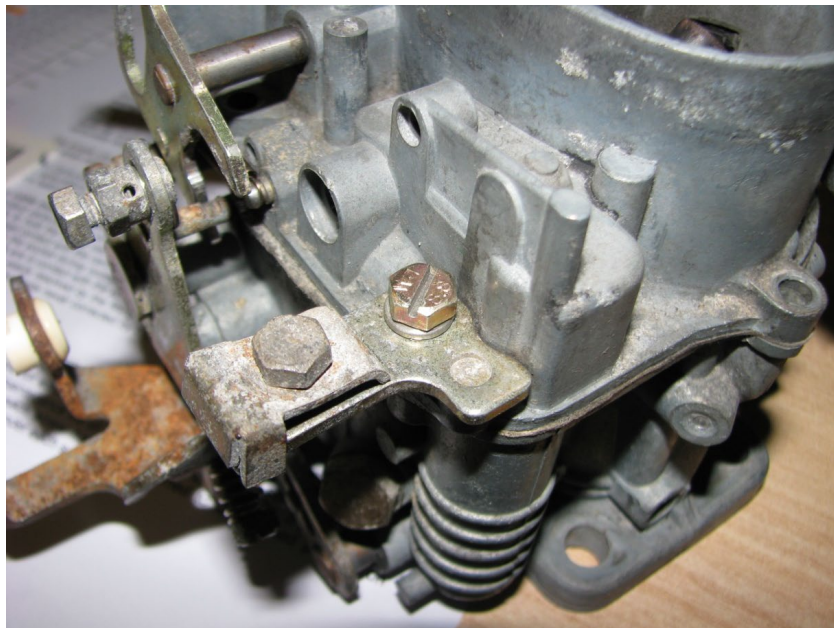
PHOTO 2

The standard carburettor top cover screws are typically 15mm in length. However, the screw which does double duty to hold the choke cable mounting bracket should be around 22mm in length (but no longer) to maximise thread contact with the carburettor body. The effect of this 7mm shortfall is the eventual stripping of the threads in the body socket during normal carburettor maintenance activities because only about *one third* of the carburettor body threads engage with the screw. A helicoil repair will be needed if the threads are stripped. The problem may be easily resolved by fitting a 22mm length screw of the *same* thread type as the original. It seems this issue was never corrected by Citroen. Again, Wilson Carburettor Service can provide the 22mm screw.

Photo 2 shows the new M5 x 0.8 x 22 screw fitted to the choke cable mounting bracket position. Note the slot cut in the head for a screwdriver.

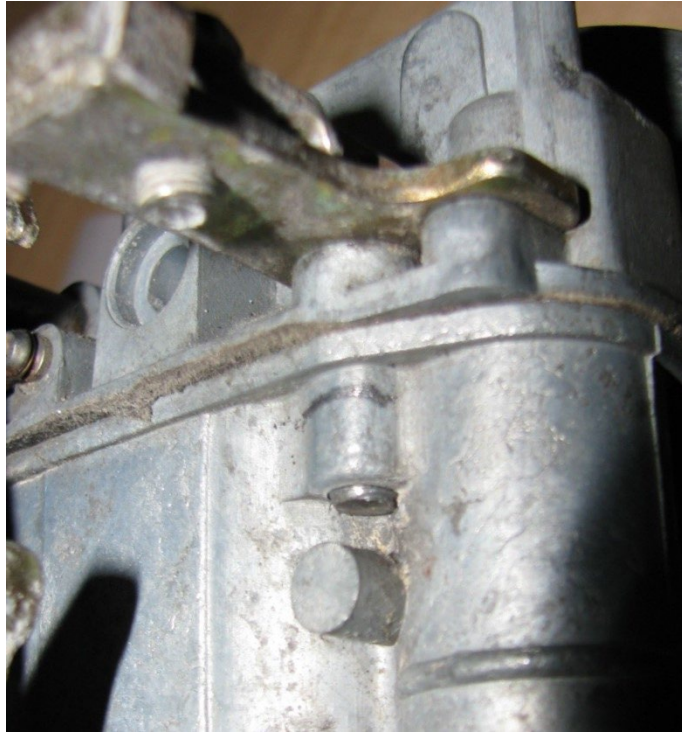
PHOTO 3

Photo 3 shows a side view of the choke cable mounting bracket, with the new M5 x 0.8 x 22 screw in position. Note the end of the screw just projecting outside of the lower opening of the carburettor body socket (centre of photo), ensuring the maximum number of engaged threads is being utilised. Ensure all new screws are not *too* long to cause binding against the carburettor body, else more stripped threads will result.
