Warning: The brake system of 4cylinder Tractions should only be worked on by persons with in-depth knowledge of the marque! This also applies to a certain extent to the 6cylinder version Daniel Eberli, www.oldtimer-taxi.ch

TRACTION BRAKES

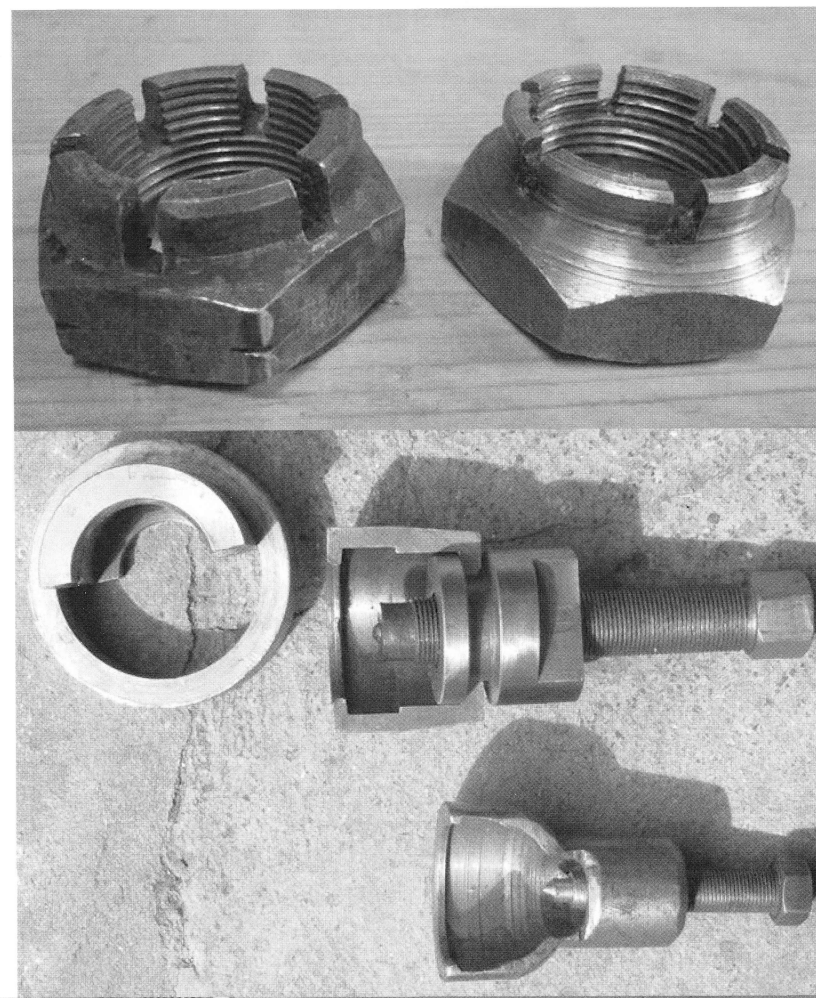
Illustration 2:
To remove the front brake drums of the 4cylinder models you must use the Citroën tool 1750-T. The heavy tool comprises two half shells which hold the neck of the brake drums tightly and are prevented from slipping off by a ring.

To remove the front brake drums of the 4cylinder models you must use the Citroën tool 1750-T. The heavy tool at the top of the picture [illustration 2] comprises two half shells which hold the neck of the brake drums tightly and are prevented from slipping off by a ring. If the drums are not sitting too tightly it is possible to work with a 'light version' as shown at the bottom of the picture. I carry the light version in my toolbox on journeys, to be able to help if anyone should have problems with the brakes.

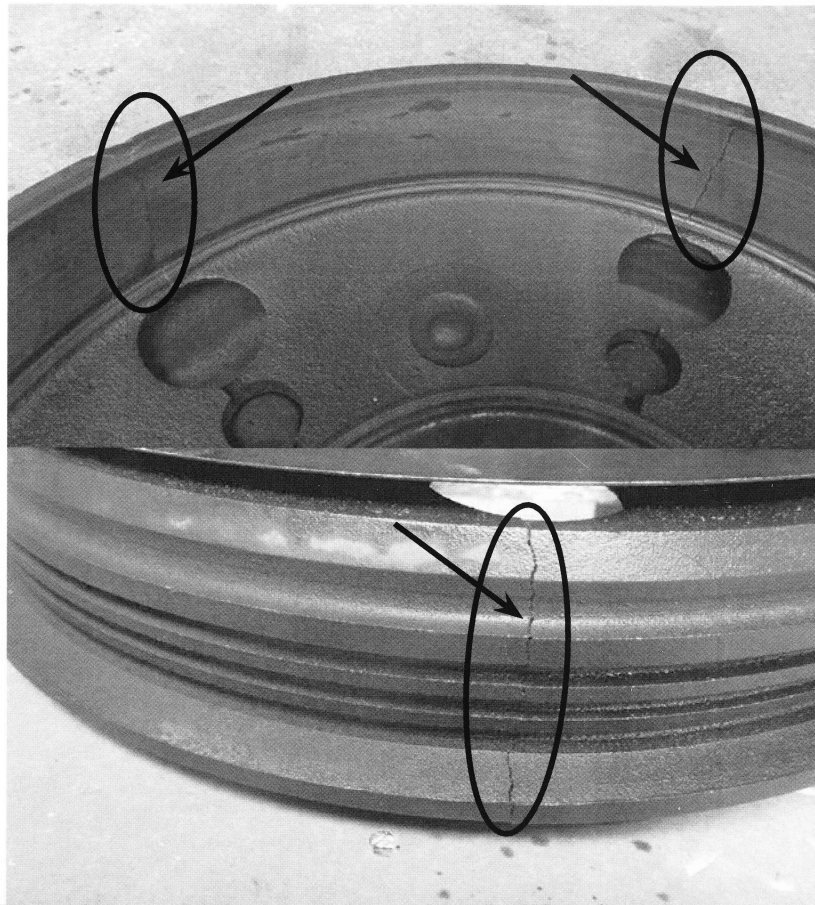
Illustrations 3 & 4: A drum which has been torn off by a 'professional' mechanic who used the wrong puller. Initially, he was not successful until he heated the drum in the centre with a torch. Finally the drum let go ~ and is now cracked in two places! The mechanic even welded one crack ~ maybe he did not even see the second one

You must use a tool which seizes the brake drum at the groove in the hub area. Any 'ordinary', commercially available puller which pulls at the wheel bolts or at the outer edge of the drum will destroy the brake drum. I recently received a sample drum [illustrations 3 and 4] from one of the participants in my courses, which had been torn off [any other term would be incorrect!] by a 'professional' mechanic who used the wrong puller. Initially, he was not successful until he heated the drum in the centre with a torch. Finally the drum let go ~ and is now cracked in two places! The mechanic even welded one crack ~ maybe he did not even see the second one...

Clearly this drum cannot be used anymore on a vehicle and

now only serves as a demonstration model. Therefore I have cut out one quarter with a cutting disc.

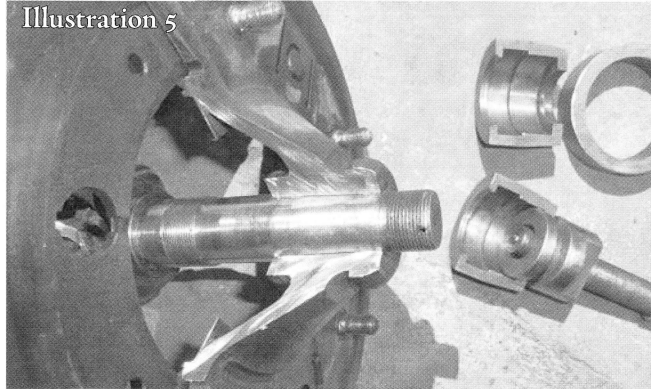
Illustration 5

Looking at the illustrations 5 and 6, it is recognizable that the brake drum rests on the cone only on the outermost and innermost

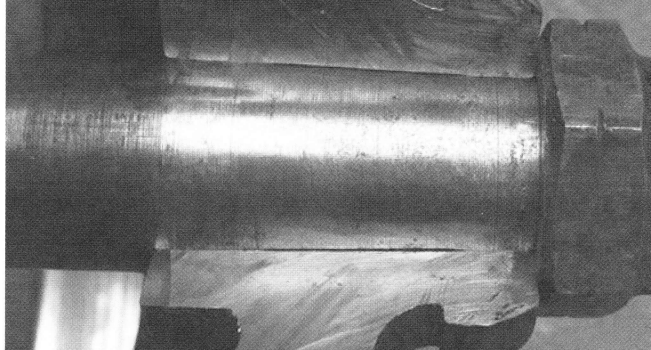
Illustration 7

½inches. This is deliberately so designed. In the next image [illustration 7] I screwed on the 38mm nut. As you can see, this is a nut with left-hand thread, and therefore it must be a drive shaft from the right side of the car.

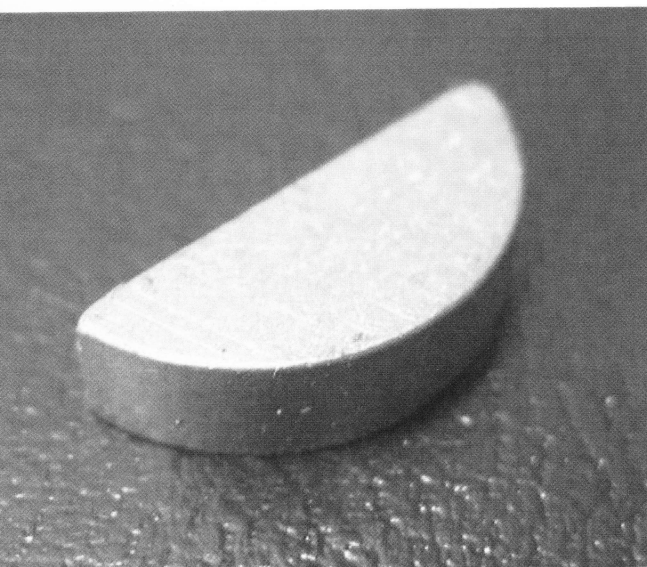
Illustration 8: The Woodruff key serves to ensure that the brake drum is mounted in the same position every time.

Additionally new Woodruff keys are often too thick. This does not allow the brake drum to rest on the cone all around but on the Woodruff key instead.

The drum is then mounted slightly off-centre, power transmission is no longer guaranteed and the Woodruff key shears off when a load is applied. If the key is too thick it needs reducing to the correct thickness before assembly in order to leave some space above.

It is essential that both the surface of the cone of the drive shaft and the inner surface of the cone of the brake drum are in good condition. The transmission of the driving force [torque] occurs only through the clamping of the cone connection. There is a Woodruff key, [illustration 8] but it cannot resist the torque. It serves only to ensure that the brake drum is mounted in the same position every time. If the cone connection is not sufficiently firm, the key is quickly sheared off and the drive

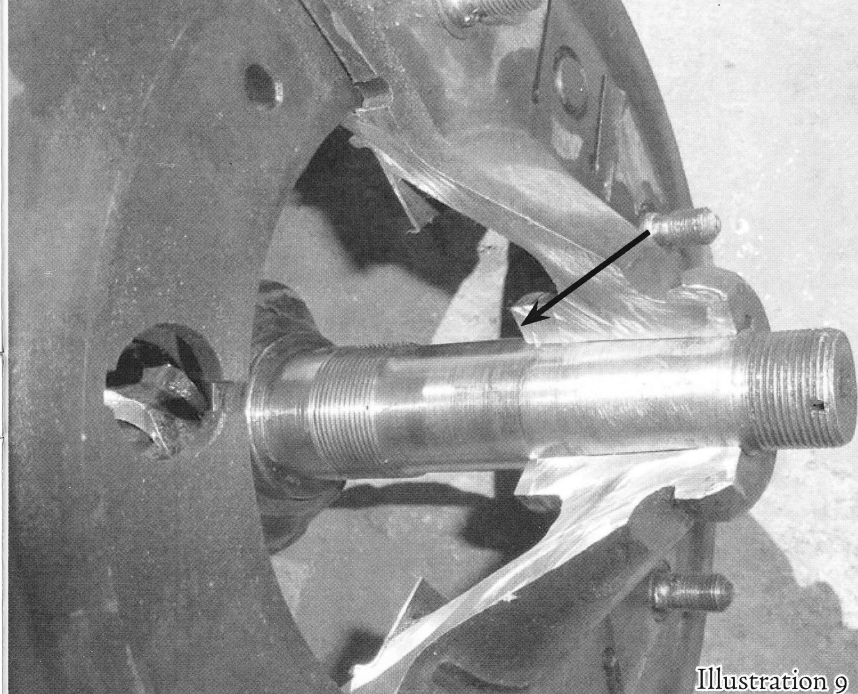
Illustration 9

Illustrations 9 & 10: The brake drum slips so far on the cone that the inner end touches the [outer] wheel bearing and the cone does not come to fruition. Skimming 1 or 2mm off the brake drum with a lathe in the area of the wheel bearing [illustration 9] would help. However, now there is a danger that the drum touches the brake plate. You would have to skim off 1 or 2mm of the outer edge of the drum also [illustration 10].

✂ The brake drum slips so far on the cone that the inner end touches the [outer] wheel bearing and the cone does not come to fruition. Skimming 1 or 2mm off the brake drum with a lathe in the area of the wheel bearing [illustration 9] would help. However, now there is a danger that the drum touches the brake plate. You would have to skim off 1 or 2mm of the outer edge of the drum also [illustration 10]. However, I do not like such measures and

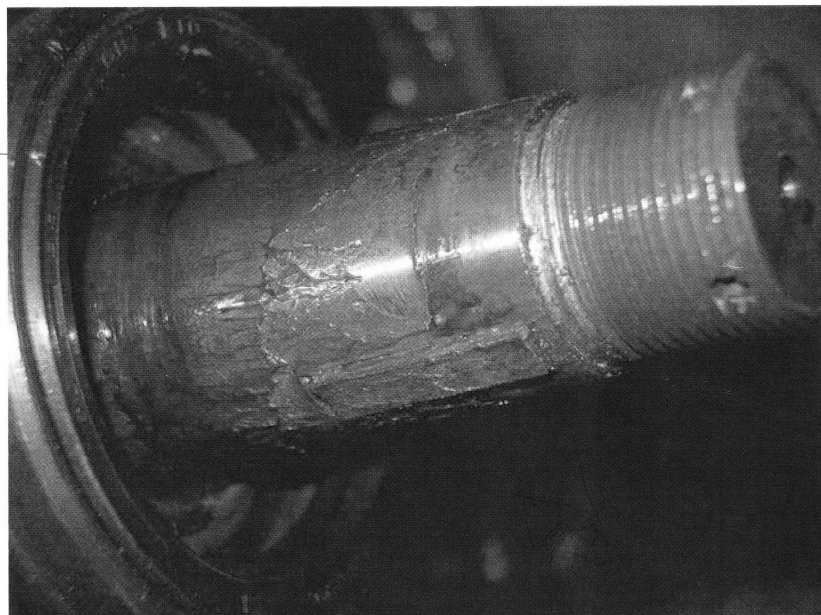
Illustration 11: Greasing the cones as shown may make removing the front brake easier, but it is only a matter of time before one of the woodruff keys will shear off.

I soon realized that he had only managed to remove the front brake with great difficulty. Becoming clever, he wanted to make sure that 'next time' it would be easier. Therefore he greased the cones generously [illustration 11]. It

would only have been a matter of time until one of the woodruff

keys sheared off and the drive shaft would have slipped in the brake drum. Moreover, since both drive shafts were mounted with left-hand threads, in the worst case this might have led to unscrewing one of the 38mm nuts, and then one of front wheels would have gone 'a different way'...

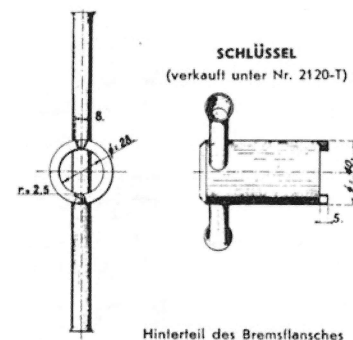
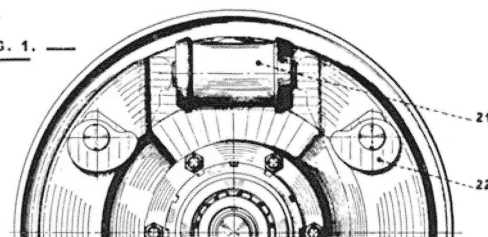
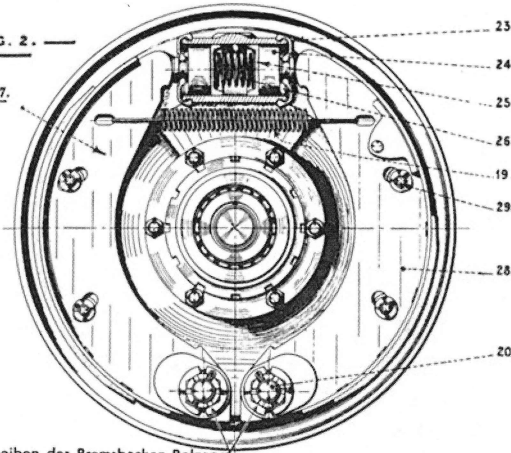
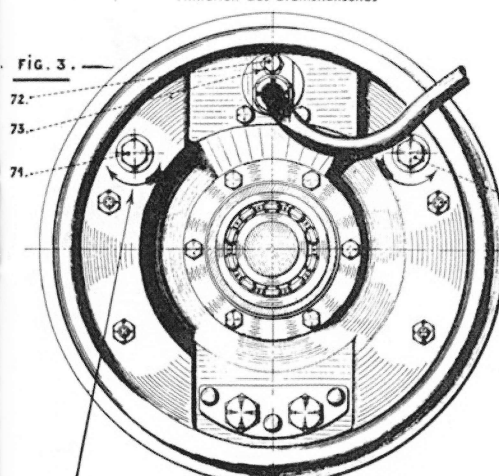
Illustration 13: Only at the very end do you put the brake pads as close as possible to the drums on the outside by the [upper] eccentrics, [No. 22 and 71], to keep pedal travel to a minimum

Trommelseite des Bremsflansches (ohne Bremsbacken)

Kompletter Bremsflansch (mit Backen)

Drehrichtung der Bolzen: 71. zum Öffnen der Bremsbacken 27 und 28.

Einlegen der Bremsbacken-Bolzen (mittels Schlüssel 2120-T verstellen)

Only at the very end do you put the brake pads as close as possible to the drums on the outside by the [upper] eccentrics, [No. 22 and 71 on the sketch illustration 13], to keep pedal travel to a minimum.

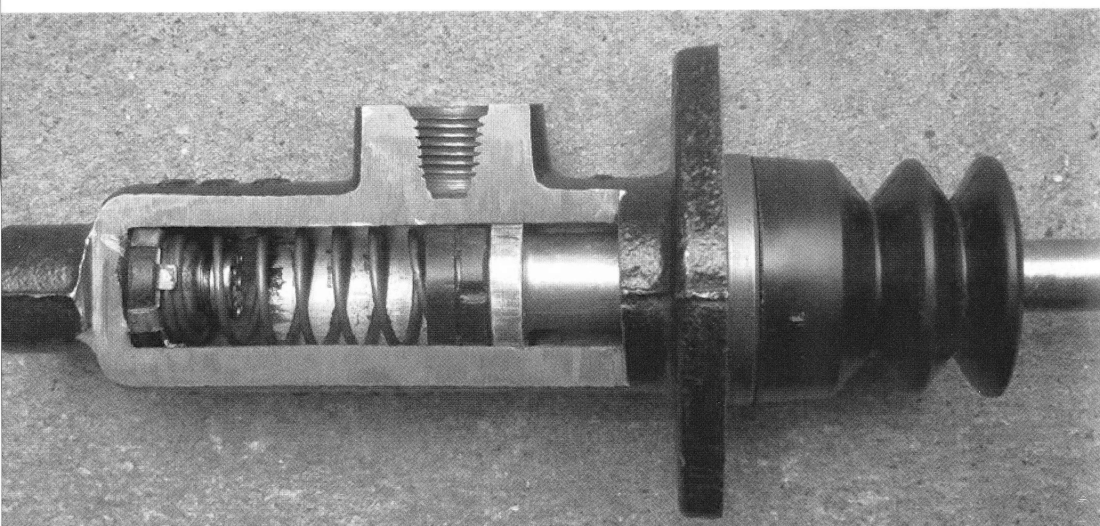
Illustration 14:
A cut-away
brake master
cylinder

On page 20 [illustration 14] there is a cut-away brake master cylinder

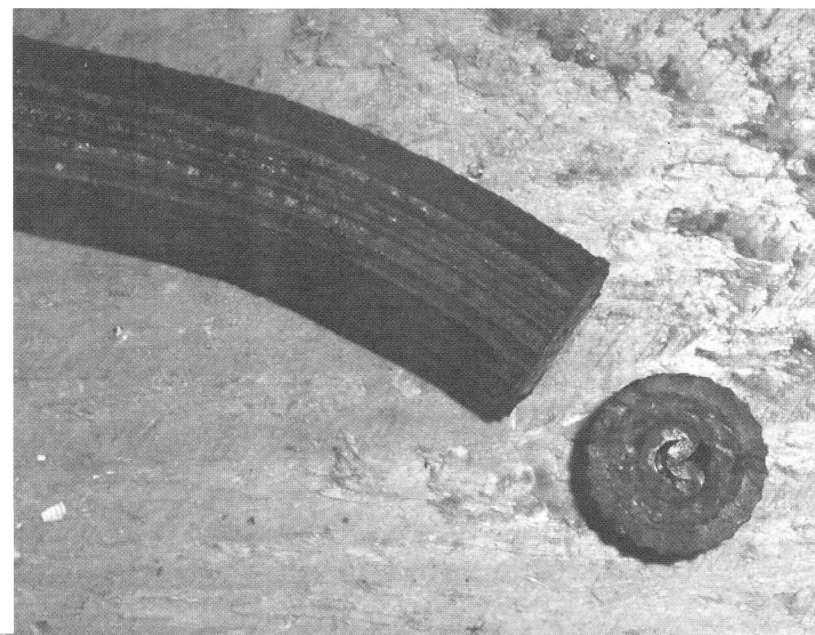
Illustration 15:
Rubber hoses
become brittle
and crack.
It takes a very
long time
until such
cracks cause a
loss of brake
fluid. How-
ever be aware
that the
rubber may
swell, as seen
in the picture.
The opening
for the liquid
is almost
blocked.

Rubber hoses become brittle and crack. It takes a very long time until such cracks cause a loss of brake fluid. However be aware that the rubber may swell, as seen in the picture. The opening for the liquid is almost blocked. [Illustration 15] While it is still possible brake

fluid can be injected through it by the pedal force and thus achieve a braking effect, the force of the springs to pull the brake shoes back is too low, so the brakes will not release properly. The brakes then heat up, which may cause damage to the brakes. It is even possible to have a tyre blown by the heat.
