LE TECHNICIAN VOUS PARLE

By Rob Koffijberg.

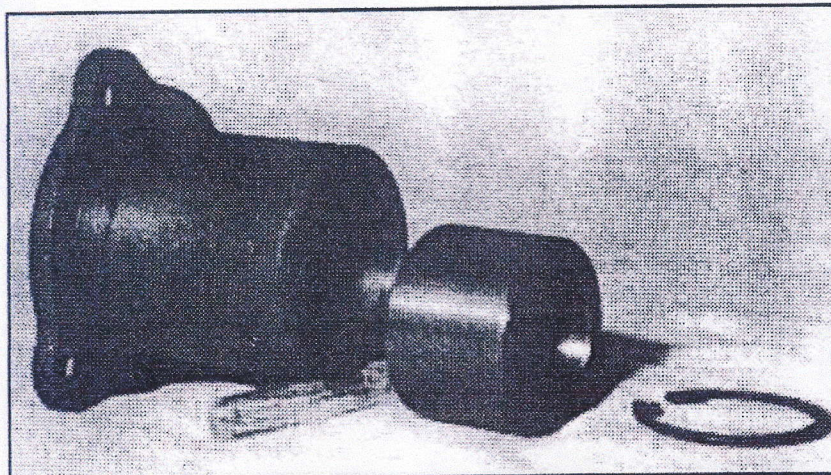
The separate parts

Well, the end of the mainshaft is beautifully smooth. So, you can use a seal when you take a part of the inside of the hub out and make the inside smooth.

The mainshaft is 25mm. When you make the inside of the hub 36mm wide and 37mm deep you can use a seal with the measurements 36 x 25 x 7. To keep this seal inside the hub you also have to make a bush for the inside of 36-25, 5-25.

Lastly, to keep the bush inside the hub you make a groove, just at the end where the bush is mounted and put a circlip inside the hub.

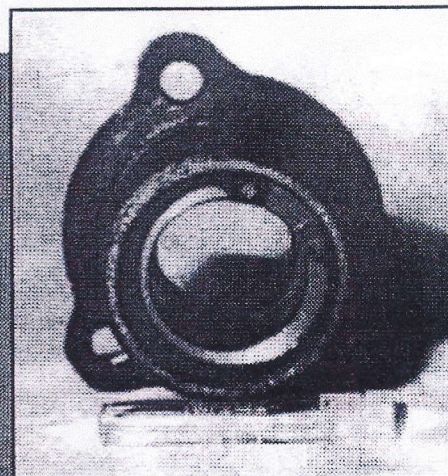
All the parts mounted
