ADJUSTING THE CLOSING POSITION OF THE 2CV SECONDARY CHOKE BUTTERFLY

By Graeme Dennes

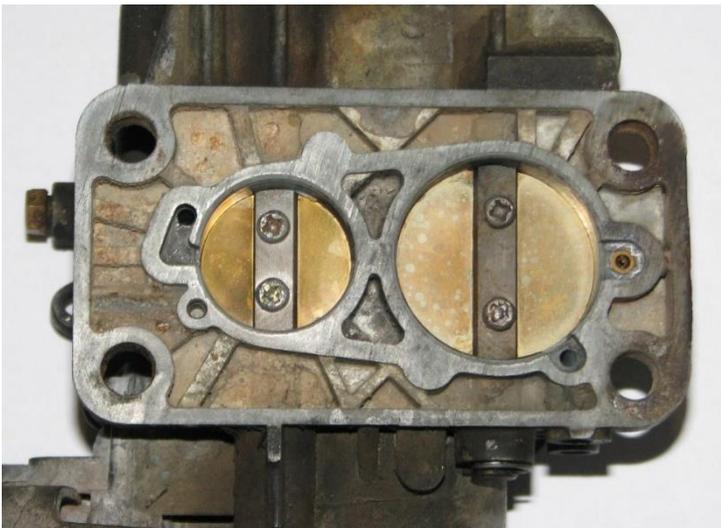
Photo 1 at left shows the bottom of the carburettor with both butterflies closed. The smaller butterfly on the left controls the quantity of air/fuel mixture from the (smaller) primary choke, while the larger butterfly on the right controls the quantity of mixture from the (larger) secondary choke, the energy source of the 2CV's unbridled power!

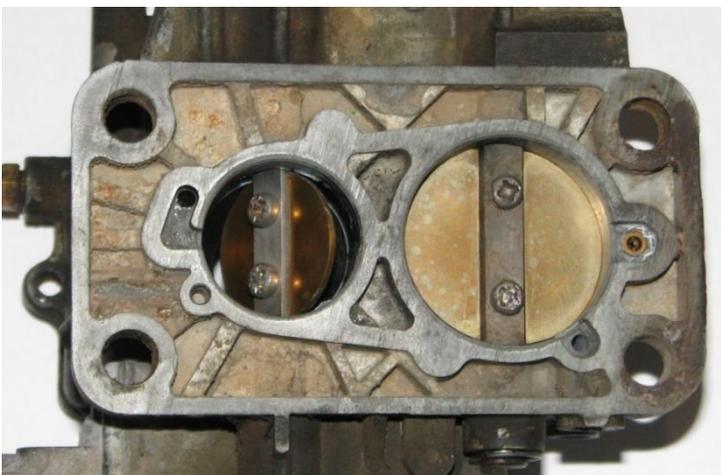
Photo 2 at left shows the butterflies as they appear with a slightly open throttle. The primary butterfly is partially open, while the secondary butterfly remains fully closed.

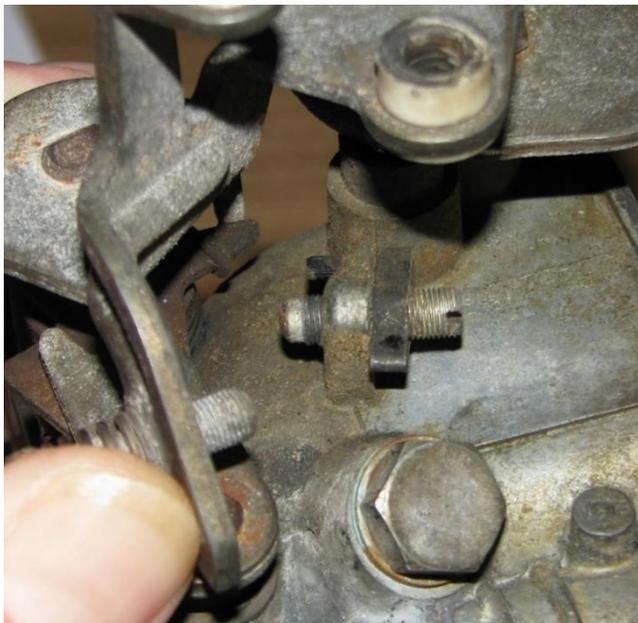
Photo 3 at left shows the secondary choke butterfly closing position adjustment screw in the centre of the photo. Note the small spring clip fitted to the adjustment screw to prevent it from moving. (This carburettor is from a 1987 2CV.)

On at least one earlier model 26/35 CSIC carburettor, the adjustment screw was located on the opposite side of the carburettor, attached to the secondary choke butterfly shaft.

1. Remove the carburettor from the car and place on a clean workspace.
2. If the secondary butterfly adjustment screw is fitted with a plastic anti-tamper cap, cut off the top of the cap to expose the screw head. In Photo 3 and Photo 4 above, the plastic cap has been completely removed from the adjustment screw.

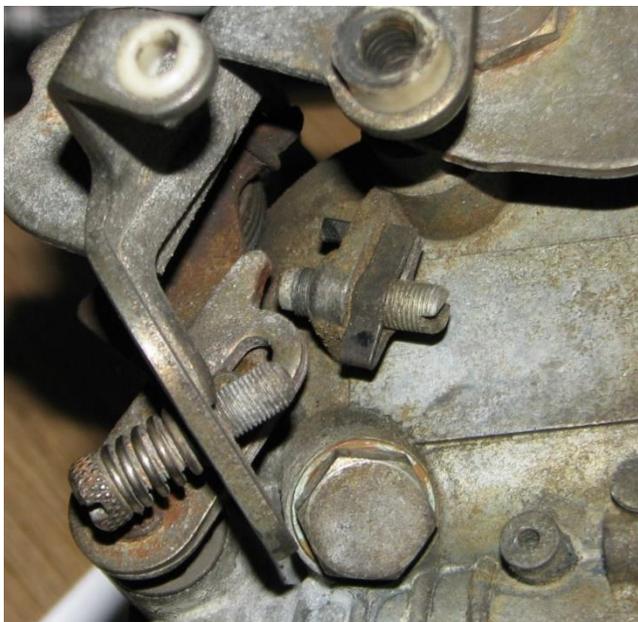
Photo 4 at left shows the “stop” arm which is attached to the secondary butterfly shaft. In the photo, it’s the metal fitting positioned immediately behind the idle speed adjustment screw and spring at the lower left. The butterfly adjustment screw has been unscrewed a few turns so its tip is well clear of the small tab on the end of the “stop” arm to ensure the secondary butterfly can fully close when the throttle is fully closed, our *raison d’être*. (As an aside, the large hex-headed “bolt” to the lower right of the idle speed adjustment screw is a removeable metal cap and washer which provides screwdriver access to the primary choke main jet.

3. After ensuring that the carburettor's throttle assembly is in its fully closed (anti-clockwise) position, turn the secondary butterfly adjustment screw anti-clockwise until its tip is well clear of the "stop" arm tab, per Photo 4 above.
