## HUBCAP HEAVEN

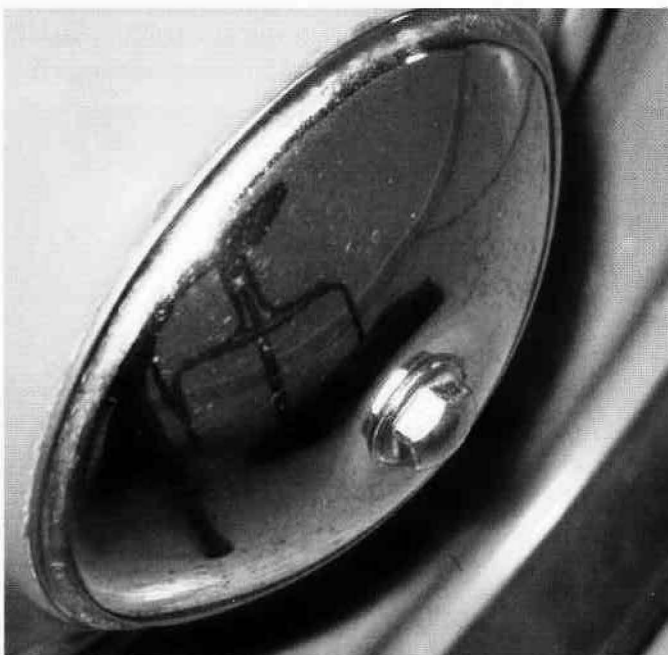
I decided that washers or tubular means could be interposed between the cross bar on the wheel and the inside of the central domed cap – a spacer to react a substantial tightening load be-

fore permanent distortion of the wheel cap area takes place. I cannot recall whether my final design involved any alternative methods, but my fix resulted in what I, and various contractors [tyres and brakes, etc.] have accommodated

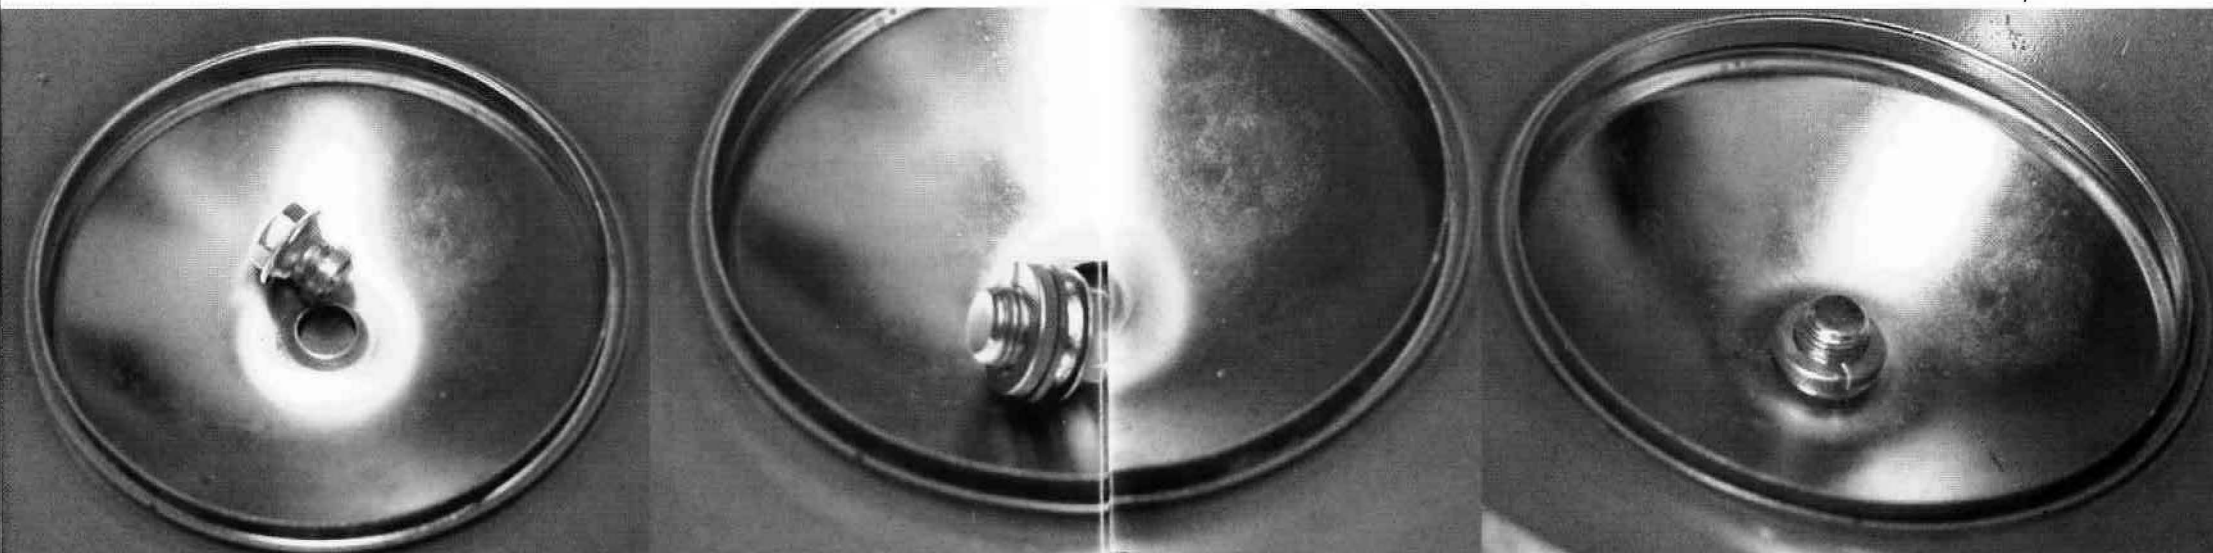
Left to right: Photos 2, 3 and 4 as referenced in Bernie Hadaway's article.

the 14mm thread. I reasoned that this good frictional engagement would provide security against the loss of the bolt when the hub cap is removed. If this spring washer/spacer arrangement needs to be adjusted for length plain washers could be added to the screw ahead of the spring washer assembly [photo 3].

All this provided a good assembly [photo 4], which although not tested in corrugated trials, must do for I am not prepared to look for the better solution, which one always suspects is there to be found.

Photo 2 shows that the method used involved discarding a wire circlip that was used around the threaded holding screw on the inside of the cap to prevent loss of the screw when the wheel cap is removed. A steel tubular spacer was manufactured which had an internal thread in its bore of 14mm diameter x 1.5 thread pitch to match the screw. The spacer measures 4.5mm long which reacts

I have accordingly explored the use of an alternative spacer a half inch 'C' spring washer, which with a bit of persuasion can be pushed over the 14mm thread without creating damage to the thread profile. The half inch spring washers I have in abundance in my miscellaneous box, all having accurate half inch bores which provide just the right frictional engagement over

I was lucky, my range of half inch spring washers provided a choice of thicknesses and I found a 4.5mm thick heavy duty spring washer which required no extra washer backing.
