Traction Oil Leaks

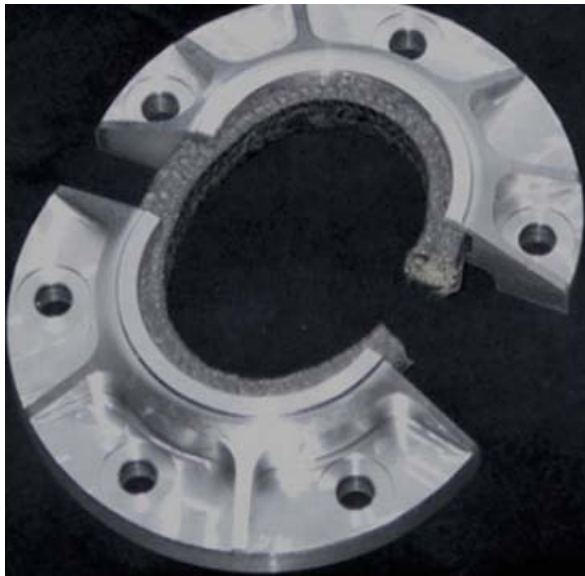
The carrier remains an expensive item yet combined with the split seal it appears a solution to the crankshaft oil leak has been solved.

A few years back I came across an improvement to the graphite rope seal where a split seal was substituted. All attempts to purchase one of these seals were in vain as the company in Europe informed me they were no longer available. At the time I was wrestling with an oil leak, hence my persistence in following this avenue.

Eventually I gave up and it became one of those issues that a Traction owner had to live with! However out of the blue one of our members managed to source a split seal

here in Australia, which fitted the rope carrier above perfectly. Having not spoken to him personally I can only imagine it was due to his frustration with oil leaks which saw him pursue an alternative?

To the best of my knowledge he reports that the replacement seal is working and the crankshaft is not “dripping oil”
