## A Draining Experience

### *D-Series: A Vital Check when Draining Coolant*

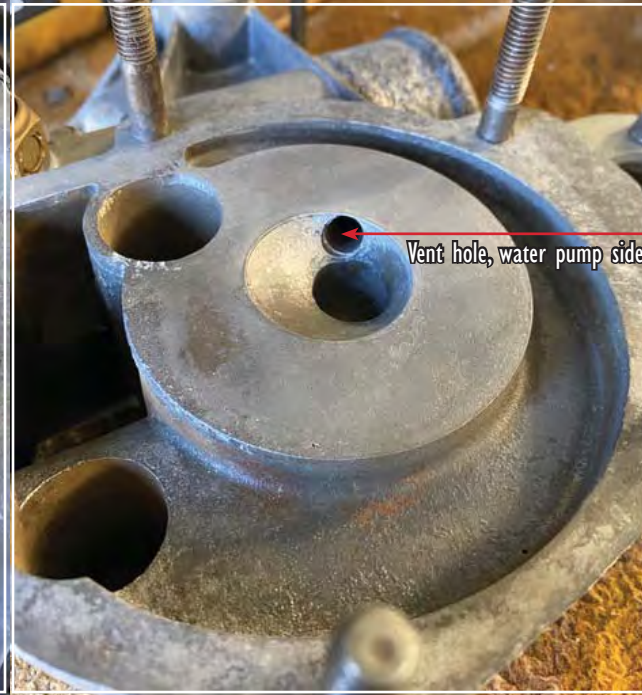
and what do you know, that was perfect too! Now this is my car's original engine, so it's cooling system has been flushed and cleaned over its life, rust inhibitor used continually in my ownership of 28 years and it is pretty clean. Not perfect, but as good as one can get an older engine. I did have another thermostat housing handy that I could inspect and found a drilling from the centre of the back of the water pump to the radiator hose outlet on the housing. When I checked this drilling on my car, it was visible at the water pump end but not at the hose outlet. Using a scraper I removed a couple of scale deposits and uncov-

ered the missing hole, cleaned the hole thoroughly with a drill bit, then re-assembled the car once again. I re-filled the cooling system once again.

removal of air in the system after refilling. This is the reason I am writing this article. So if you have a need to drain your cooling system, before re-filling, remove the top radiator hose and check this hole is clear; it may save you a lot of problems.
