2CV GEARBOX OUTPUT HUBS

Revision 4

This article describes the procedure to replace the oil seals, and optionally, the bearings, in the 2CV gearbox output hubs. The critical items associated with the procedure are described. The article commences with background information and an overview of the procedure.

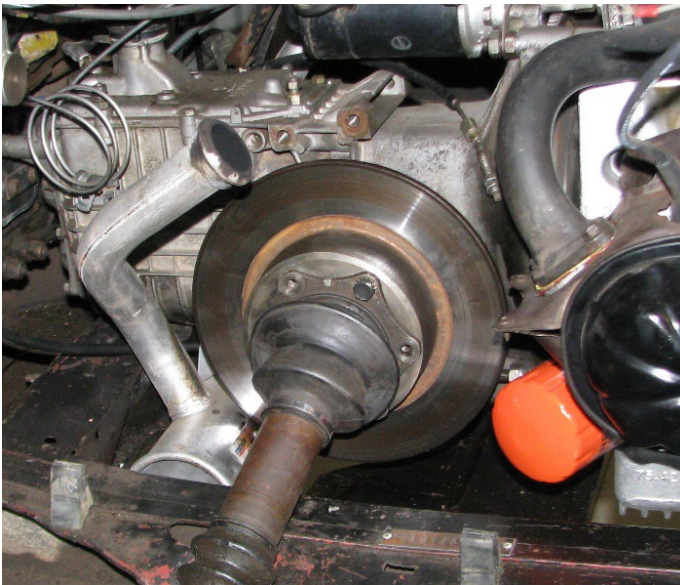
Photo 1: Firstly, remove both front guards. Disconnect all cables from the battery **negative** terminal. Remove the air tubes. Disconnect the heater cables from the exhaust system heat exchangers. Remove the heat exchangers. Disconnect the handbrake cables from the brake calipers. Remove the brake pads and the brake calipers, including the *very important* thin metal shim fitted on the two caliper mounting bolts and fitted between the inner caliper halves and the gearbox. One shim should be fitted on each side of the gearbox. No more, no less! Watch out for it.

Next, the CV-joint mounting plate on the inner end of each front wheel drive shaft is unbolted from the gearbox output hub drive flange by removing the six bolts and washers shown in the centre of the photo. This allows the CV-joint mounting plate and the brake disc to be separated from the output hub, exposing the output hub. The brake disc is sandwiched between the CV-joint plate and the output hub drive flange. Lift the driveshaft rearward, out of the way.

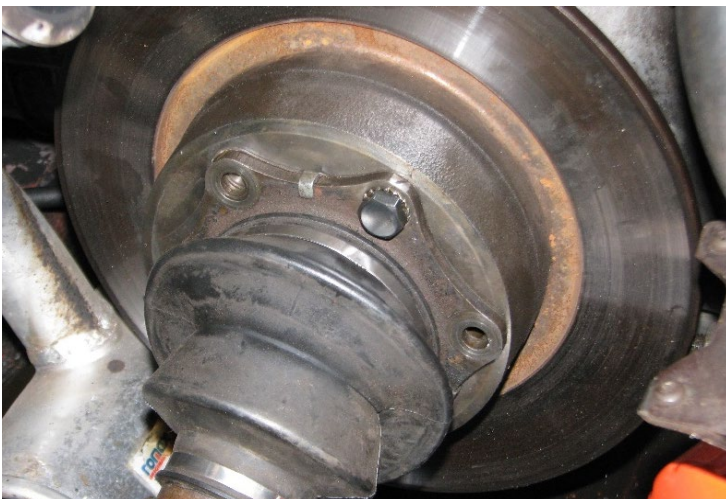
Photo 2: Crikey. Looks like I got to this job just in time! (Only joking. That single bolt was fitted for the photo!)

Shows a closer view of the inner CV-joint plate and brake disc still bolted to the drive flange on the output hub (the hub is still hidden behind the disc).

You may observe a small bent metal clip situated between the two upper bolt positions. There are three of these clips positioned on the CV-joint plate

and they hold in place what is essentially a shaped metal gasket.

The metal gasket fits between the CV-joint plate and the outer face of the brake disc. The metal gasket normally won't be loose and fall off, but ensure it is properly fitted and secured before the CV-joint plate and brake disc are later refitted to the output hub with the six bolts.

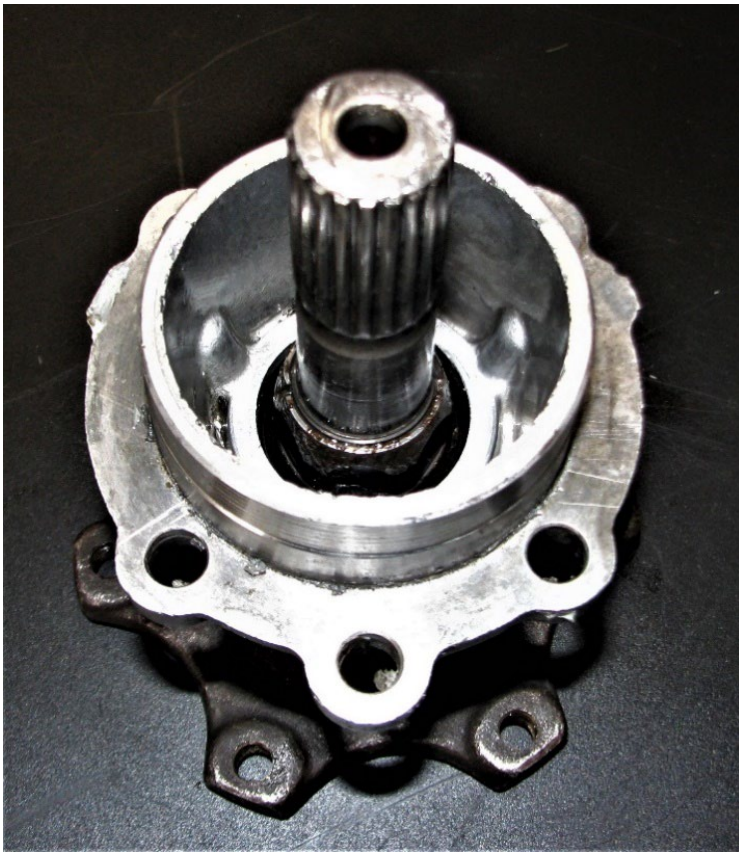
Photo 13: Shows the inside of the hub and the splined shaft which engages with the differential gearing.

Shows the lock nut which locks the *outer* bearing and steel spacer in place on the shaft. It can just be seen at the bottom of the shaft as a hex nut. The lock nut is tightened to **75 foot-pounds**. Add some copper grease first. Note the nut has been peened at its 9 o'clock position to ensure it does not loosen.

The writer experienced the consequences of this nut loosening in the left-side output hub during RAID 2016. The lock nut unscrewed completely, allowing the output hub shaft to slowly move outwards, sliding through the (tight) fit of the hub bearing until eventually the splines

disengaged from the differential gearing, at which moment the vehicle failed to proceed while travelling along a red-dust road in Northern Territory somewhere near Lajamanu. (Note: the car had drum brakes at the front at that stage, so the drum was able to move outwards.)

Thanks to the swift diagnosis and repair effort by Stephane Laguna and Elliot Beniada, the output hub was removed from the gearbox and the recalcitrant lock nut fitted, tightened and peened. We were back on the road in two and a half hours. A truly magnificent effort by these gentlemen in a situation well away from the comforts and tools of a workshop and in exceptionally difficult, dusty and dirty conditions on the side of the road. Thank you both once again! That was the day the writer was formally introduced to the 2CV gearbox output hubs!
