2CV SECONDARY CHOKE
BUTTERFLY ADJUSTMENT
Revision 5

2CV SECONDARY CHOKE BUTTERFLY ADJUSTMENT

Revision 5

By Graeme Dennes

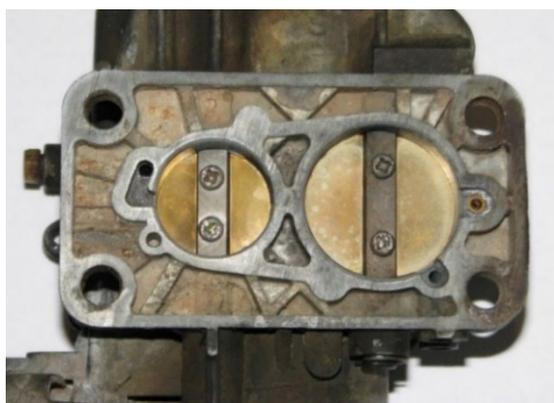
Photo 1 shows the underneath of the carburettor with the throttle at the idle position. The barely open (smaller) butterfly on the left controls the quantity of air/fuel mixture delivered by the (smaller) primary choke, while the larger butterfly on the right controls the quantity of mixture delivered by the larger secondary choke, the source of the 2CV's unbridled power! Um, unbridled *what...??*

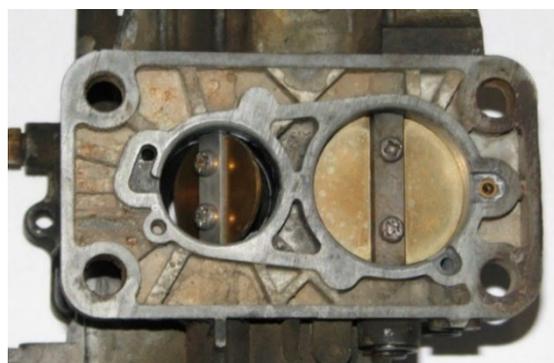
Photo 2 shows the butterflies as they appear with a partially open throttle. The primary choke butterfly on the left is around half open, while the secondary choke butterfly on the right is (still) closed. In fact, the secondary butterfly remains closed until around half throttle, after which it starts to open. Both butterflies reach maximum opening at full throttle.

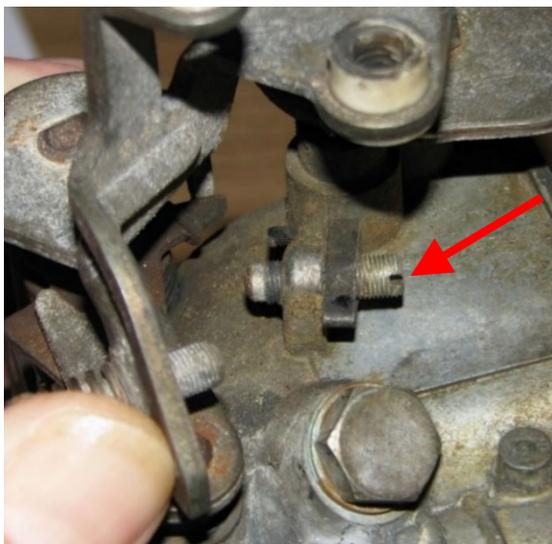
Photo 3 below shows the secondary choke butterfly adjustment screw in the centre of the photo. Note the small spring clip fitted to it to ensure it does not move. The throttle is being held in the fully open position.

6. If the secondary choke butterfly adjustment screw is fitted with an anti-tamper cap, remove the cap to expose the slotted screw head. In Photos 3 and 4, the cap has been removed.
