Camber Correction

Front wheel camber problems on our Light 15 ~ a DIY solution!

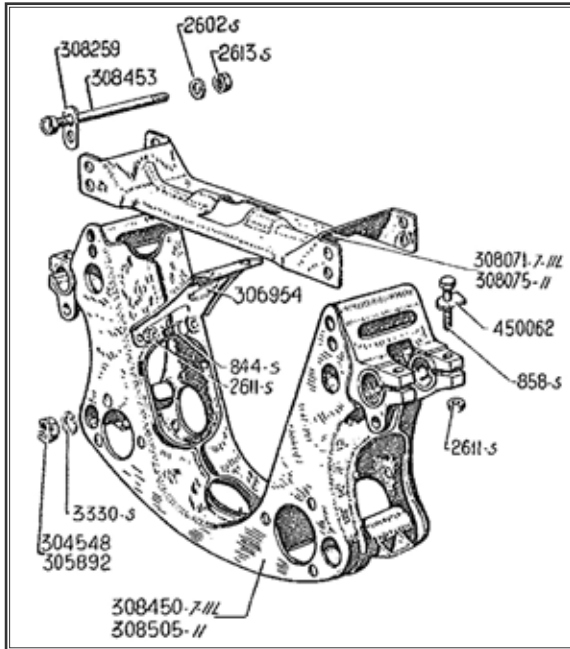
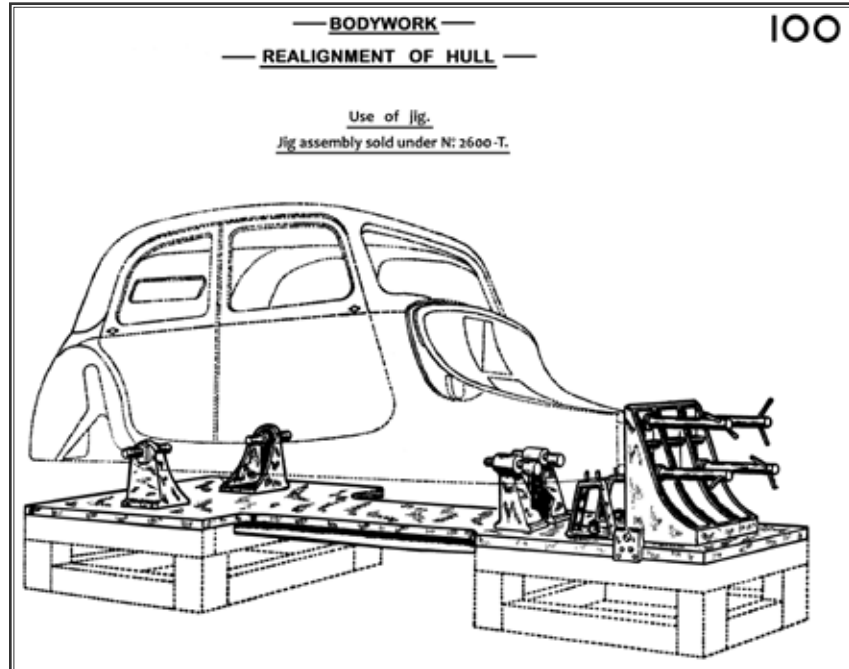
ed in 'Diagram 100 ~ Realignment of Hull' in the manual. The alignment of the main section of the body shell didn't appear to have been affected by the minor accident.

The mis-alignment was restricted to the jambonneaus, where I had to lift the left hand side [LHS] 6mm with respect to the right hand side [RHS], so I ratcheted the RHS jambonneau down as hard as I could and iteratively jacked and measured the LHS jambonneau. After several iterations, the two jambonneaus were aligned to the rest of the body shell!

Undeterred, I decided to have a go at straightening it myself. We have a brother-in-law who owns a quarry and cement processing plant near Nelson, and has a great 'spare parts department'. I took a tour through his yard, and identified a couple of lengths of 150mm RHS which I thought would form an ideal basis for a home chassis straightener. I also ordered a 10tonne jack and three 2.5tonne ratchet tiedowns, and picked up some wood from the recycling centre, then set to work.

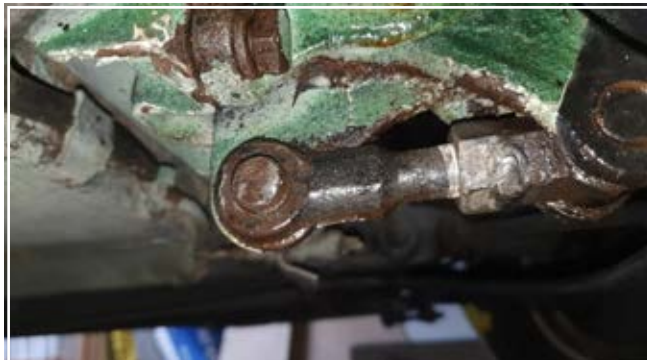
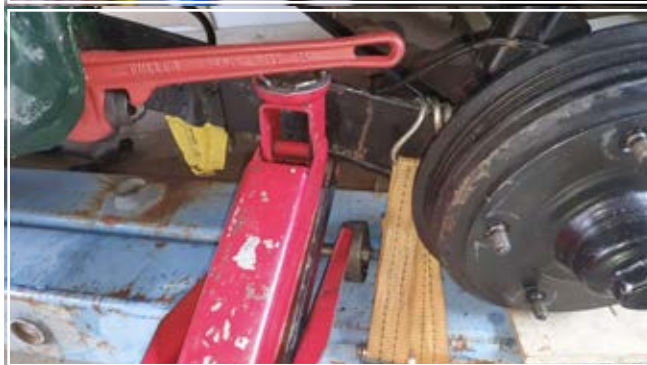
Great I thought, the next task, levelling up rear suspension heights will be easy! The LHS rear was 7mm lower than the RHS. I doubt whether the heights have been adjusted in the life of the car. Butchered adjusters indicated somebody had attempted to adjust them, but obviously not successfully.

Seventy years of water and rusting had to be overcome. I drowned all supposedly moving parts in CRC but to no avail. I was able to get the pin out of the adjuster, with a ball joint puller, so

I freed up the adjuster nut in the vice. To make my life easier, I drilled out the thread of a 16mm nut and then welded the nut to the existing adjuster nut because there was plenty of space for the longer combination nut. This had the benefit of leaving me easier access to the nut, and also I could now use a standard 24mm spanner which I have, rather than a 23mm proprietary tool.

Well, still no movement, so I realised I'd need to undo both the torsion bar castle nuts to free up the joints. What a challenge that proved to be. I jacked the Stilsons against both lengths of RHS to which I had the suspension are tied down. After a lot of heaving and groaning, the grip of the rust was finally broken. After a lot more CRC and oil in the appropriate places, I can now easily adjust the rear height [on the LHS anyway].

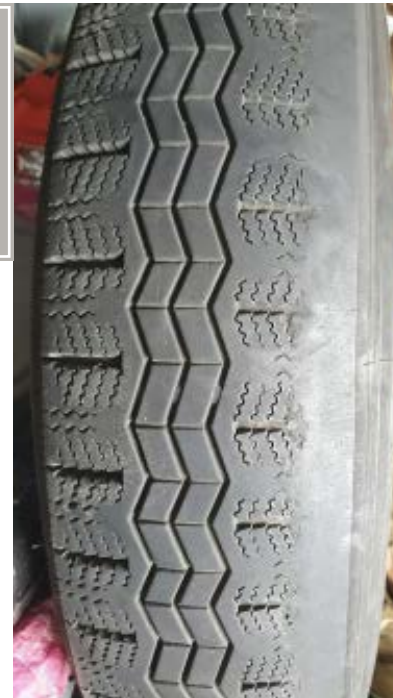
The effect of rotation of the suspension cross-member on camber and weight distribution. The more acute angle [shown in red] results in higher weight on the right hand wheel as a consequence of the crossmember rotation, which exacerbated the tyre wear.

We discovered that our Light 15 had significant camber issues on the front wheels. Camber is not adjustable on the Traction and is determined by the orientation of the front suspension cross-member, which attaches to the jambonneaus [the ham legs at the front of the body shell]. Our suspension crossmember was rotated clockwise, with respect to the road, due to:

- 1 the rear suspension being lower on the left hand side;
- 2 a previous left front accident slightly twisting the body shell.
