2CV GEARBOX OUTPUT HUBS

Revision 5

This article describes the procedure to replace the oil seals, and optionally, the bearings, in the 2CV gearbox output hubs. The critical items associated with the procedure are described. The article commences with background information and an overview of the procedure.

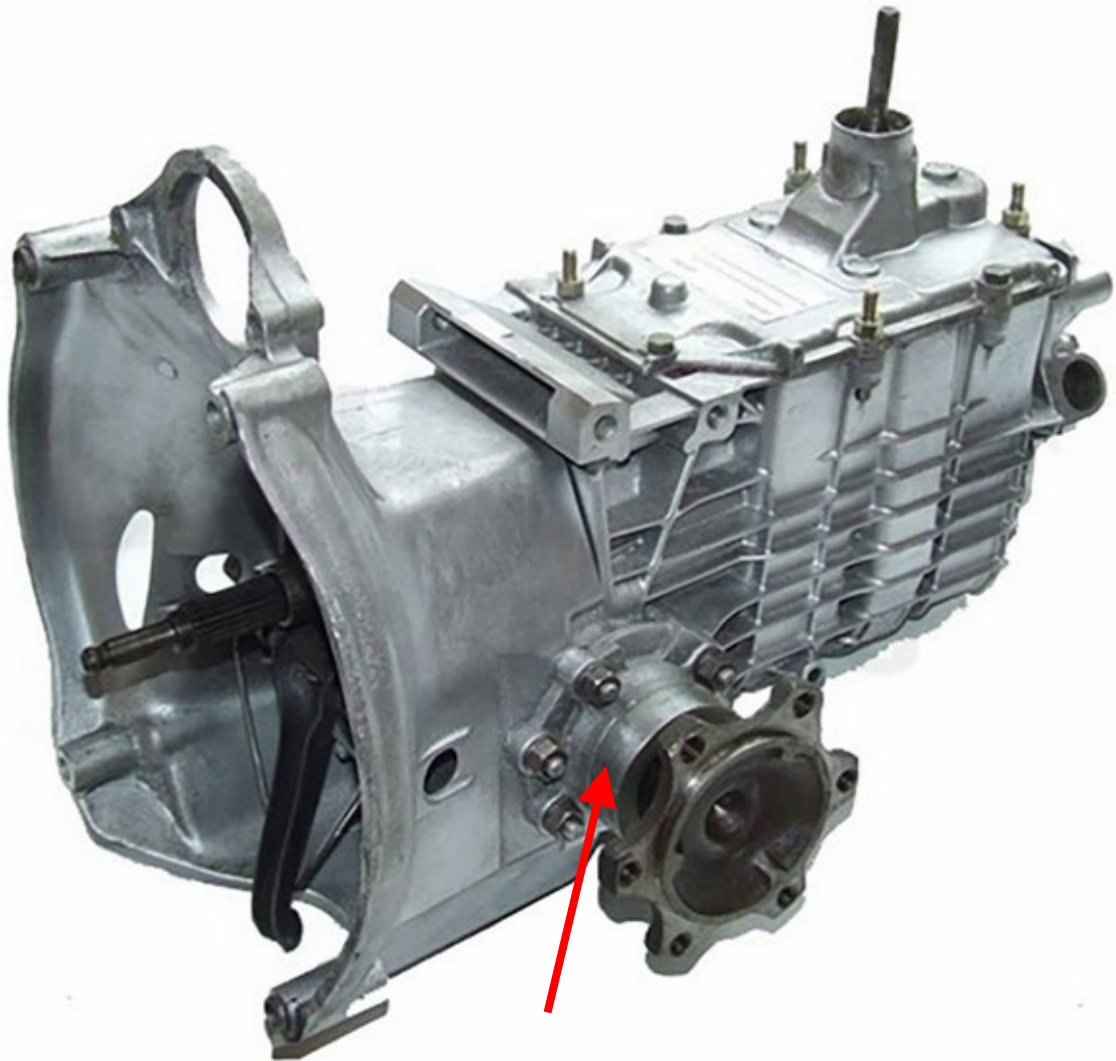
2CV Gearbox showing the left-side output hub (arrowed)

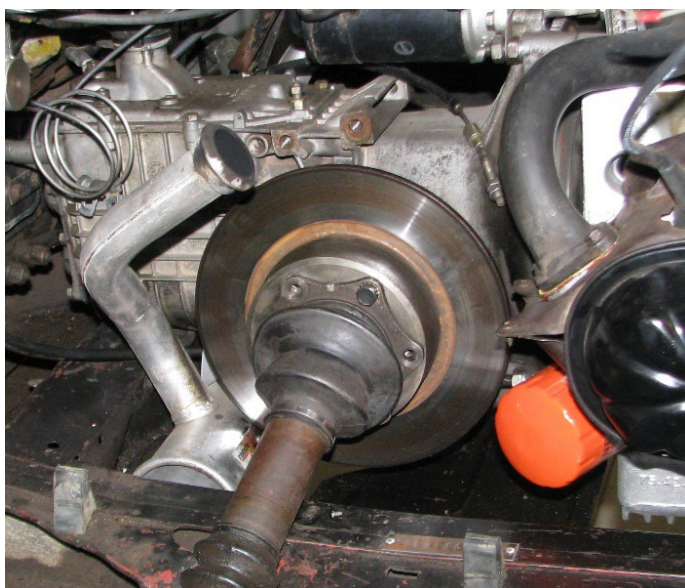
Photo 1: Firstly, remove both front guards. Disconnect all cables from the battery **negative** terminal. Remove the air tubes. Disconnect the heater cables from the exhaust system heat exchangers. Remove the heat exchangers. Disconnect the handbrake cables from the brake calipers. Remove the brake pads and the brake calipers, including the *very important* thin metal shim fitted on the two caliper mounting bolts and fitted between the inner caliper halves and the gearbox. One shim should be fitted on each side of the gearbox. No more, no less! Watch out for it.

Next, the CV-joint mounting plate on the inner end of each front wheel drive shaft is unbolted from the gearbox output hub drive flange by removing the six bolts and washers shown in the centre of the photo. This allows the CV-joint mounting plate and the brake disc to be separated from the output hub, exposing the output hub. The brake disc is sandwiched between the CV-joint plate and the output hub drive flange. Lift the driveshaft rearward, out of the way.

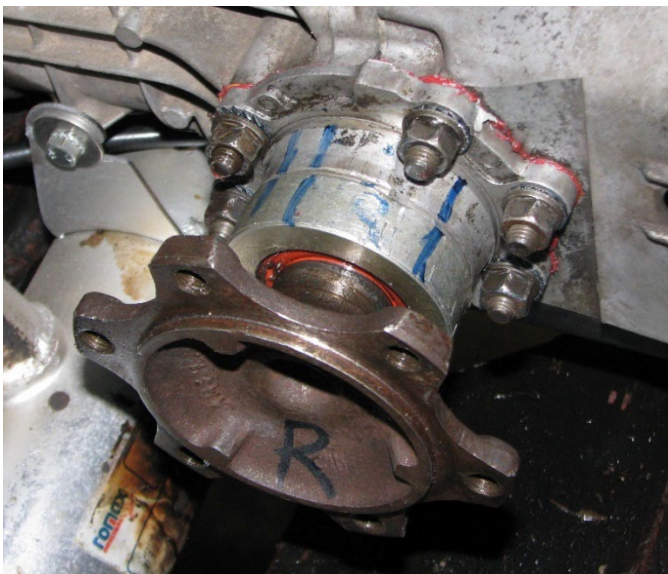
Photo 5: Another view of the gearbox output hub, showing the hub and its mounting flange which is held on the gearbox by six studs, nuts and star washers. A thin paper gasket (with gasket sealant on *both* sides) fits between the hub mounting flange and the gearbox face. The excess gasket sealant is shown in orange at the upper part of the photo.

Note: The orange colour at the centre of the photo is part of the face of the sealed

outer shaft bearing, mostly hidden by the ring nut. (The *inner* shaft bearing is inside the gearbox.) Note: Citroen refers to the ring nut as a bush nut. The output hub shaft extends outwards from the hub and is flared to form the metal drive flange which holds the six bolts for attaching the brake disc and the CV-joint plate fitted to the front wheel drive shaft.

Critical item: If gasket sealant is not applied, the joint will leak!

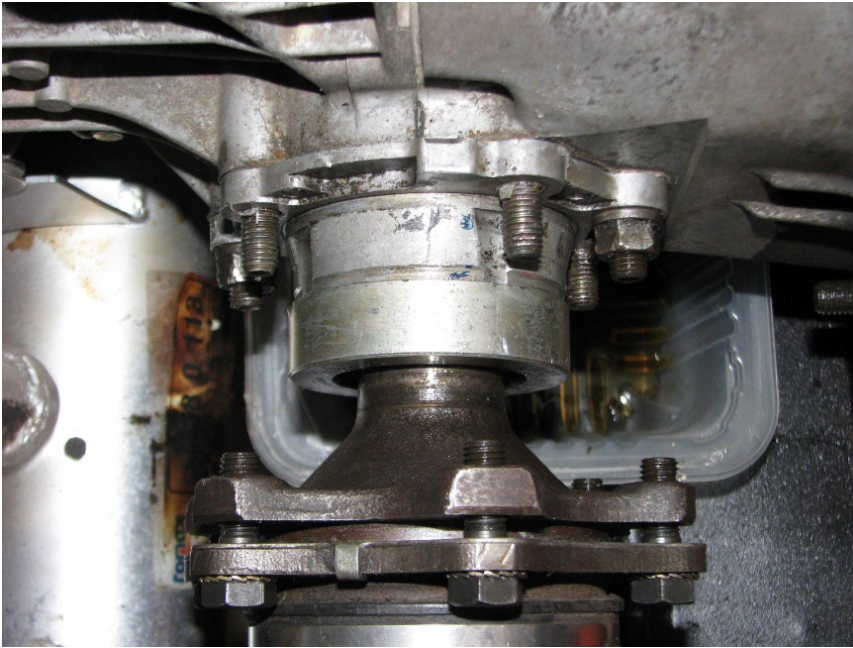
Photo 6: A view of the (temporarily-refitted) output hub on the right side of the gearbox, taken directly from above. This photo was taken after the brake disc was removed for clarity and the CV-joint plate temporarily reattached to the output hub drive flange with several of the bolts.

The output hub drive shaft, driven by the gearbox differential gearing, exits the hub at the ring nut and is flared to form the output hub

drive flange which attaches to the CV-joint plate, with the brake disc held between them.

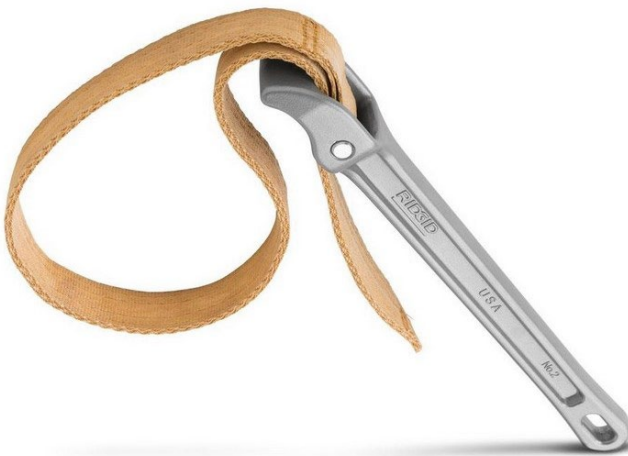
Photo 7: Strap spanner. Used for unscrewing the ring nut from the hub body. It is also used for tightening the ring nut during reassembly of the hub.

This particular tool is made by Ridgid and uses a resin-impregnated nylon strap about 30 mm wide. It is *very* strong!

As noted, should the strap spanner be unable to loosen the ring nut and unscrew it, a cold chisel and hammer will be required to firstly cut a notch in the ring nut and then to drive the ring nut counter-clockwise to unscrew it.

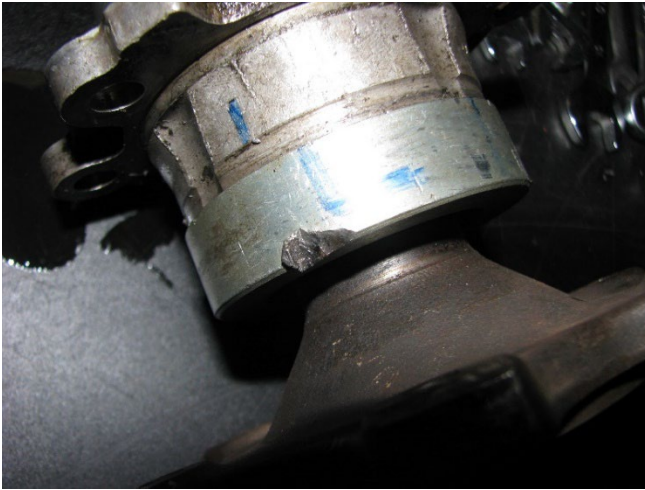
Photo 8: Shows the notch cut into the outer edge of the ring nut to take the tip of a cold chisel which is struck by a hammer, should it be necessary, to open the peening and loosen the ring nut so it may be unscrewed from the output hub with a strap spanner.

You may feel very uneasy about cutting a notch in the ring nut with a hammer and cold chisel in such a seemingly brutal manner to loosen the ring nut. However, it does the job perfectly and efficiently. If you know of a better way to remove a stubborn ring nut, please let the writer know.

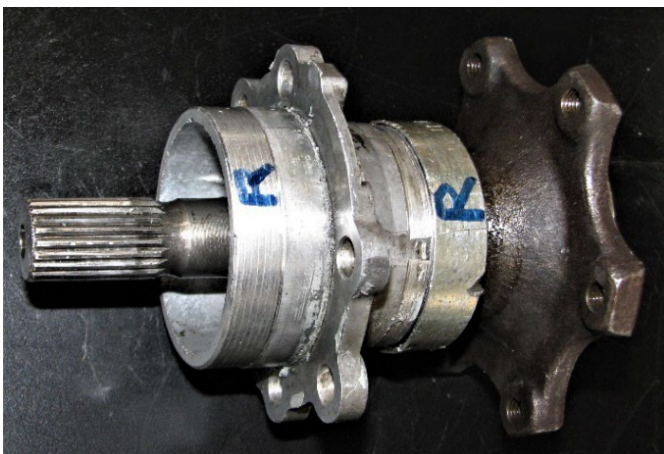
Photo 11 above: The gearbox output hub assembly after its removal from the gearbox. The splined end on the left is driven by the differential gearing. The metal flange on the right drives the CV-joint plate which drives the front wheel drive shafts which drives the front wheels! The brake disc is sandwiched between the drive shaft flange and the CV-joint plate. The left "R" is on the hub body and the right "R" is on the ring nut. A notch is visible on the ring nut, just below the "R". There is a third "R" needed...

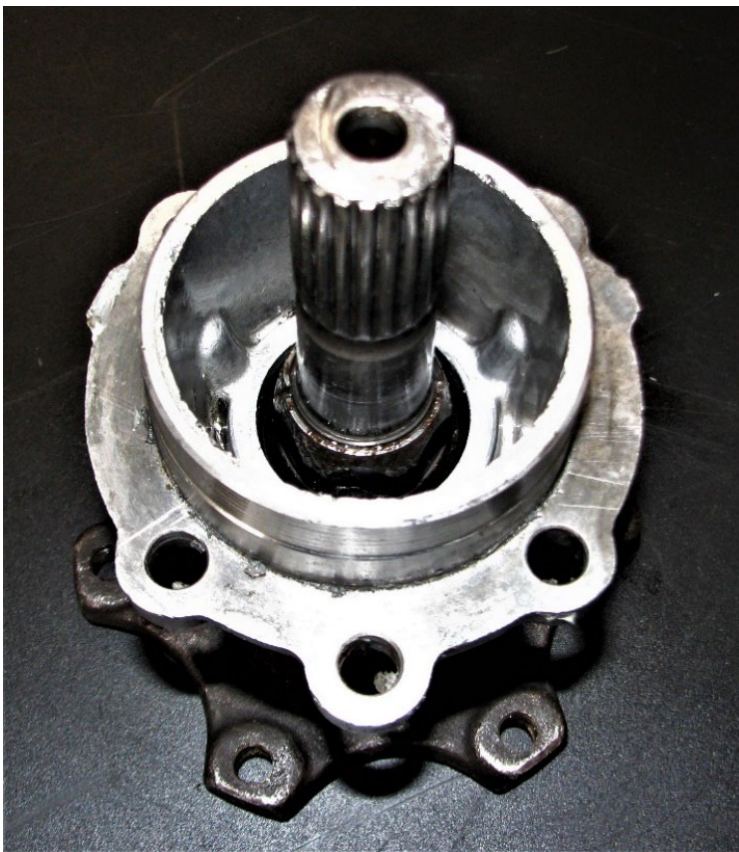
Photo 13: Shows the inside of the hub and the splined shaft which engages with the differential gearing.

Shows the lock nut which locks the *outer* bearing and steel spacer in place on the shaft. It can just be seen at the bottom of the shaft as a hex nut. The lock nut is tightened to **75 foot-pounds**. Add some copper grease first. Note the nut has been peened at its 9 o'clock position to ensure it does not loosen.

The writer experienced the consequences of this nut loosening in the left-side output hub during RAID 2016. The lock nut unscrewed completely, allowing the output hub shaft to slowly move outwards, sliding through the (tight) fit of the hub bearing until eventually the splines

disengaged from the differential gearing, at which moment the vehicle failed to proceed while travelling along a red-dust road in Northern Territory somewhere near Lajamanu. (Note: the car had drum brakes at the front at that stage, so the drum was able to move outwards.)

Thanks to the swift diagnosis and repair effort by Stephane Laguna and Elliot Beniada, the output hub was removed from the gearbox and the recalcitrant lock nut fitted, tightened and peened. We were back on the road in two and a half hours. A truly magnificent effort by these gentlemen in a situation well away from the comforts and tools of a workshop, and in exceptionally difficult, dusty and dirty conditions on the side of the road. Thank you both once again! That was the day the writer was formally introduced to the 2CV gearbox output hubs!

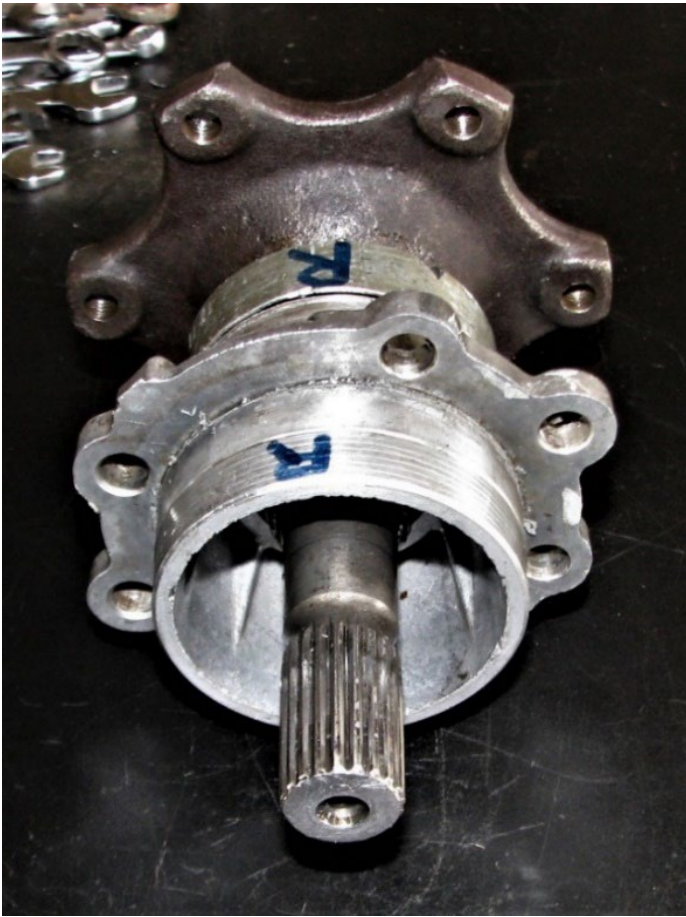
Photo 14: Another view of the output hub.

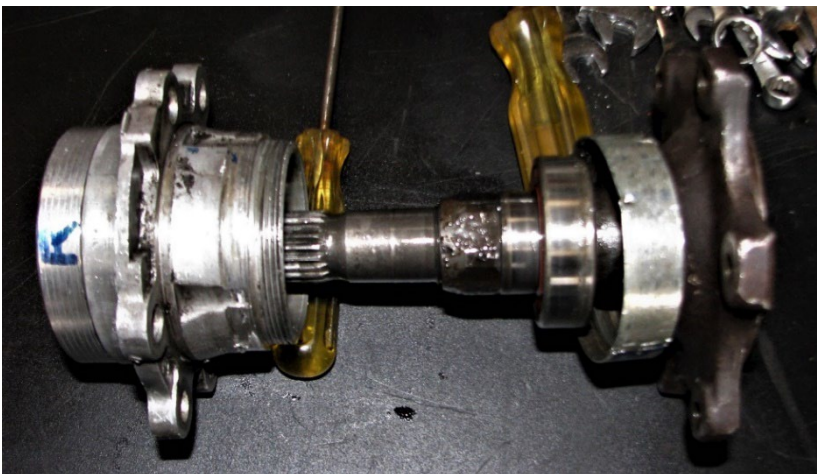
Photo 15: Shows the output hub shaft and components after being almost separated from the hub body after the ring nut is unscrewed. More follows.

From left to right, the components are: output hub, output hub shaft, shaft lock nut, shaft steel spacer, shaft outer bearing, ring nut and output shaft drive flange.

The ring nut may now be fully unscrewed from the hub body. After the ring nut is unscrewed, the shaft and bearing assembly should separate easily from the hub body by tapping on the splined end of the shaft with a rubber mallet. Do not damage the splines, the hub body or the bearing when doing this. The bearing has a close, sliding fit in the hub body.

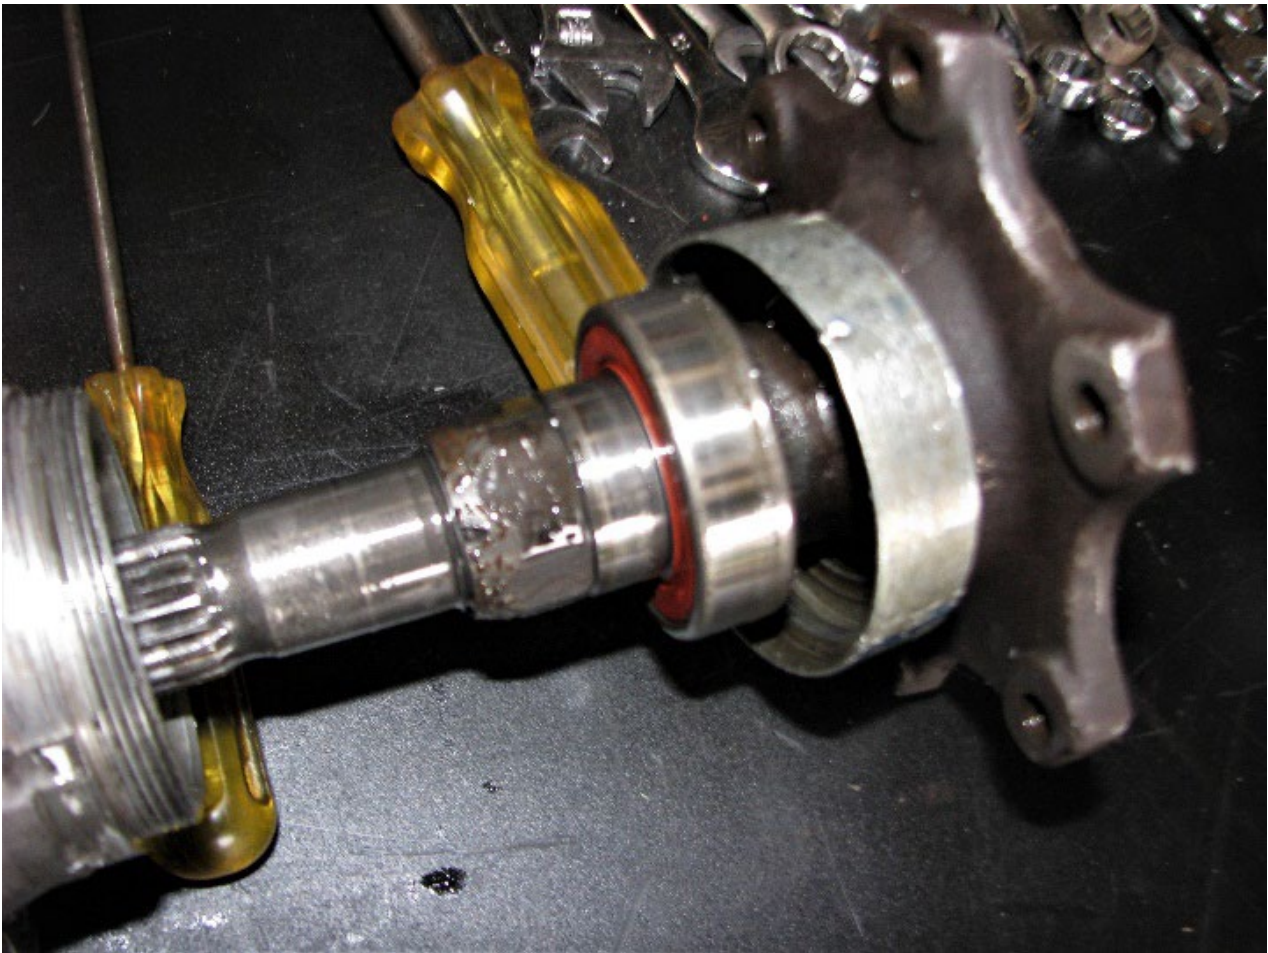
Photo 16 above: A closer view of the output hub shaft assembly showing the output hub, the hub shaft, the shaft lock nut, the spacer, the bearing, the ring nut and the output shaft drive flange. Should the ring nut need to be replaced, the lock nut and steel spacer will need to be removed from the shaft, then the bearing extracted from the shaft with a bearing puller, after which the ring nut may be removed from the shaft.

The purpose of the lock nut is to lock the bearing and the steel spacer in position on the shaft. The purpose of the ring nut is to hold the output hub shaft and bearing in position in the hub.

Don't damage the steel spacer. The oil seal runs against its polished face and any marring of its surface will result in the oil seal having an exceedingly short life and you will get the chance to repeat the entire procedure all over again, *after the steel spacer is replaced!* Aaaaggggghhh!!!!

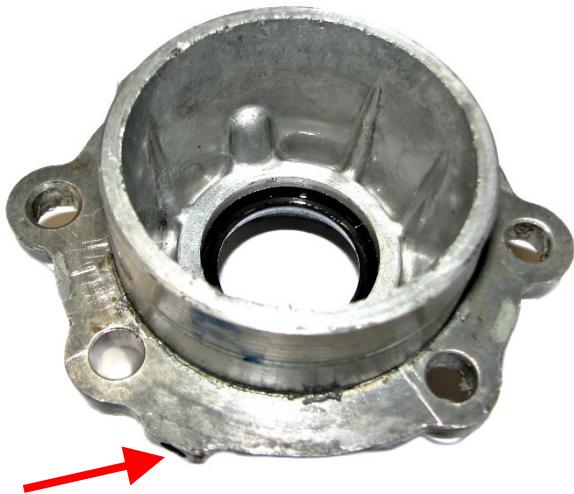
Photo 20: The inside of the hub. The upper-most section in the photo is inserted into the gearbox opening, along with the splined shaft end. The shaft seal is shown at the bottom.

In the photo, there are three hub mounting holes on the left side of the photo (one hidden at top-left) and three on the right side (one hidden at top-right). The oil drain hole in the edge of the hub mounting flange can just be seen, shown by the red arrow.

Q. Is this the left-side hub or the right-side hub?
A. It's the left hub. Q. How can you tell?

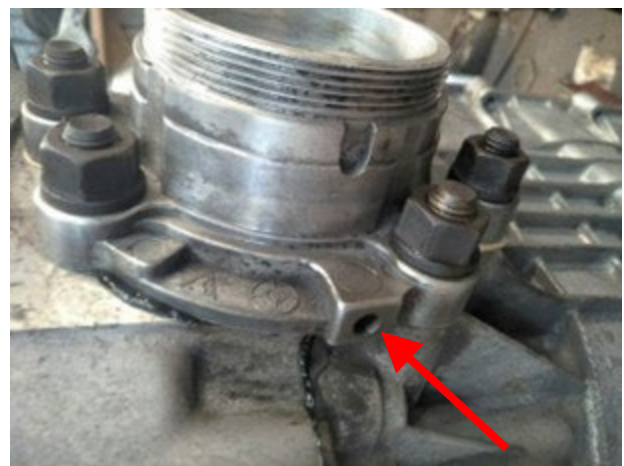
Any oil escaping past the shaft oil seal (shown in the centre of the hub) passes down through the oil drain hole and exits the hub from the oil drain hole located at the lower rear edge of the hub mounting flange as shown in **Photo 22** above right. The oil drain hole is arrowed. Photo 22 also shows one of the hub body peening detents for peening the edge of the ring nut. (Both photos courtesy of Peter Fosselius).

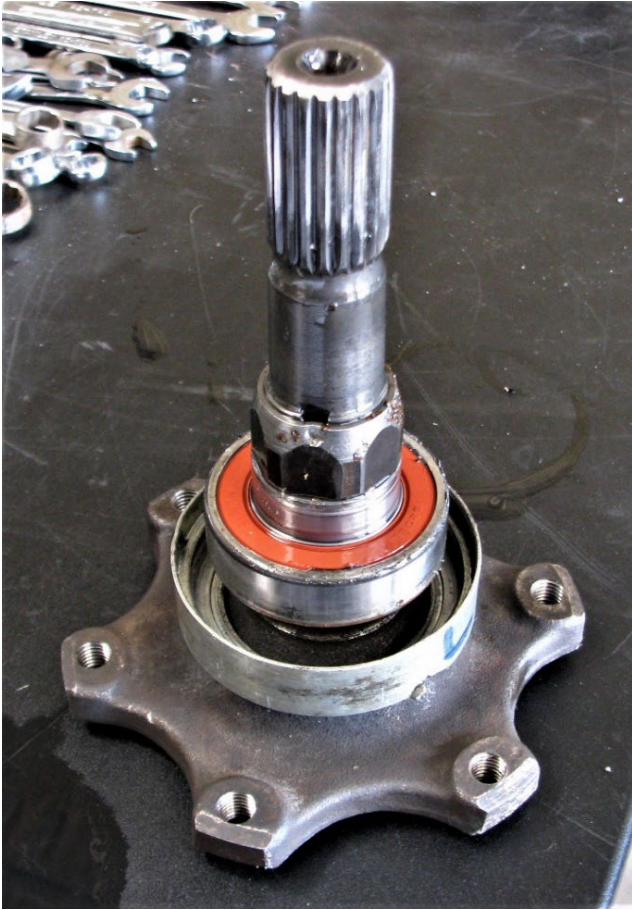
Photo 23: Shows the output hub shaft assembly after separation from the hub body after the ring nut is unscrewed. The lock nut is seen in the centre of the photo. The peening is also (just) visible at the top edge of the nut.

To replace the bearings, remove the lock nut and steel spacer, then use a bearing puller to remove the bearing from the shaft. Don't damage the shaft or the steel spacer! Use a press and steel tube to fit the new bearing, followed by the steel spacer and the lock nut, torqued as below.
