# What about that second gear

by Bernie Hadaway

The "Traction Box"

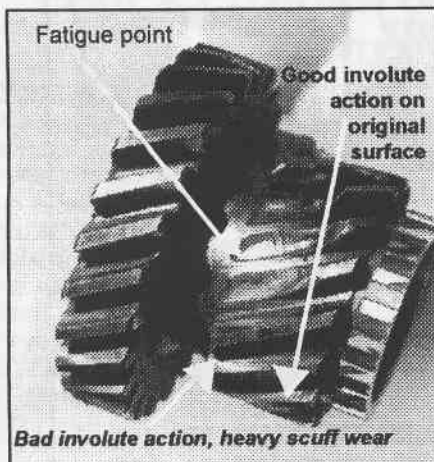
Many of us listen to those disconcerting noises from the 'traction box' and wonder about the two possible sources. We all know about the main culprit but what about that 2ND GEAR that suddenly decided to disintegrate with often disastrous results?

I suspect the combinations of 1, 2 and 3 produce a condition when a worn bearing allows the 2nd gear teeth to ride high (out of mesh) adjacent to the maximum bush wear whilst still maintaining a satisfactory (in mesh) condition at the less worn bush (syncro end).

This would account for the mode of breakage that always occurs. A progressive tooth fatigue failure starting at the maximum wear end and running out progressively to surface before reaching the syncro end. Scrutiny of my worn 2nd gear tells the story. The heavy scuffing of the gear teeth where the breakages occur indicates poor involute action with high tooth flank contact - whilst the syncro end shows better contact with original surfaces still evi-
