THE TALE OF THE DUCK THAT ALMOST COOKED ITS GOOSE

By Graeme Dennes

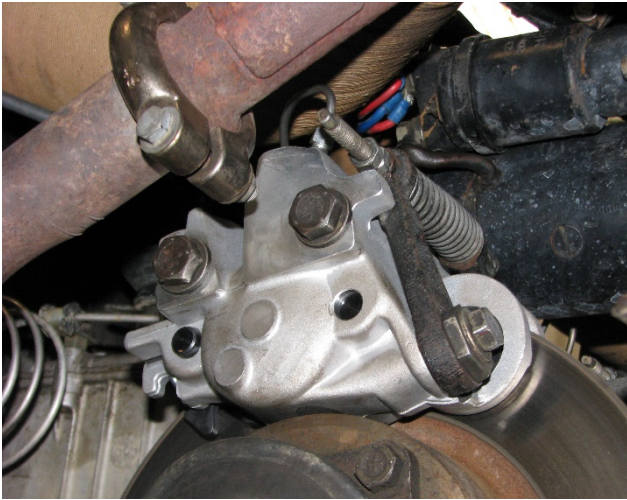
Figure 3 One of the new calipers

2. Fitted pre-loved disc brake calipers after installing new pistons, new LHM rubber piston seals and dust seals, new LHM rubber O-rings between the two caliper halves, new LHM brake line rubber seals on all brake line fittings under the bonnet, and a new bleed nipple on the left caliper, just to be sure.
