## **Fitting modern drive shafts – not as simple as it seems!**

This document is the outline of a presentation by Ian Macdermott at a CCOCA meeting in 2019.

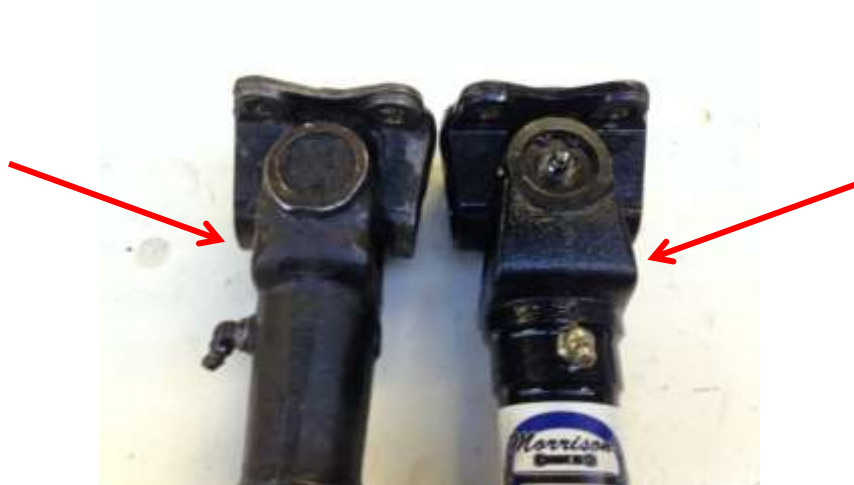
- I noted the shape of the new inner joints when I picked the shafts up, and assumed they were OK based on nobody reporting trouble.

- I had lent my engine stand to another club member, so I fitted the shafts by breaking ball joints as per the procedure outlined in the workshop manual, rather than by removing the engine and gearbox and working from the inside of the cradle.
- The result: Clunk, clunk, .... Click on link to play a YouTube clip.  
[Traction drive shaft conversion](#)
- The inner universal fouled on the lower link arm of the suspension when the suspension was hanging down.

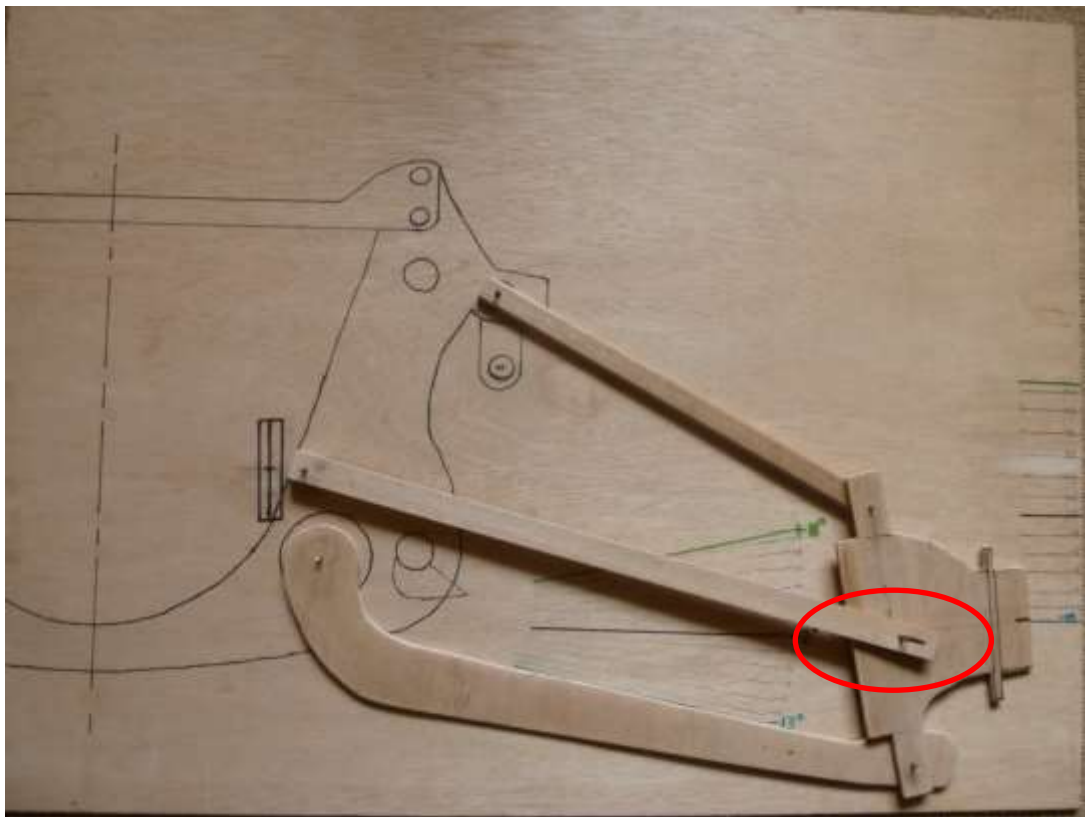
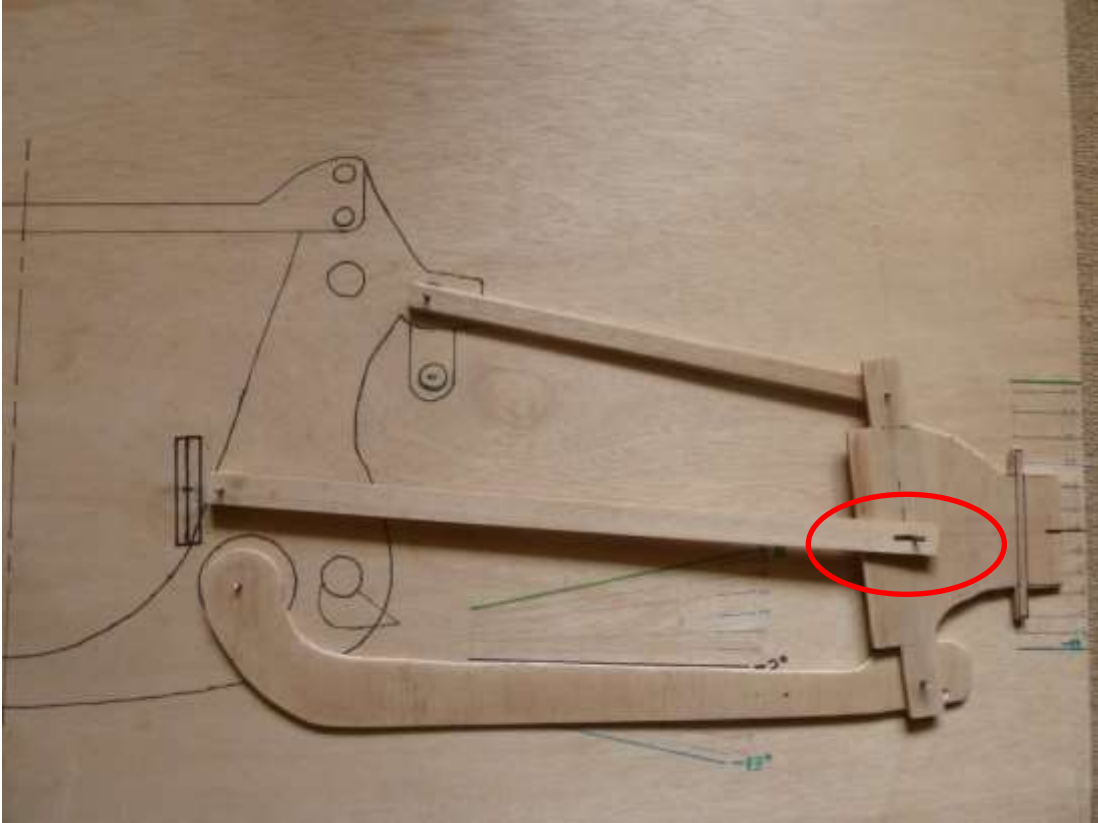
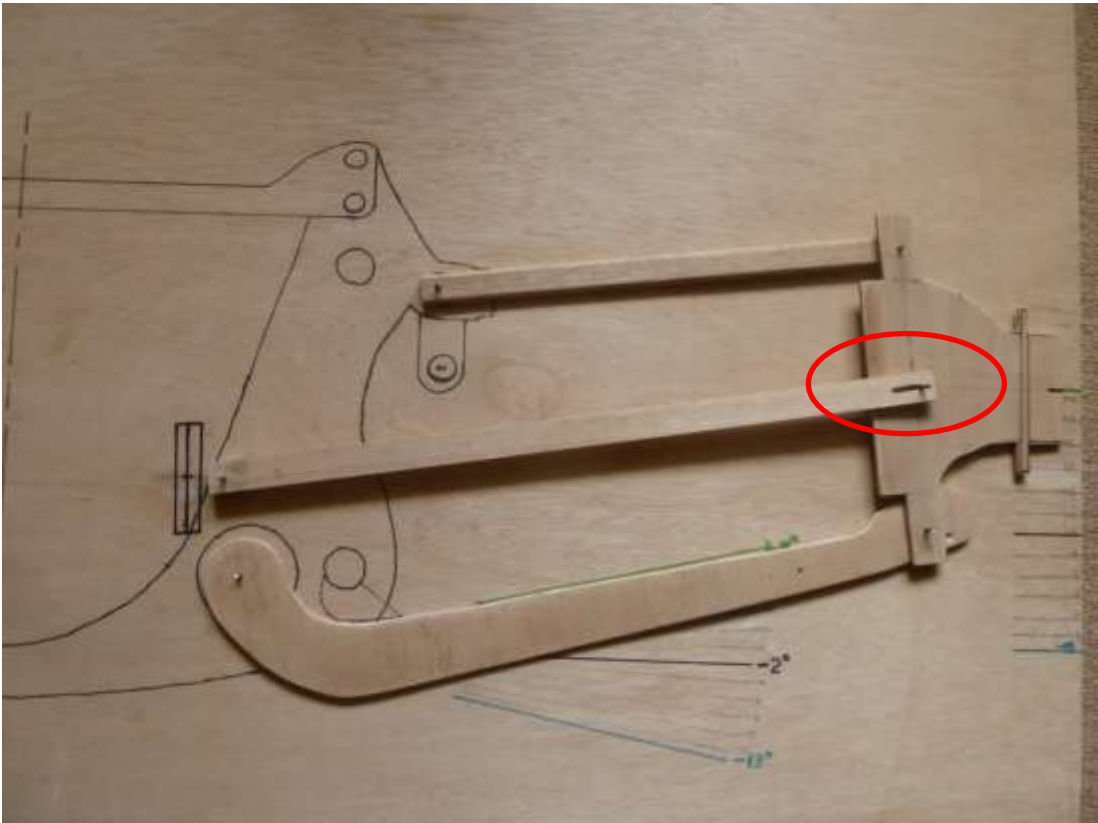
- Up
  - Rubber buffer on lower link arm, and design of axle cradle
- Down –
  - Some people said it was the shock absorber reaching maximum length. That is not so (60 mm travel left when suspension is hanging down).
  - It turns out to be drive shaft shortening to its minimum length is what limits suspension travel.
- Wooden model.
  - Demonstrate length of shafts as suspension goes up and down.
  - Demonstrate length of shock absorber.
  - 1 mm difference in shaft length makes a huge difference to travel distance of suspension.

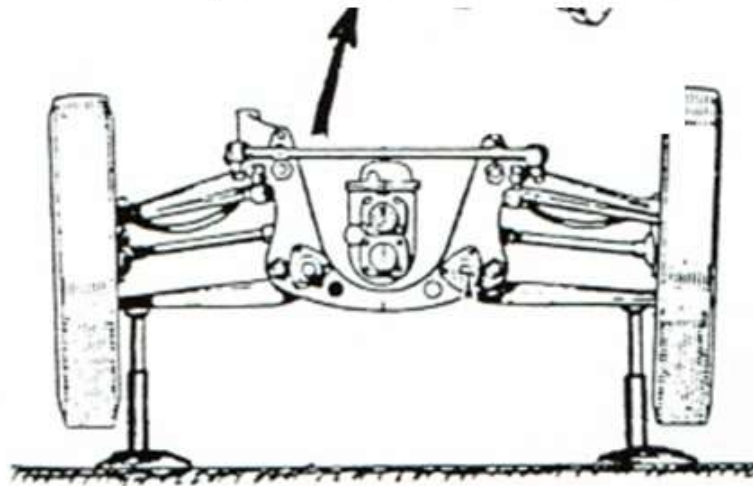
Jack up at ends of lower link arms:

- Wheels off the ground so drive shafts can be rotated to provide access to nuts on gearbox
- Drive shafts are at maximum length
- Inner universals can be then disengaged from gearbox and slid away, so engine can be lifted

Sketch taken from early edition of Front Drive – so nothing new!

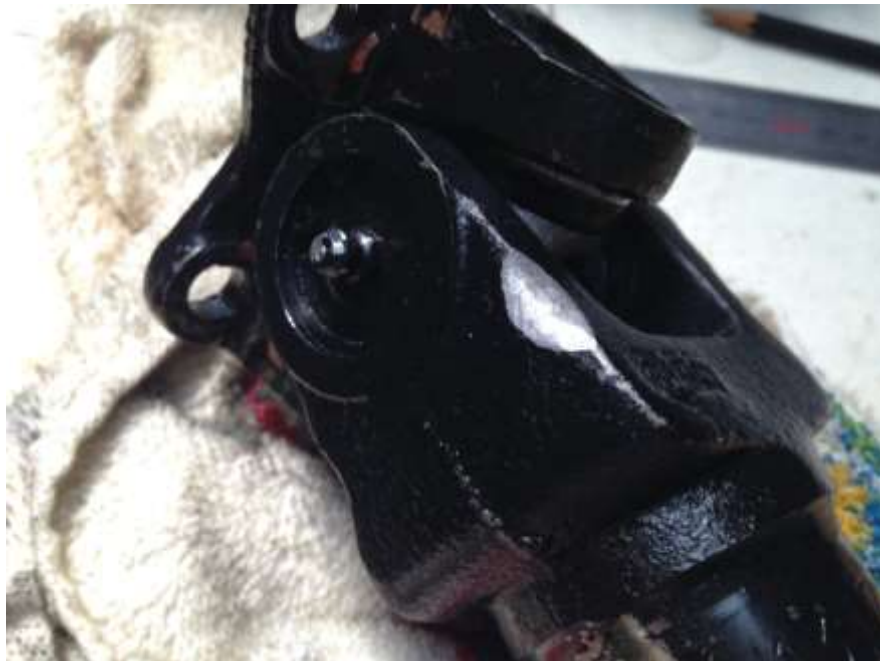
- I took a conservative approach, taking 1 mm off at a time, and finished up doing the first one 5 times before noticing something about original Citroën shafts.
- I had some old inner universals which were relieved at exactly the point where I was having trouble. (Leads one to suspect that Citroën knew about this interference problem, and maybe not all suppliers made identical length shafts)?
- Photos from Dave Gilbert show that there are several variations of universal joints – maybe from different years or different suppliers.

- Options for removing metal
  - Wayne Morrison offered to grind it off, but I had no idea how much to remove
  - Use a lathe – I haven't got one, and it would require some dismantling to set the parts up for machining
  - Use a half round file. If you are getting into trouble, at least you are doing it slowly!
- Question was how much metal to remove? Impossible to measure anything in a really confined space inside the cradle, and it is almost impossible to see what is going on.
- The trouble with experimenting is you have to assemble the shafts in the swivels, and install the ball joints to see if you have taken enough metal off.
- Assembling bottom ball joints is a pain. A small tab of steel bolted onto the lower link arm to hold the spring and ball in place while inserting the key and screwing on the nut makes the job much easier!
