2CV HARD LUCK STORIES

Revision 4

By Graeme Dennes

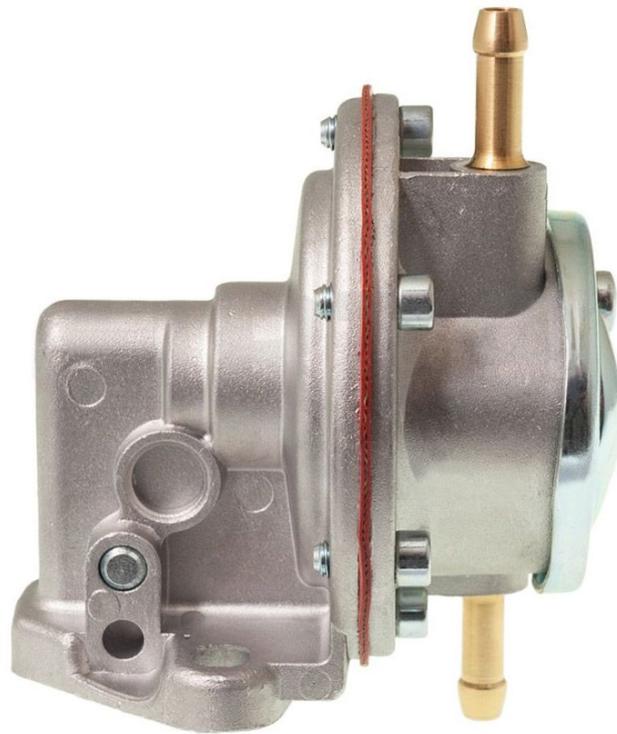
2CV Fuel Pump

While away from home, our orange 2CV would run for perhaps 2-3 km, then almost die from what seemed like fuel starvation, but, with much encouragement it would (blorp, blorp, blorp, just) come good again, and after a couple of kangaroo hops, off we'd go again (blorp, blorping blorping), with the process being repeated. Fuel was not overflowing from the carburettor, which would otherwise indicate a failed float valve. It seemed probable that it was being caused by either dirty fuel (possible), a restriction in the fuel line from rubbish from the tank (less likely), a dirty fuel filter (possible, but the filter had just been changed), a sticking carburettor float valve (repeated cycling with a sticking action is very unlikely), dirt in or around the carburettor jets (possible), or a fuel pump failure (possible). It could also have been due to rubbish trapped in the fuel filter, whereby the very act of fuel being drawn through the fuel filter by the pump pulls on the rubbish sufficiently to cause the filter to block itself off, when the engine would stop or almost stop, at which point the rubbish would fall away again, allowing fuel to pass, and repeating the cycle. However, as the fuel filter had just been replaced as noted, I discounted that option for the moment. I therefore put my money on the fuel pump diaphragm, so my first step was to disconnect the rubber fuel hose from the carburettor fuel inlet spigot, then start the engine for just a few seconds to check how much fuel was being discharged from the fuel hose. Ah ha, gotcha! It was found to be almost zero. As no spare fuel pump or diaphragm was carried as a spare, RACV Total Care gave us a lift home!

I later confirmed that the fuel pump diaphragm had suffered a small tear, causing the problem. The diaphragm material had also become sufficiently "floppy" such that very little pumping action was occurring anyway.

And what have we learnt? As the fuel pump diaphragm is not generally inspected, my new rule is to change it every five years, reminding myself by an entry in the maintenance log book. If unsure when the diaphragm was last replaced in your car, do it now as a matter of urgency. Always carry a new spare diaphragm or pump with you.
