2CV IGNITION COIL

Revision 8

By Graeme Dennes

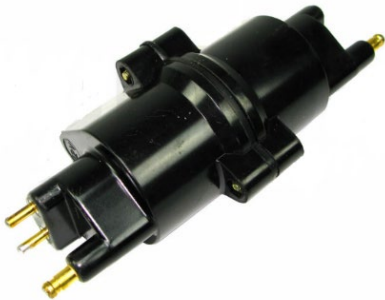
The photo at left shows the black 2CV ignition coil. Typically, points-ignition coils are designed and scaled so that a voltage of around 300V is induced in the primary winding by the collapsing magnetic field. In the 2CV coil, by reverse engineering, the collapsing field induces 300V in the 200-turns primary winding, so the basic coil design parameter is 1.5V per turn. The 15,000-turns secondary winding receives, *at the exact same moment*, an induced voltage of $1.5\text{V} \times 15,000$ or 22,500V from the shared, collapsing magnetic field.
