2CV IGNITION COIL

Revision 10

Background: The 2CV inductive-discharge ignition coil is an iron-cored electrical transformer made up of separate primary and secondary windings. In various forms, it has been used almost universally in vehicle ignition systems for more than a century. It is usually mounted inside a protective metal, bakelite or plastic housing, and is typically a rugged and reliable device. Its purpose is to produce *high-voltage pulses from a low-voltage DC supply for firing the spark plugs*. It is the classic spark coil. It's made up of a laminated soft iron core wrapped in a layer of oil-impregnated paper insulation, followed by the primary winding of around 200 turns of wire. This is wrapped in another layer of insulation, followed by the secondary winding of around 15,000 turns. This provides a turns (step-up) ratio of $15,000 / 200 = 75$, i.e. a turns ratio of 75 to 1. The secondary winding is floating, with the winding ends being brought out to terminals which connect to the spark plug leads.

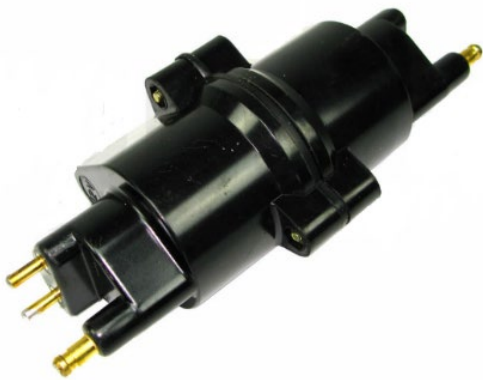
The photo at left shows the standard black 2CV ignition coil. Traditionally, points-ignition coils are designed so that a voltage of around 300V is induced in the primary winding by the collapsing magnetic field. In the 2CV coil, by reverse engineering, the collapsing field induces 300V in the 200-turn primary winding, so a basic coil design constant is 1.5V per turn. The 15,000-turn secondary winding receives, *at the exact same moment*, an induced voltage of $1.5\text{V} \times 15,000$ or 22,500V from the shared, collapsing magnetic field in the iron core.
