DS RUSTFINDER

The DS is built on a rectangular chassis frame, with two box section 'sill' members running down each side, two other box sections running across the car, and the main floor 'underslung'. This gives the car strength - none of the upper outer panels are stressed. As explained in the article, there was little or no factory rustproofing, so 'inside corrosion of the box sections can occur.

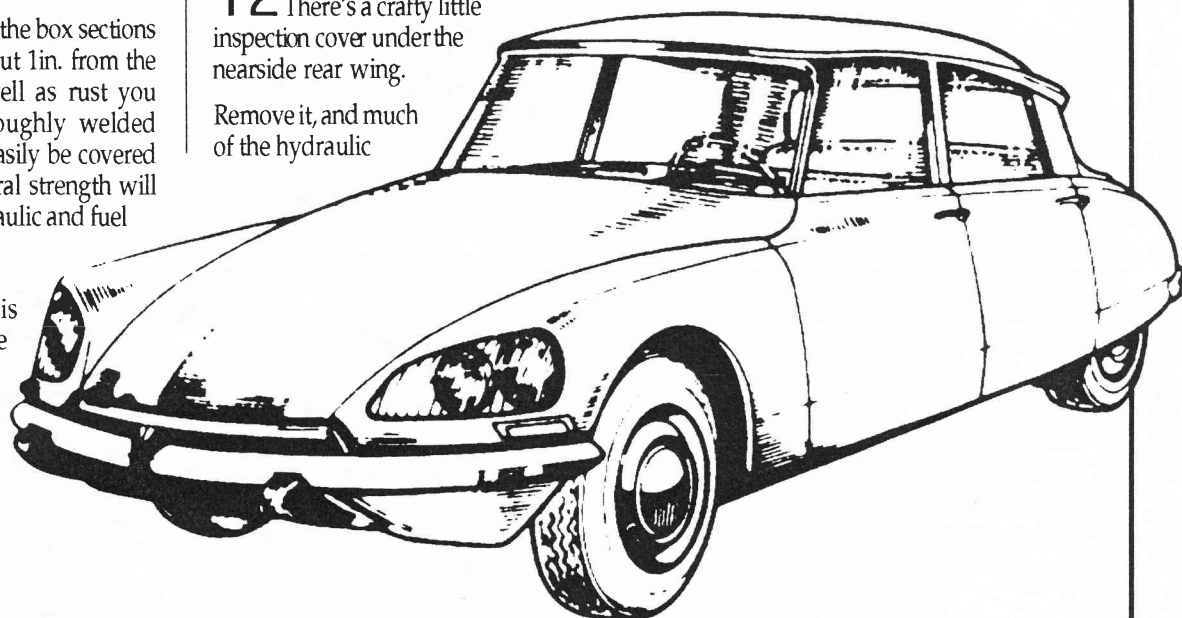
1 Rust can form where the sill and floor join. It is not unknown for the floor and sill to part company completely. Poke the whole area - there should be no give in floor or box section.

2 Examine the sides of the box sections too - corrosion up to about 1in. from the bottom can occur, as well as rust you should look out for roughly welded patches - rot holes can easily be covered up, but the car's structural strength will still be suspect. The hydraulic and fuel lines run inside the sills.

3 Wing removal is straightforward, and once they're off, you can inspect the scuttle/bulkhead assembly. Access to some of the mechanicals is also easier.

4 Start by looking in the front skirt wells - in front of the wheel on either side. Rot here isn't critical structurally, unless it affects the adjacent chassis legs

5 Look at the front of the box sections beneath the front wing. With the wing off you can check the whole scuttle and A post area right up to the windscreen.

6 The top of the scuttle area can be checked for rot with the bonnet open and the wing still on. Rust here can occur, but as welding jobs go, rectification is easy - lots of nice straight edges.

7 You must check the whole floor thoroughly - look out for loose underseal and rust underneath. The common problem area is the floor directly underneath the petrol tank

8 There's a long pipe under the offside rear wing from the filler cap. This is where it enters the tank. Water can get between the fuel pipe and the body. The ligerex clip on the fuel line often rusts - and breaks - resulting in petrol leakage.

9 The inner rear wing area, and the whole back end must be examined carefully for rust.

10 You must look along the inner wings too, particularly where they join the outer, and down the leading edge.

11 The rear suspension and rear sphere mounting points are vital, and must be checked carefully, along with the whole underbody between the rear wheels.

12 There's a crafty little inspection cover under the nearside rear wing.

Remove it, and much of the hydraulic

pipework comes into sight. If these pipes are rusty, you'll probably end up replumbing much of the car.

13 Have a good feel all the way round the windscreen too. As the seal hardens with age water can get behind - and the metal underneath rots.
