SILENT BLOCS

Roger Williams "Preamble" to Rob Little

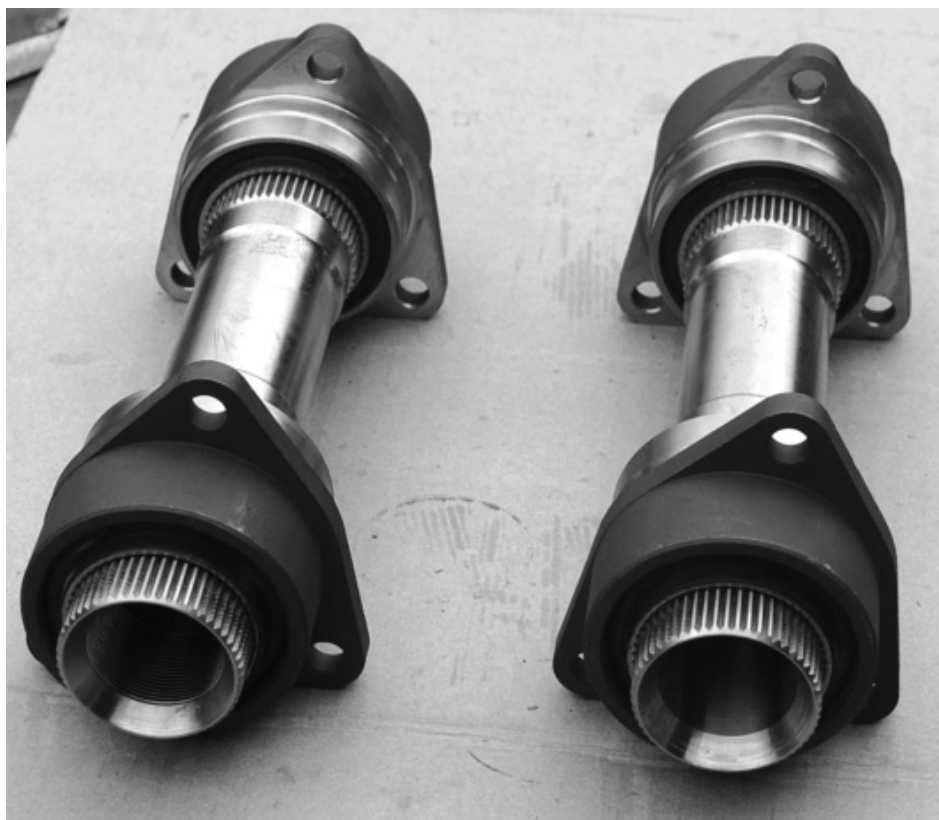
Fig 8

**New silent blocs with their
splined connecting pins**

There are new silent bloc systems that eliminate the problems of the original ones but being made from all new parts are expensive - see Fig 4. There is no exchange and they are compatible with the Normale/Legere cradle and bottom suspension arms. Advantages are that:

- a heavy press is not required to assemble them - it can be done by a single person with a 7lb copper hammer

- they dispense with packing shims yet give the correct alignment and 'nip' to the bottom suspension arm

- gives full and even contact between the splined connecting pin, the broached tube in the silent bloc and bottom suspension arm

- the splined tube is concentric with the housing and hence no additional stresses are induced during assembly

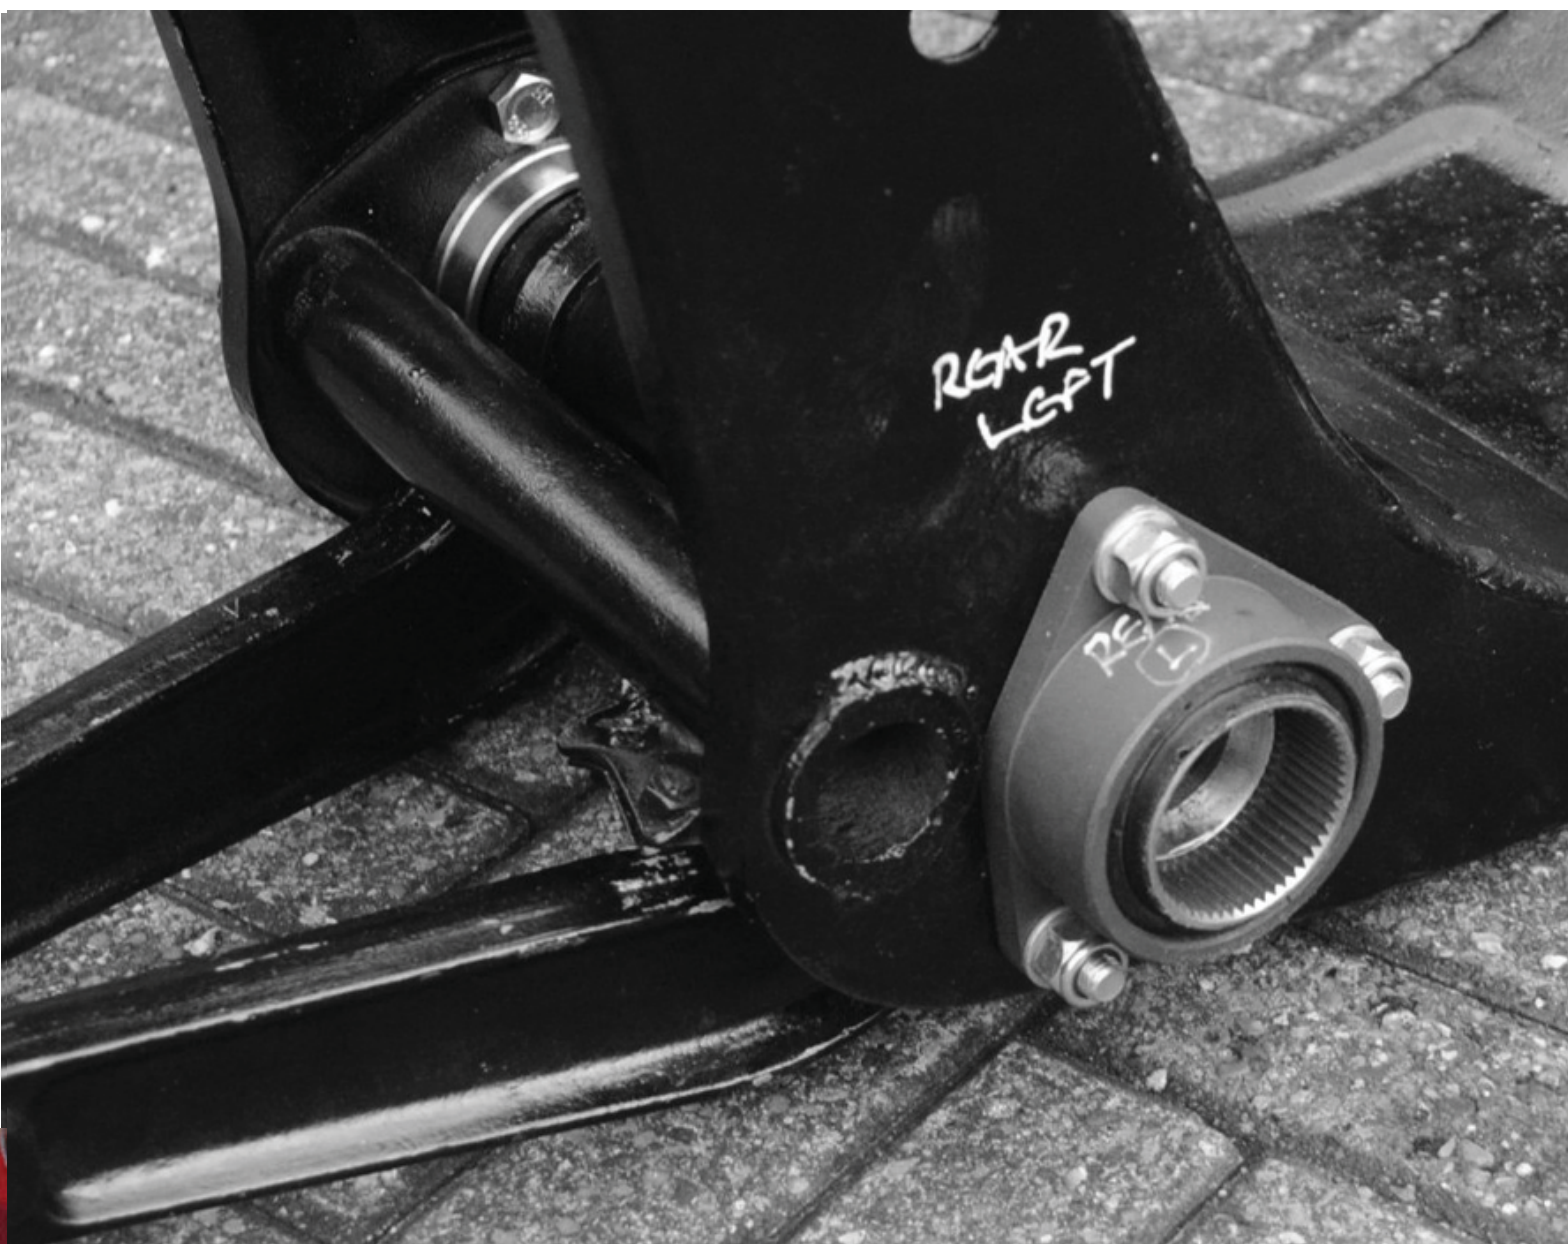
Fig 9

Silent blocs fitted to cradle
