# 2CV KNIFE EDGES REPLACEMENT

## Revision 5

By Graeme Dennes

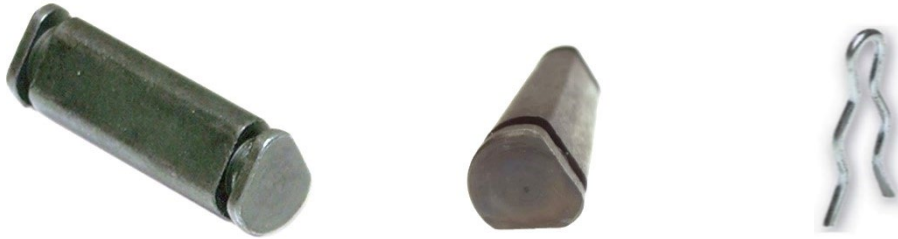
Photo 1: Knife Edge (left, centre) and Knife Edge Retaining Clip

The 2CV has four steel knife edges of the type shown in Photo 1. Two are part of the front suspension system and two are part of the rear suspension system. The rear knife edges are a little larger than those at the front. The knife edges are located between two mounting brackets attached to the suspension arms and held in place by two retaining clips fitted in the grooves on the ends. The knife edges are not circular in cross-section but have an angled edge. The items in the photo are shown approximately full-size.

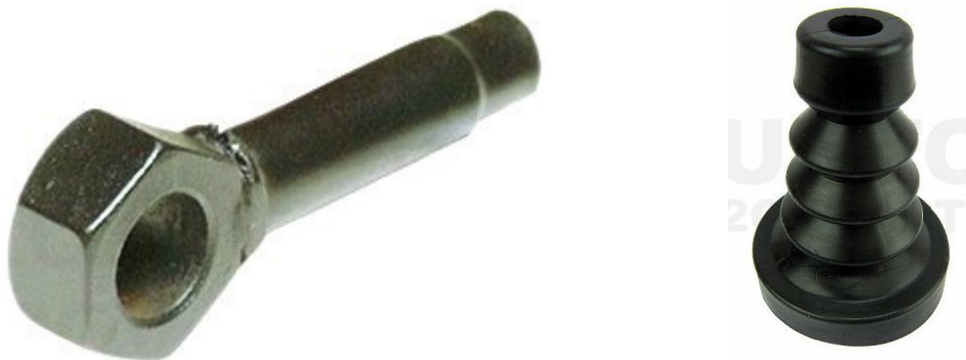
Photo 2: Suspension Tie-Rod Eye (left) and Suspension Tie-Rod Boot.

A suspension cylinder lies along each side of the chassis under the vehicle. A suspension tie-rod exits from each end of the suspension cylinders, and a suspension tie-rod eye (Photo 2) is screwed onto the threaded end of each tie-rod. Each tie-rod eye is held in position between the mounting brackets by a knife edge and retaining clips. A suspension tie-rod boot (Photo 2) is fitted over each tie-rod at its exit point from the suspension cylinder.

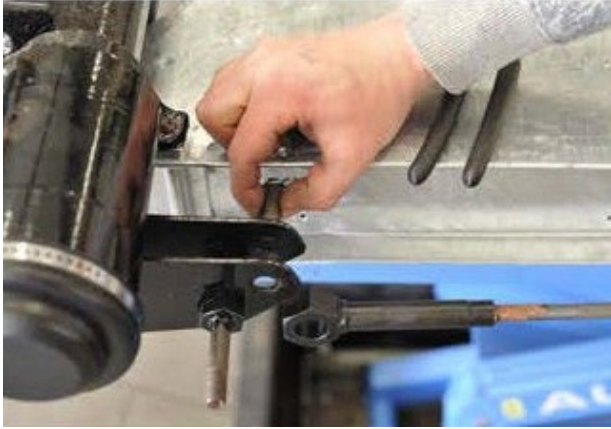
Photo 3 (left) shows a suspension tie-rod at lower right, fitted with its screwed-on tie-rod eye. The “nut” section at the end of the eye fits centrally between the two mounting brackets shown, locked in place by the knife edge which is ready to be inserted into position in the openings in the brackets. The brackets are fitted to the suspension arm assembly. The “nut” of the tie-rod eye is ready to be raised into position between the brackets, after which the knife edge is inserted into one bracket, passes through the “nut” of the tie-rod eye and out through the other bracket, then is locked in place in the brackets by retaining clips at each end. The large pin at lower left is a shock absorber mounting spindle.

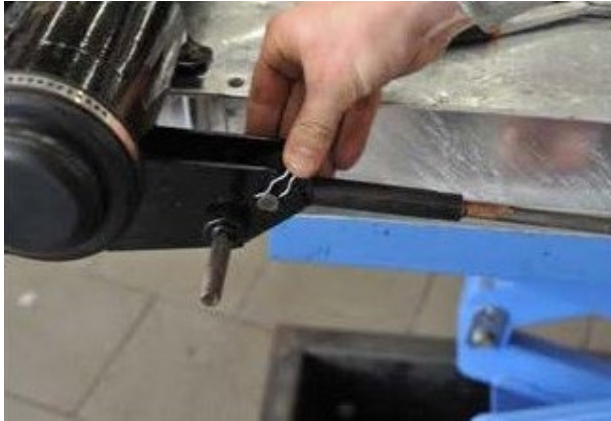
Photo 4 (left) shows a knife edge retaining clip being fitted into the grooved end of the knife edge after the knife edge has been passed through the mounting brackets and the tie-rod eye.

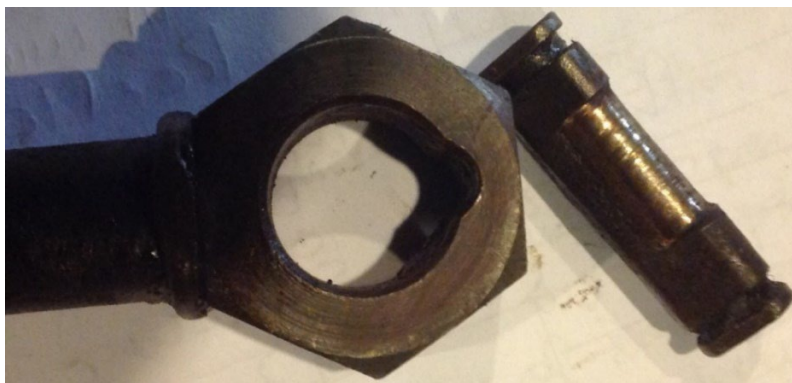
Photo 5: Well-worn “nut” on the Tie-Rod Eye and well-worn Knife Edge. Both items are due for immediate replacement. Don't attempt to repair them!

A reality for 2CV owners is that knife edges and tie-rod eyes eventually wear sufficiently to require their replacement. See Photo 5. Also, tie-rod eyes can and do break! See Photo 6. The following describes the parts required and the procedure to be followed to replace the knife edges, *and optionally*, the suspension tie-rod eyes. If one knife edge has worn, replace all four. If one tie-rod eye has worn or failed, replace all four.

10. Thoroughly degrease and clean the tie-rod eye and inspect it. There may be a small “vee” groove worn into the inside face of the “nut” on the tie-rod eye at the point where the “nut” contacts the angled edge of the knife edge.  
This is the only point of contact between the knife edge and the tie-rod eye. If the “vee” groove is very small, all is fine. Should excessive wear be observed, the tie-rod eye will need to be replaced. Don’t attempt a repair.  
Photo 5 shows a worn tie-rod eye and a worn knife edge. Note the depth of the “vee” worn into the “nut”. This amount of wear will be adding to the stress experienced by the “nut” because of the reduction in its cross-sectional area, so this suspension tie-rod eye is clearly overdue for replacement. The angled edge of the knife edge has also clearly worn and the edge rounded, so the knife edge shown is also due for replacement.

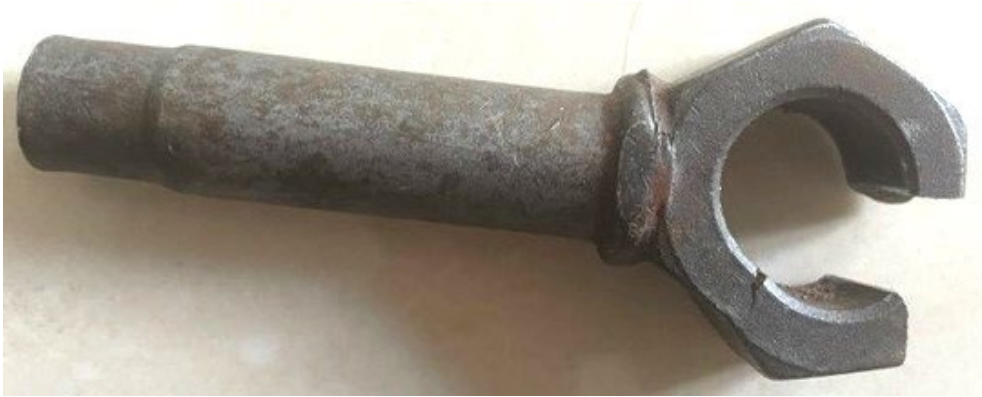
Photo 6: Suspension Tie-Rod Eye broken on Raid Cape York 2022  
(Photo courtesy of Peter Moloney)

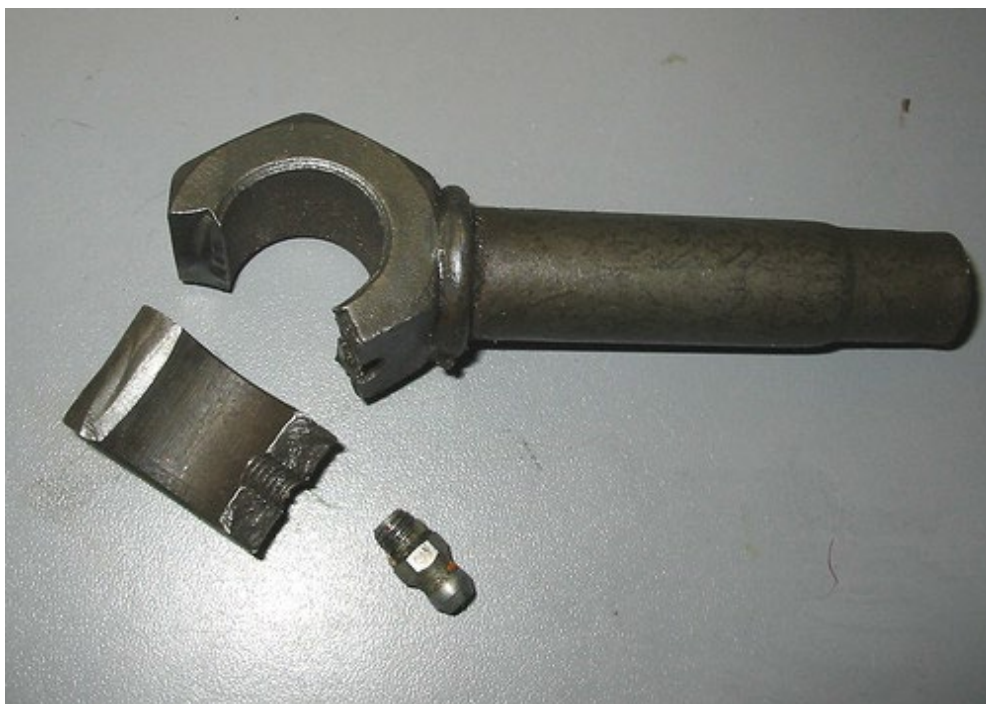
Photo 7: Suspension Tie-Rod Eye destroyed  
by a modification to fit a grease nipple

16. Run a couple of turns of lockwire around the ends of each retaining clip to act as a security measure to stop the clips being dislodged.
  17. Inject some high-shock-loading grease such as Castrol Spheerol LMM into the tie-rod eye “nut” into the space above and below the knife edge using a needle-size attachment on the grease gun, angling it in via the small side openings. It does indeed work!  
*Don’t be tempted to modify the tie-rod eyes by fitting grease nipples to simplify greasing of the knife edges. Although some 2CV owners have gone this route, it can result in the destruction of the tie-rod eyes and a very long and winding road home!* Refer to Photo 7 for an example of a tie-rod eye destroyed by such action!
