2CV BATTERY PROBLEMS SOLVED

Revision 9

By Graeme Dennes

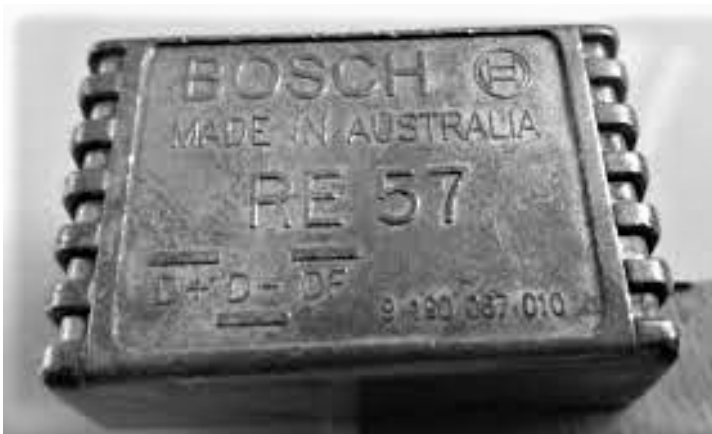
On the left is a photo of the Bosch RE57 voltage regulator, packaged in a small die-cast case. It is a sealed, non-adjustable three-terminal (D+, DF, D-) device which provides an install-and-forget solution. It has a voltage set point of 14.2V. More follows. The regulator's metal case is a heatsink, so mount the unit firmly on the firewall.

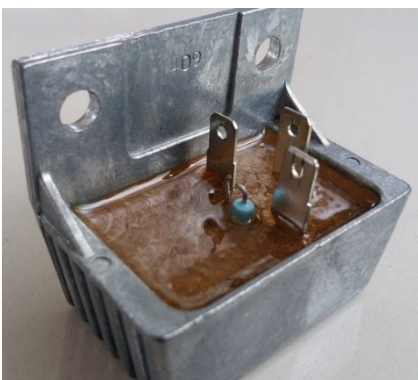
The photo above shows the underside view of the Bosch RE57 regulator with its three connection pins. Note the end of a resistor projecting above the epoxy fill. **Not all RE57 regulator's have the exposed resistor.**

If the exposed resistor wire is cut, the regulator's voltage set point is increased from the default of 14.2V to 15.2V. This compensates for diode-isolated charging situations such as in dual-battery setups, where voltage drops occur across the diodes. The 2CV uses the standard lead-acid battery which requires the 14.2V regulator setting, so **don't** cut the resistor wire (if it's present)!

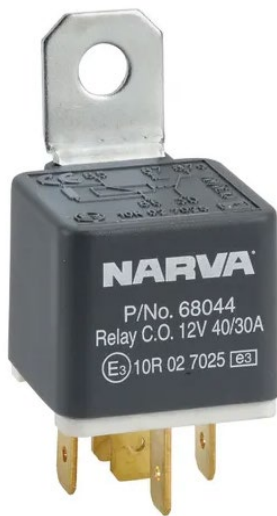
The Bosch RE57 regulator and Narva relay and socket are usually available at auto parts stores, and often appear on eBay. Do an ebay search on "RE57". Don't use substitute products for the voltage regulator, the relay or the socket. Below is a photo of the relay.

Four wires connect to the relay socket via brass spade connectors and these are pressed into and locked in the bottom of the relay socket after being crimped to the wires. Identify the correct orientation for the brass spade connectors *before* inserting them into the relay socket. These connectors are usually supplied with the socket. Three red-coloured crimp connectors are needed for connecting to the RE57 voltage regulator pins. Two crimped connectors of a size suitable for mounting under the battery post bolts are also needed to connect the regulator D- terminal to the battery negative post and to connect pin 30 of the relay socket to the battery positive post. Ensure all crimps are correctly fitted to the wires using correctly sized and adjusted crimping tools.

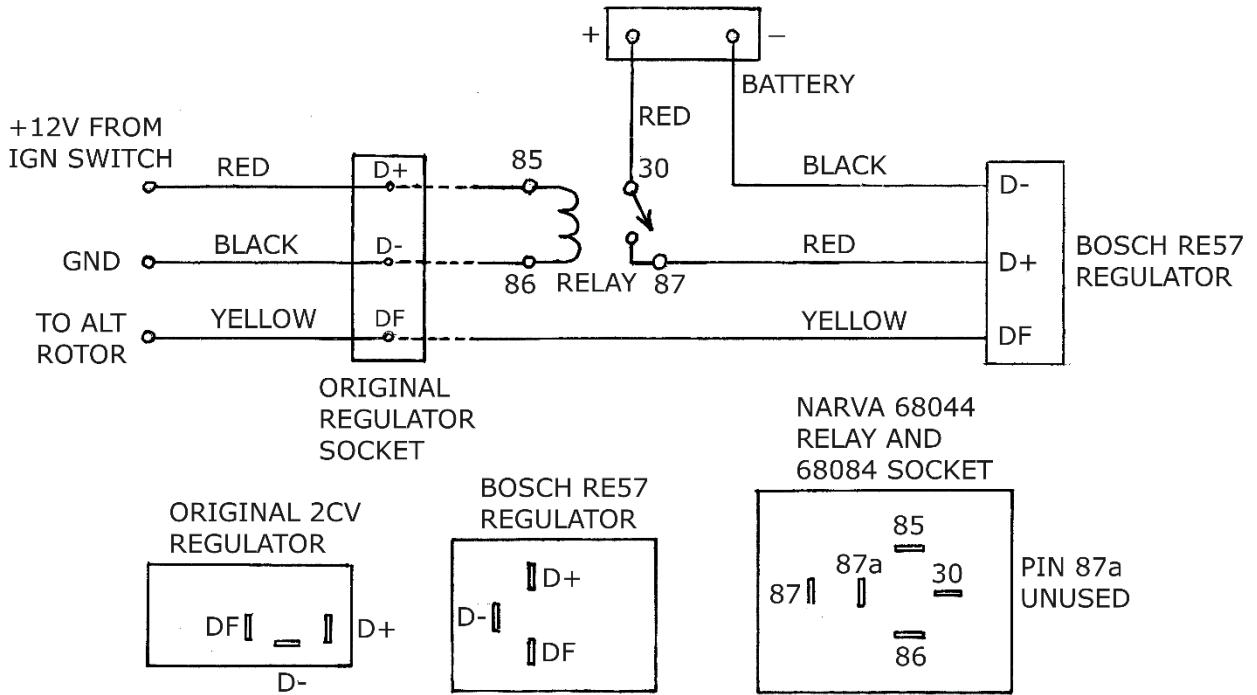
2CV VOLTAGE REGULATOR AND RELAY WIRING (2024)

The attached circuit diagram shows the modified wiring needed to connect the RE57 voltage regulator and relay to your 2CV to replace the original electro-mechanical voltage regulator. Briefly, when the ignition switch is turned on, the original D+ (12V) connection from the ignition switch is used to activate the relay. When the relay is activated, its closed contacts connect the D+ terminal of the RE57 regulator to the battery positive post. So now, with the RE57 regulator's D+ and D- terminals connected *directly* to the battery posts, the voltage regulator can (finally) sense the *true* battery voltage and ensure the battery is properly charged and kept properly charged.

At the lower section of the circuit diagram is shown the pin layout diagrams and pin designators for the original 2CV voltage regulator, the RE57 voltage regulator and the Narva 68044 relay and 68084 socket **when looking directly at the connection pins**. As may be seen in the photo above, **the same pinout** for the RE57 regulator is also provided on the top face of the regulator, just below the "RE57" designator. After attaching the small metal mounting bracket supplied with the relay to the relay cover, mount the RE57 regulator and the relay and socket next to each other on the firewall, close to the battery, with their connection pins pointing downwards. Three short wires with spade crimp terminals can be made up to extend the three connections (D+, D- and DF) from the

PIN DESIGNATORS ARE SHOWN WHEN LOOKING DIRECTLY AT THE PINS

As shown on the circuit diagram at the last page, the 2CV voltage regulator is a three-terminal electrical device. The connections are named D+ (Dynamo+), D- (Dynamo-) and DF (Dynamo Field). Although car alternators have been around for over 60 years, the earlier Dynamo (Generator) terminology has generally remained in the automotive electrical industry.

As manufactured, the D+, D- and DF wires from the wiring loom terminate at a three-pin socket (shown on the circuit diagram), which connects to the three mating pins on the bottom face of the standard voltage regulator. This forms the voltage regulation and battery charging arrangement as the 2CV left the factory.
