# 2CV KNIFE EDGES REPLACEMENT

Revision 6

Graeme Dennes

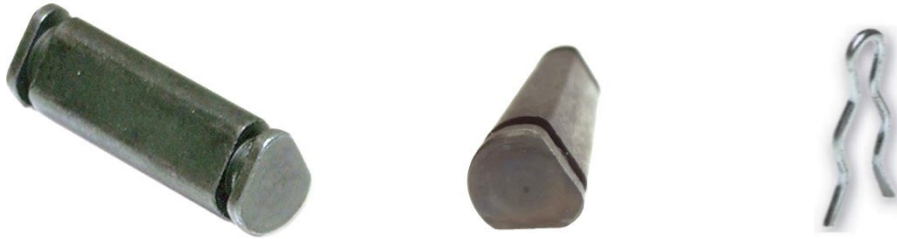
Photo 1: Knife Edge (left, centre) and Knife Edge Retaining Clip

The 2CV has four steel knife edges of the type shown in Photo 1. Two are part of the front suspension system and two are part of the rear suspension system. The rear knife edges are a little larger than those at the front. The knife edges are located between two mounting brackets attached to the suspension arms and held in place by two retaining clips fitted in the grooves on the ends. The knife edges are not circular in cross-section but have an angled edge. The items in the photo are shown approximately full-size.

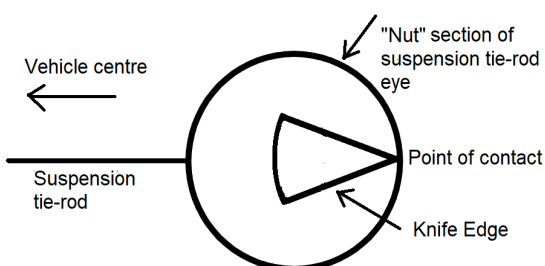
Fig. 1 (left) shows the physical relationship between the "nut" of the suspension tie-rod eye and the knife edge. The knife edge is positioned inside the "nut". The angled edge of the knife edge forms one contact face and the inner face of the "nut" forms the other, as in a fulcrum. These two faces are held in constant contact with each other due to the tension on the tie-rod from the suspension cylinder spring.

*The angled edge of the knife edges faces directly away from the suspension tie-rod and the vehicle centre when the vehicle is on level ground, as depicted in Fig. 1 above.*

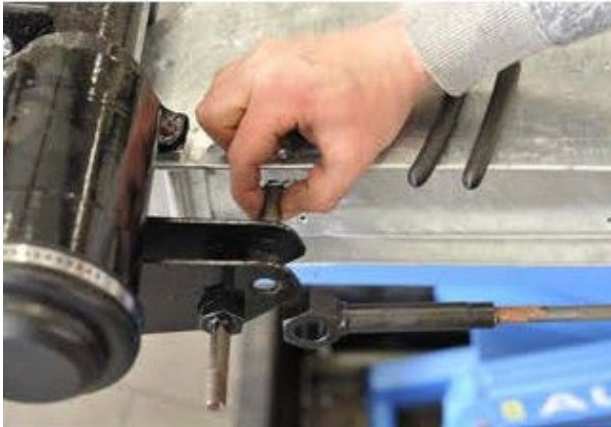
Photo 3 (left) shows a suspension tie-rod at lower right, fitted with its screwed-on tie-rod eye. The “nut” section at the end of the eye fits centrally between the two mounting brackets shown, locked in place by the knife edge which is ready to be inserted into position in the openings in the brackets. The brackets are fitted to the suspension arm assembly. The “nut” of the tie-rod eye is ready to be raised into position between the brackets, after which the knife edge is inserted into one bracket, passes through the “nut” of the tie-rod eye and out through the other bracket, then is locked in place in the brackets by retaining clips at each end. The large pin at lower left is a shock absorber mounting spindle.

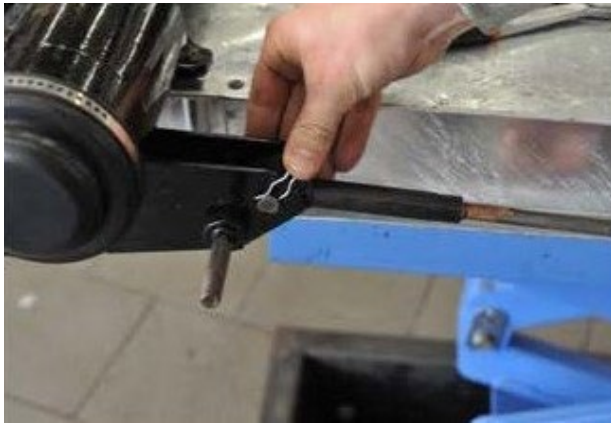
Photo 4 (left) shows a knife edge retaining clip being fitted into the grooved end of the knife edge after the knife edge has been passed through the mounting brackets and the tie-rod eye.

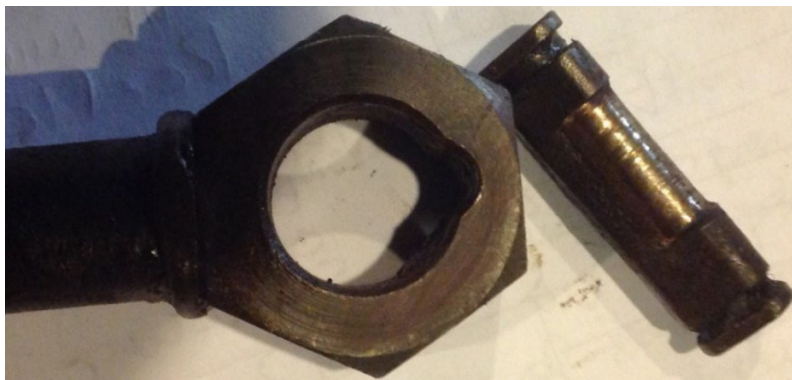
A reality for 2CV owners is that knife edges and tie-rod eyes eventually wear sufficiently to require their replacement. See Photo 5. Also, tie-rod eyes can and do break! See Photo 6. The following describes the parts required and the procedure to be followed to replace the knife edges, *and optionally*, the suspension tie-rod eyes. If one knife edge has worn, replace all four. If one tie-rod eye has worn or failed, replace all four.

10. Thoroughly degrease and clean the tie-rod eye and inspect it. There may be a small “vee” groove worn into the inside face of the “nut” on the tie-rod eye at the point where the “nut” contacts the angled edge of the knife edge.  
This is the only point of contact between the knife edge and the tie-rod eye. If the “vee” groove is very small, all is fine. Should excessive wear be observed, the tie-rod eye will need to be replaced. Don’t attempt a repair.  
Photo 5 shows a worn tie-rod eye and a worn knife edge. Note the depth of the “vee” worn into the “nut”. This amount of wear will be adding to the stress experienced by the “nut” because of the reduction in its cross-sectional area, so this suspension tie-rod eye is clearly overdue for replacement. The angled edge of the knife edge has also clearly worn and the edge rounded, so the knife edge shown is also due for replacement.

Photo 5: Well-worn “nut” on the Tie-Rod Eye and well-worn Knife Edge. Both items are due for immediate replacement. Don't attempt to repair them!

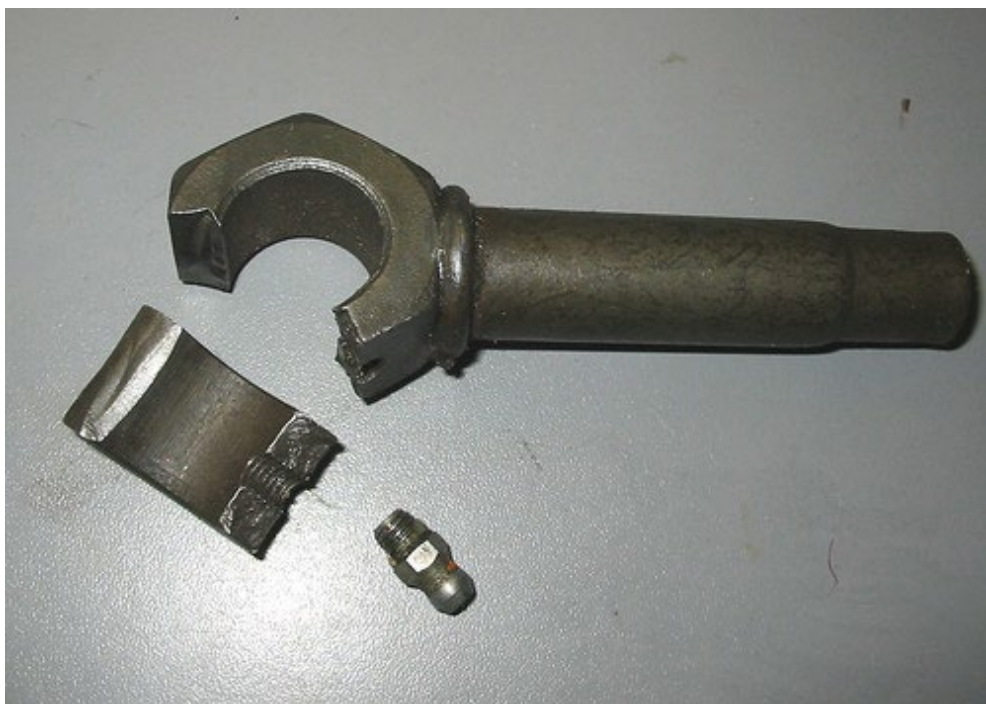
Photo 7: Suspension Tie-Rod Eye destroyed  
by a modification to fit a grease nipple

16. Run a couple of turns of lockwire around the ends of each retaining clip to act as a security measure to stop the clips being dislodged.
17. Inject some high-shock-loading grease such as Castrol Spheerol LMM into the tie-rod eye “nut” into the space above and below the knife edge using a needle-size attachment on the grease gun, angling it in via the small side openings. It does indeed work!  
*Don’t be tempted to modify the tie-rod eyes by fitting grease nipples to simplify greasing of the knife edges. Although some 2CV owners have gone this route, it can result in the destruction of the tie-rod eyes and a very long and winding road home! Refer to Photo 7 for an example of a tie-rod eye destroyed by such action!*
